Dirt Gravel and Low
Volume Road Program

Stream Crossing Replacement Monitoring

Hammond Run Replacement

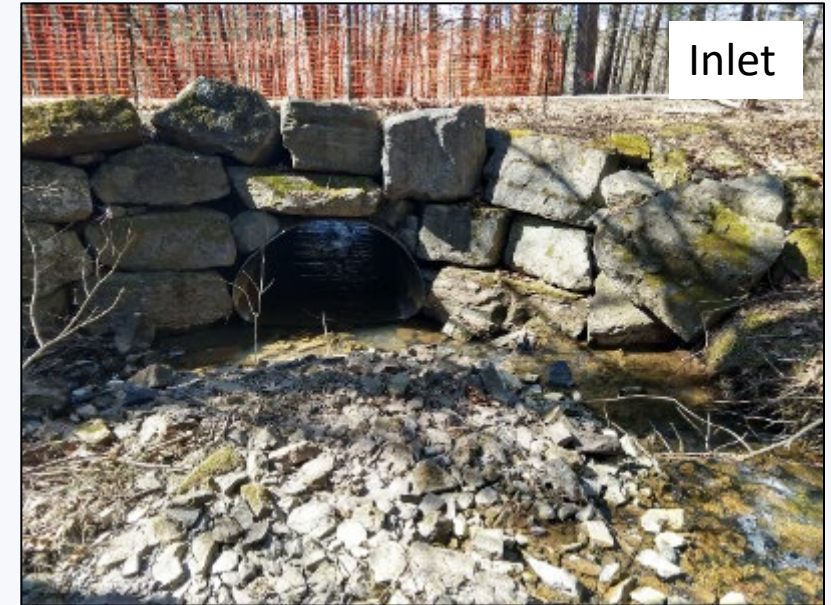
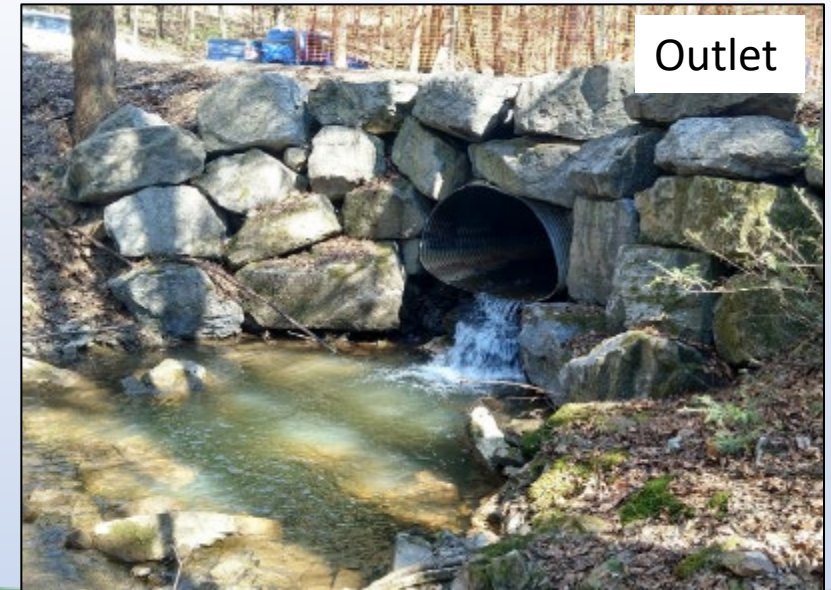
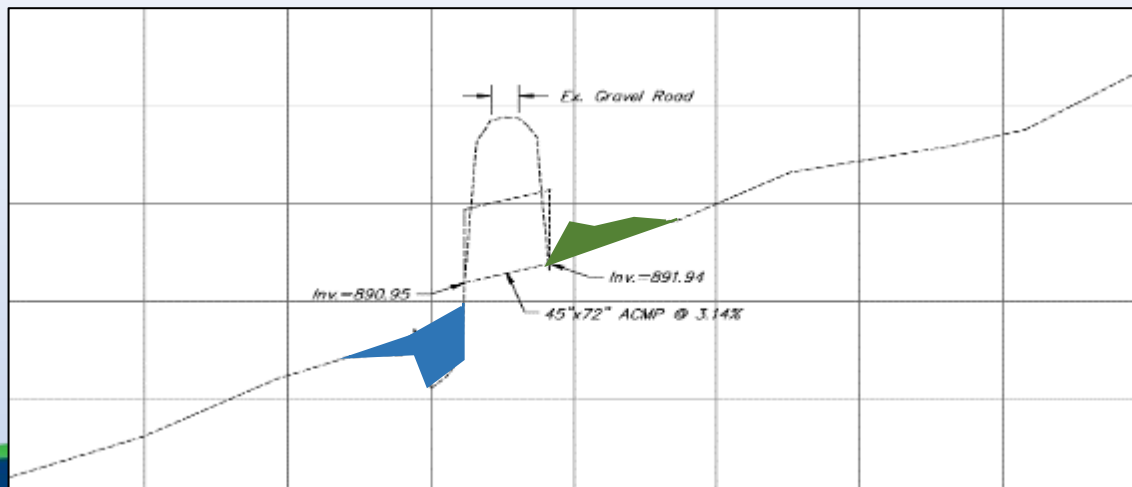
- Failing 6' squash pipe in a headwater stream with a 14' bankfull channel.
- Undersized crossing had created a significant upstream sediment wedge and downstream scour hole with a ~3' outlet drop.
- ~5% Slope

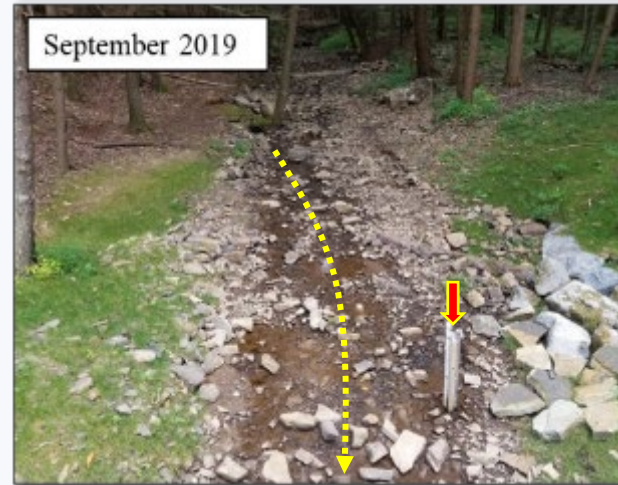
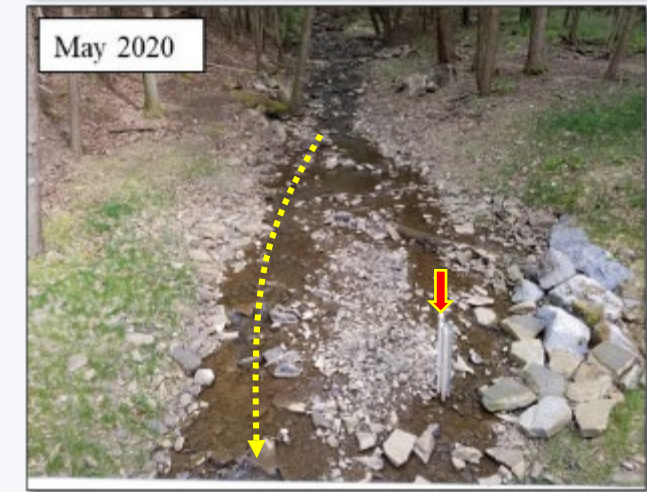
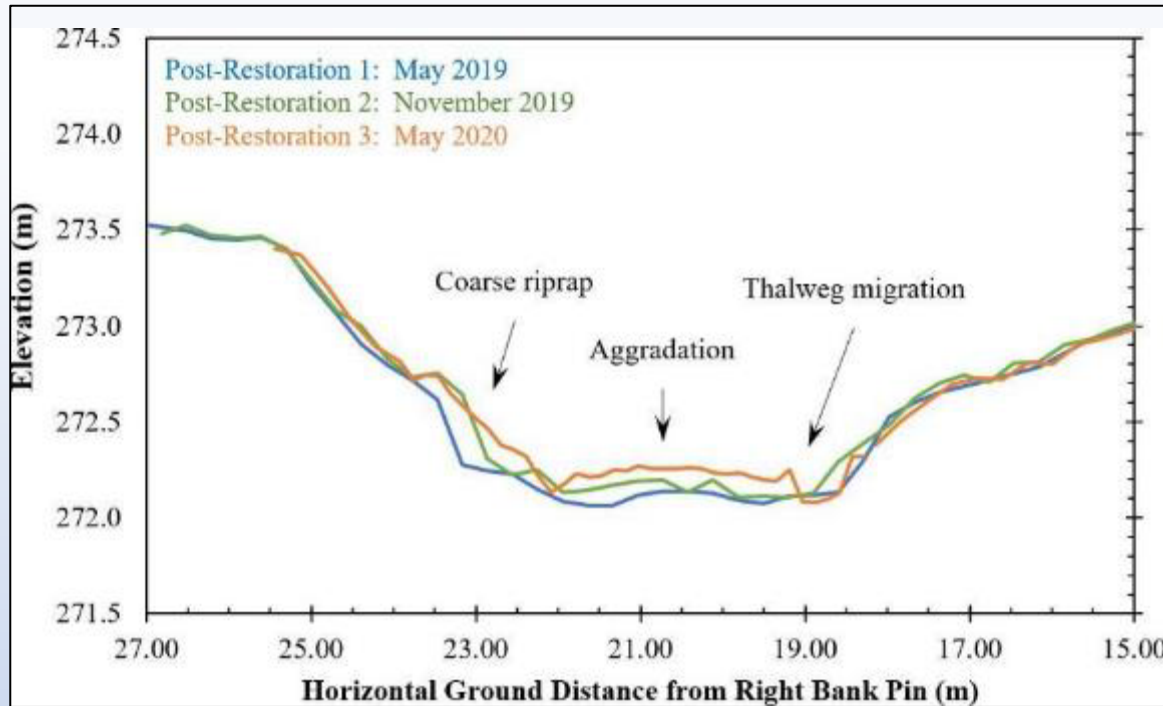
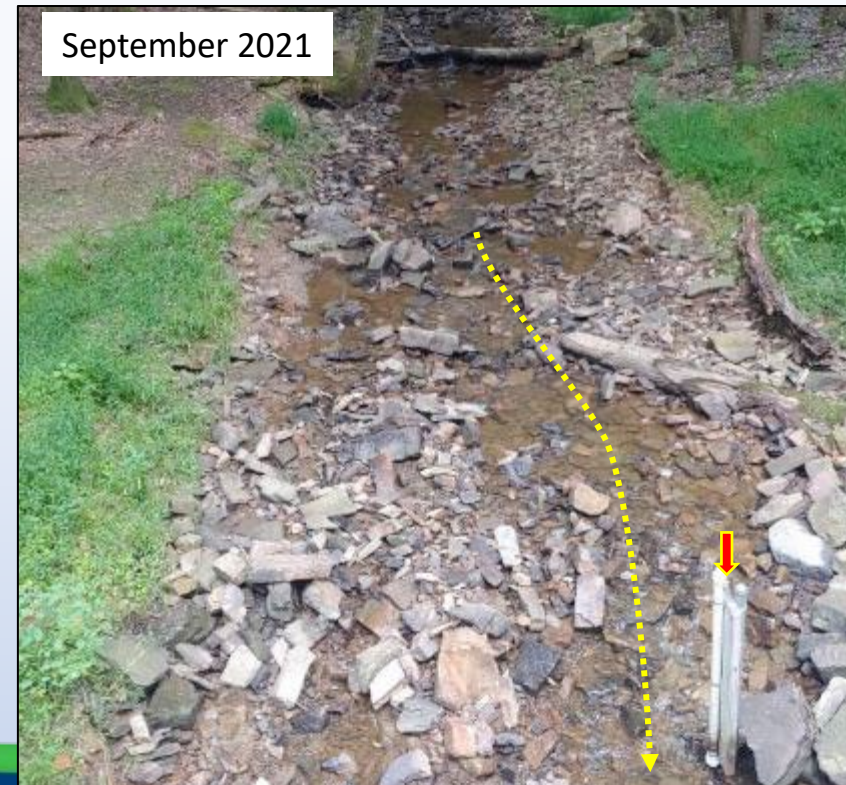
- Channel adjustments through aggradation, degradation and thalweg migration.

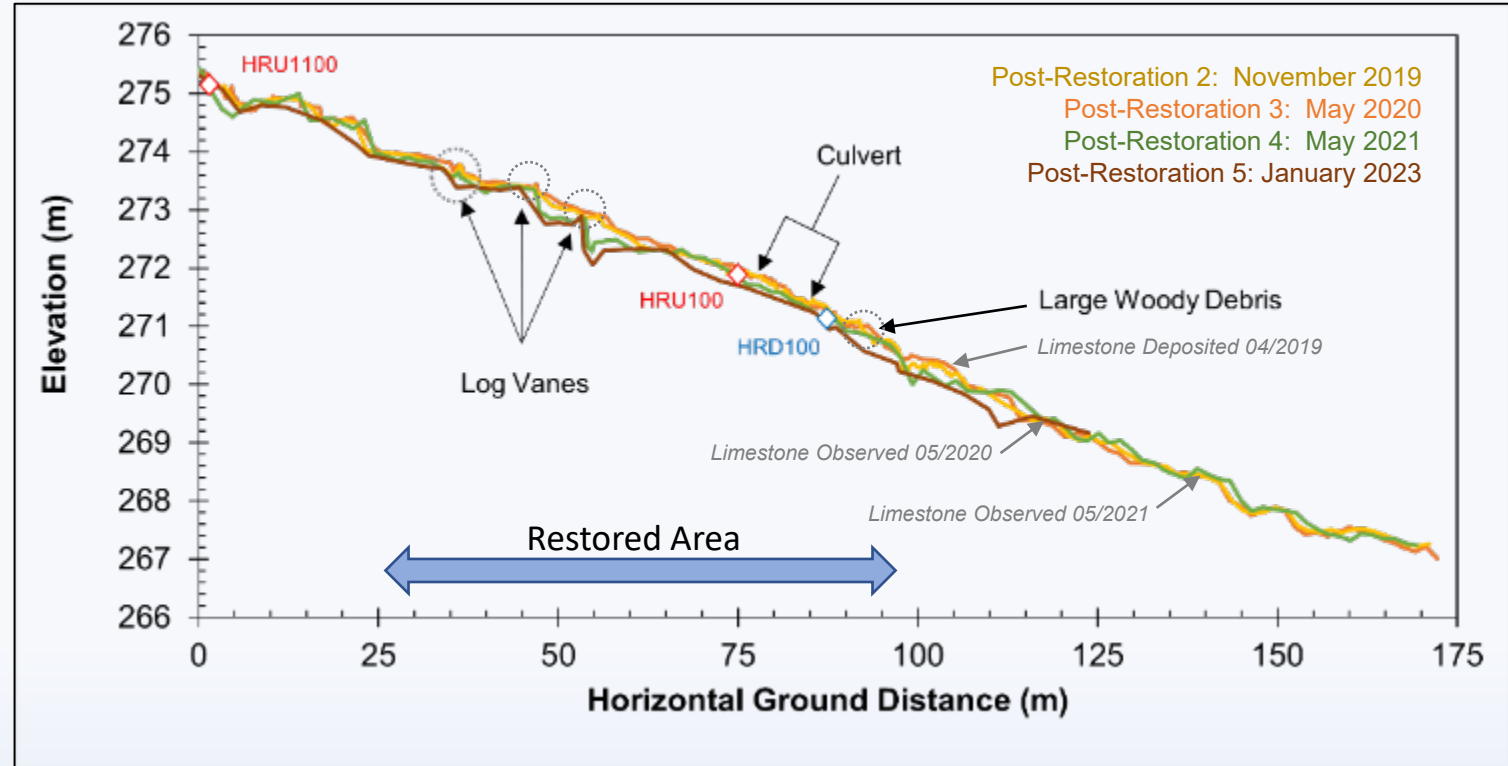
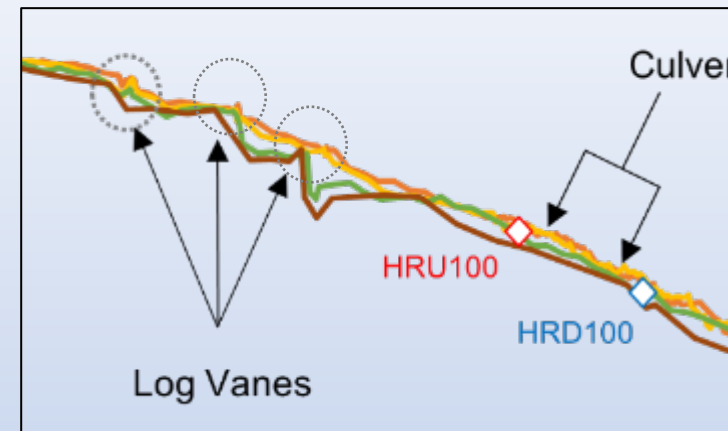
- Significant changes at 1st upstream cross-vane
- Some change at 2nd upstream cross-vane
- Stable through crossing
- Moving material larger than 12-18" diameter

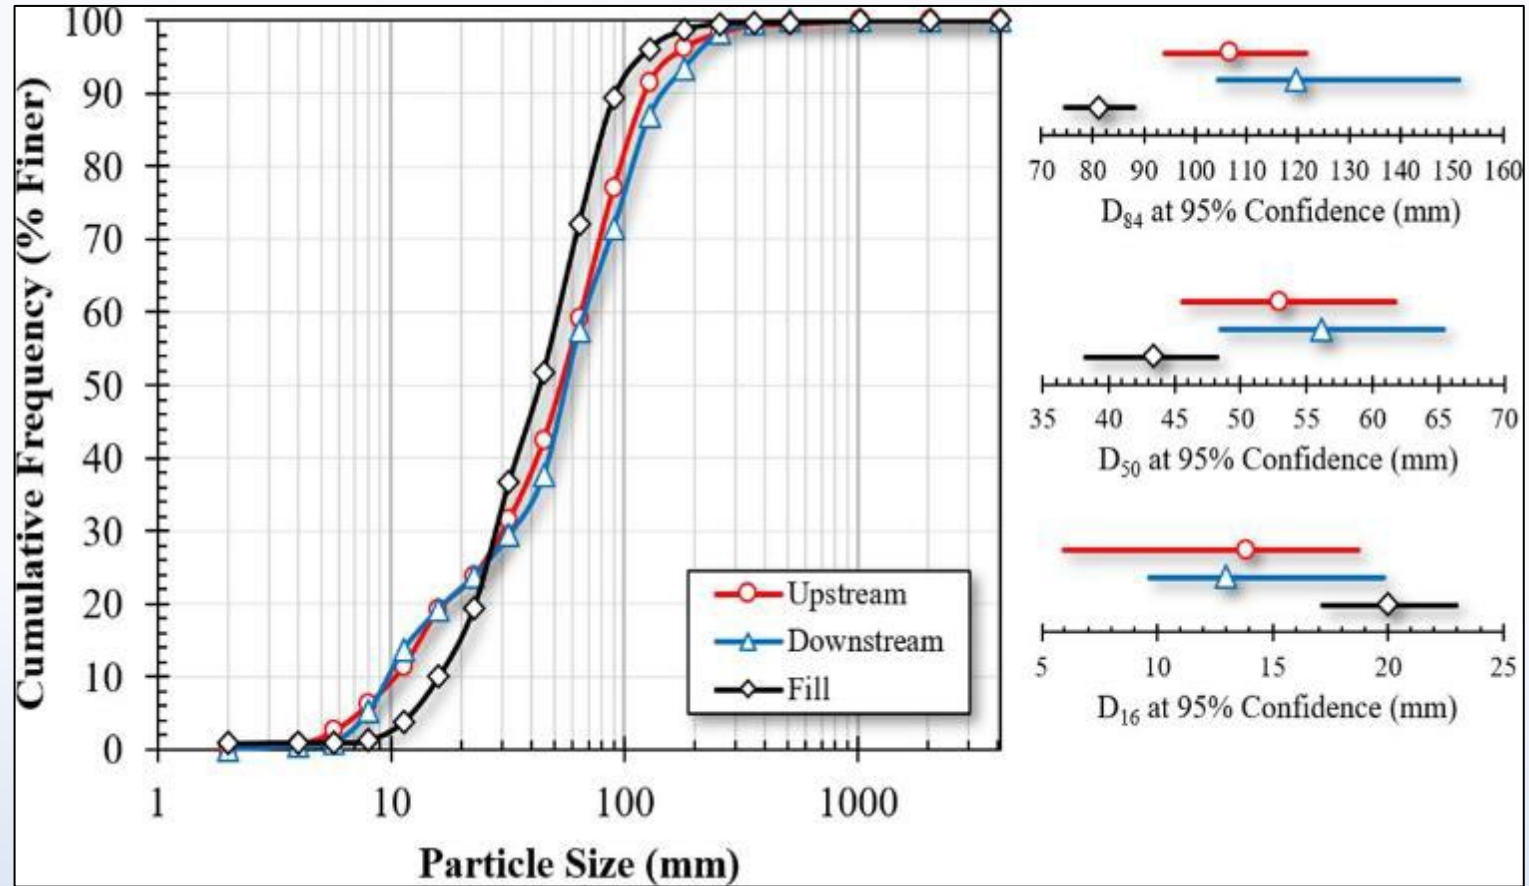
- Fill material has less fine material and is smaller on the upper end.
- Upstream and downstream outside restored reach are similar.
- Subsurface flow during summer low-flows around crossing.

“Perfect continuity” means particle sizes upstream, downstream and through structure would be the same
