**COMPARATIVE ANALYSIS OF COMMONLY USED AGGREGATE
MATERIALS AND PLACEMENT METHODS FOR A SURFACE WEARING
COURSE ON LOW-VOLUME ROADS IN PENNSYLVANIA**

A Thesis in

Environmental Pollution Control

Steven M. Bloser

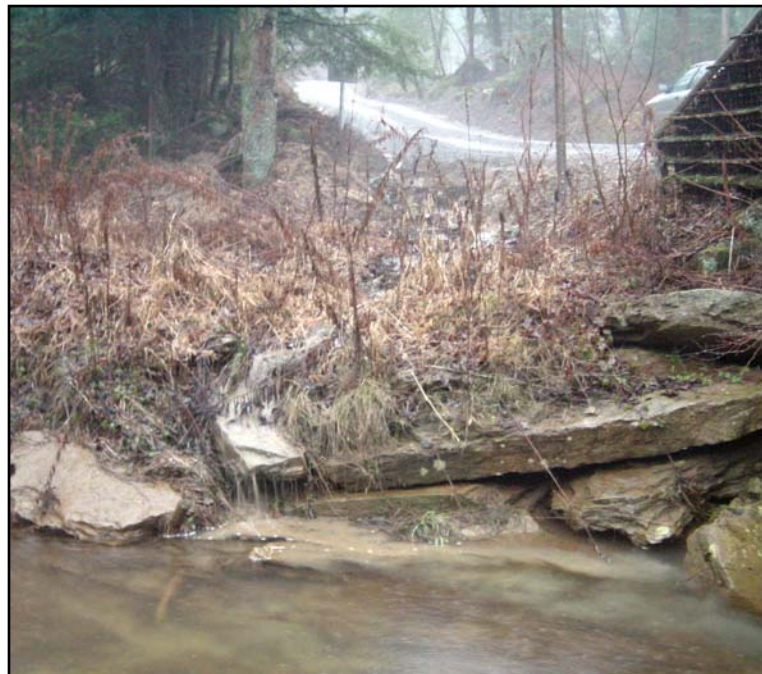
Figure 1. Ditches from the unpaved road in the background dump sediment into a High Quality stream at a bridge crossing near Clarion, PA.

Any loose material generated from the road surface is mobilized in runoff during rain events. Runoff containing eroded aggregate from the road surface is usually collected in ditches that run parallel to the road. These ditches collect and concentrate road drainage until they leave the road area, either through a cut in the road bank or a culvert (cross-drain or crosspipe) under the road. Many times, these ditches and crosspipes drain water directly into adjacent streams, lakes, and wetlands. Figure 1 illustrates a road ditch as it empties road sediment into a stream at a typical crossing in Pennsylvania during a moderate rain event. To gain a more complete perspective on the pollution potential of unpaved road runoff, the ditch pictured in Figure 1 needs to be multiplied by four, in order to account for the other three ditches not pictured at this single bridge. The four ditches at this one stream crossing then need to be multiplied by the tens of thousands of stream crossings that exist on Pennsylvania's 20,000 miles of unpaved public roads. As they wear down and wash away, many of these roads are continually being surfaced with some form of surface aggregate. Any improvement in the durability and erosion resistance of surface aggregates will achieve extensive reductions in the amount of sediment pollution generated by unpaved roads.

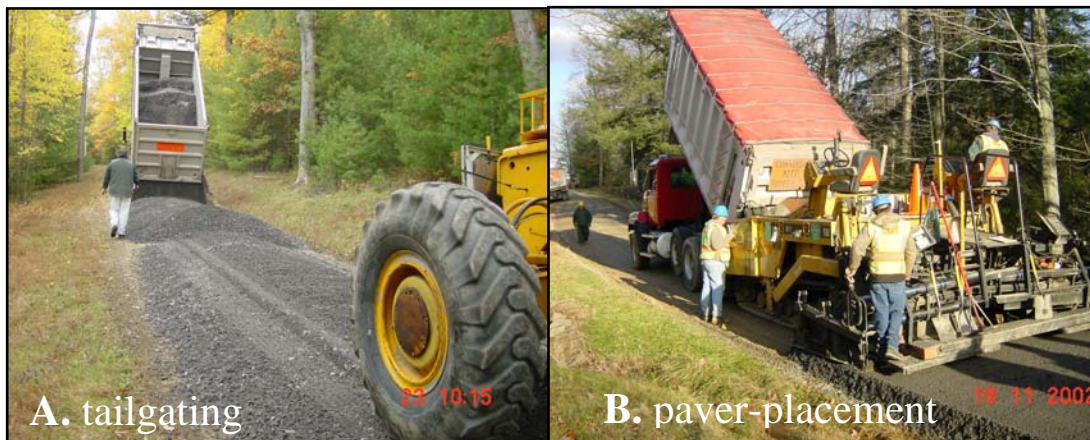
Figure 2. Photo “A” on the left illustrates the process of tailgating aggregate. A windrow of aggregate has just been dumped out of the truck. A motor-grader waits to spread the material and shape the road. Photo “B” on the right illustrates the placement of aggregate through a paver. The truck is dumping aggregate directly into the paver which uses an auger to minimize segregation as it places material on the road.

Paver placement of aggregate, shown in Figure 2B, is done to prevent segregation of aggregate by size, and to control the depth and shape of placement. The paver is the same equipment used to place asphalt. Aggregate is dumped out of trucks directly into the paver which places it onto the road in a single lift at the desired depth and shape. No asphalt or other bonding agents are used. A roller is then used to achieve proper compaction of the placed aggregate.

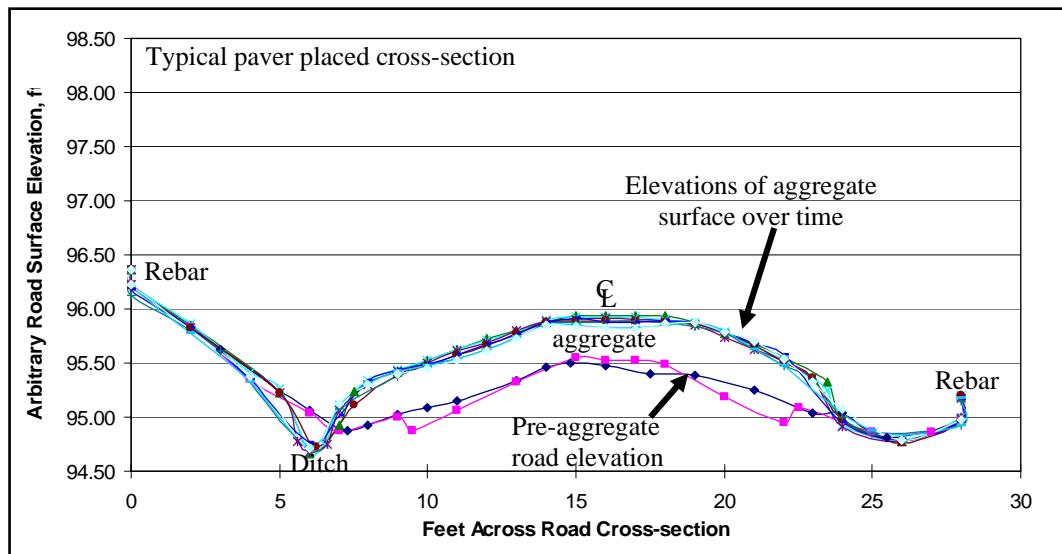
Figure 4. Repeated surveys of a single cross-section for a paver placed aggregate are illustrated here.

section. Successive cross-sectional surveys were conducted at time intervals of 1 month, 4 months, 6 months, 8 months, 12 months, 16 months, 2 years, 2 ½ years, and 3 years from aggregate placement. In conjunction with each survey that was conducted, pictures and notes were taken for each of the six aggregate sites. Pictures were standardized to allow for direct comparisons of road surfaces over time. The surveyed profiles of aggregate will be used to determine and compare both bulk aggregate loss and surface deformations (rutting) over the three years of study.

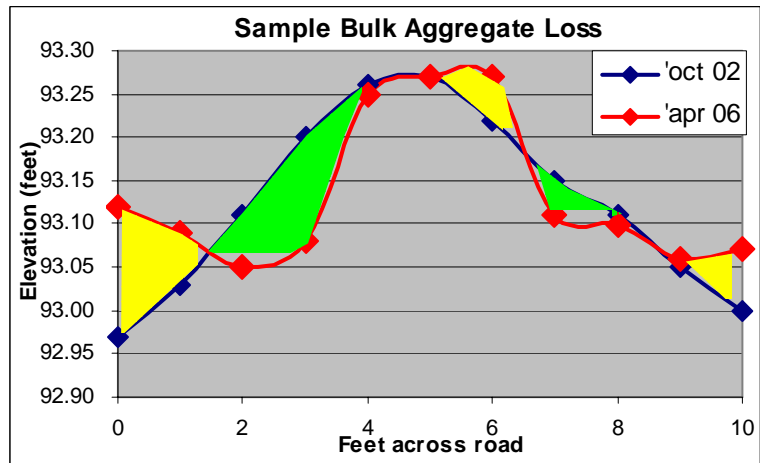
Figure 6. Sample of bulk aggregate loss analysis. In this case, simply comparing the average elevation change would make this cross-section look stable since elevation loss (shaded green) is nullified by elevation gain (shaded yellow).

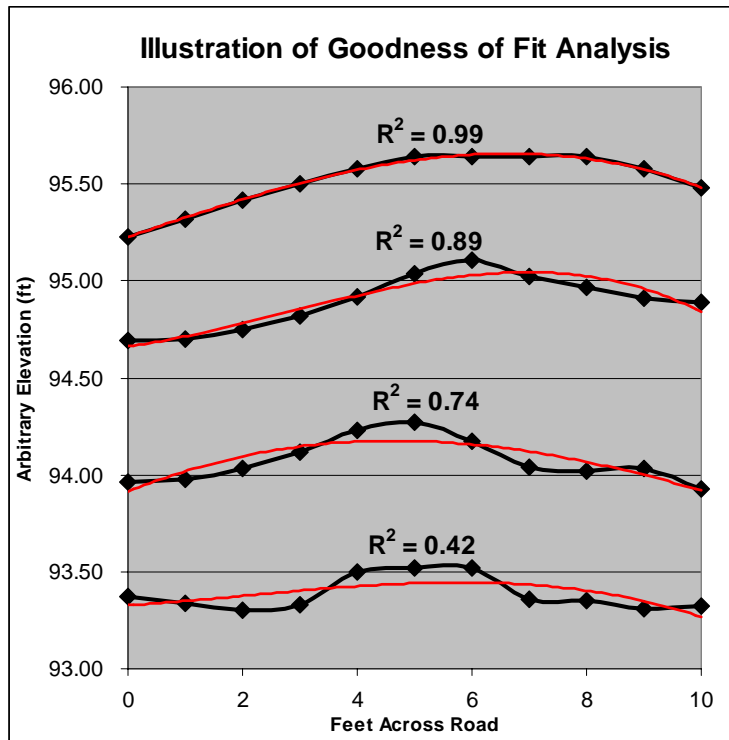
Figure 8. Sample of goodness of fit rutting analysis. The data points on each cross-section (shown in black) are fitted to their third order polynomial trendlines (shown in red). The resulting R^2 value is a quantification of the rutting with $R^2=1$ indicating an ideal surface. Actual cross-sections are illustrated (cross-section IDs from top = 5.3, 1.3, 3.2, 4.3). Elevation baseline is arbitrary; Figure is for R-squared comparative purposes.

The degree of rutting can be further quantified by comparing the goodness of fit of the points on each cross-section with the ideal cross-sectional shape. The ideal cross-section shape can be approximated by determining the trendline for each road profile. It was determined that a third-order polynomial trendline provided the best approximation of the ideal cross-sectional shape since it was the lowest order trendline that fit the newly placed aggregate profiles with an average R^2 of over 95%. A third-order polynomial provided an average of 97% goodness of fit for the surveys of newly placed aggregate. Figure 8 illustrates the value of using R^2 to quantify rutting by illustrating several cross-sections along with their trendlines and corresponding R^2 value. By comparing the R^2 value of newly placed aggregate to the surveys completed in April, 2006, it is possible to further quantify the increase in rutting over the course of the study. This test is confirmed by comparison with rut depth and volume calculations, and by visual correlations with field and survey observations. An R^2 value of 100% would indicate no rutting, while a R^2 value of below 85% would indicate significant rutting, and an R^2 value of below 70% would indicate severe rutting.

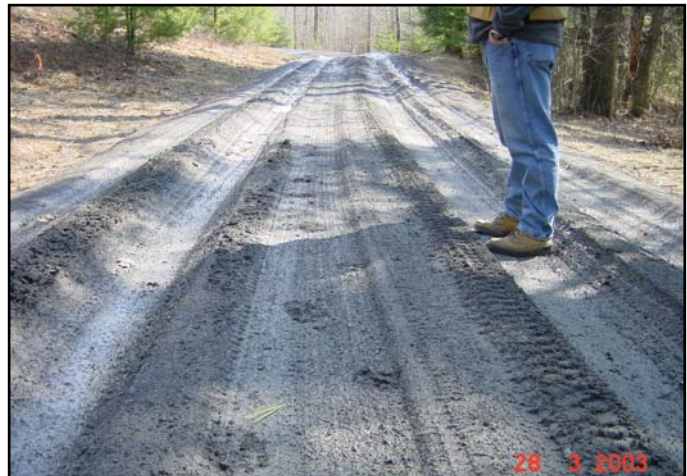
Figure 9. Severe rutting occurred on both of the 2RC aggregates over the first winter. The severe rutting on “Section 4: 2RC, Paver” is illustrated here.

Bulk aggregate loss analysis showed little signs of an overall drop in road surface elevation in the time periods before or after grading in 2003. An extremely high degree of rutting (average 47% drop in R^2 value) was found in this aggregate placement both before and after grading. This corresponded to the observations of rutting as shown in Figure 9.

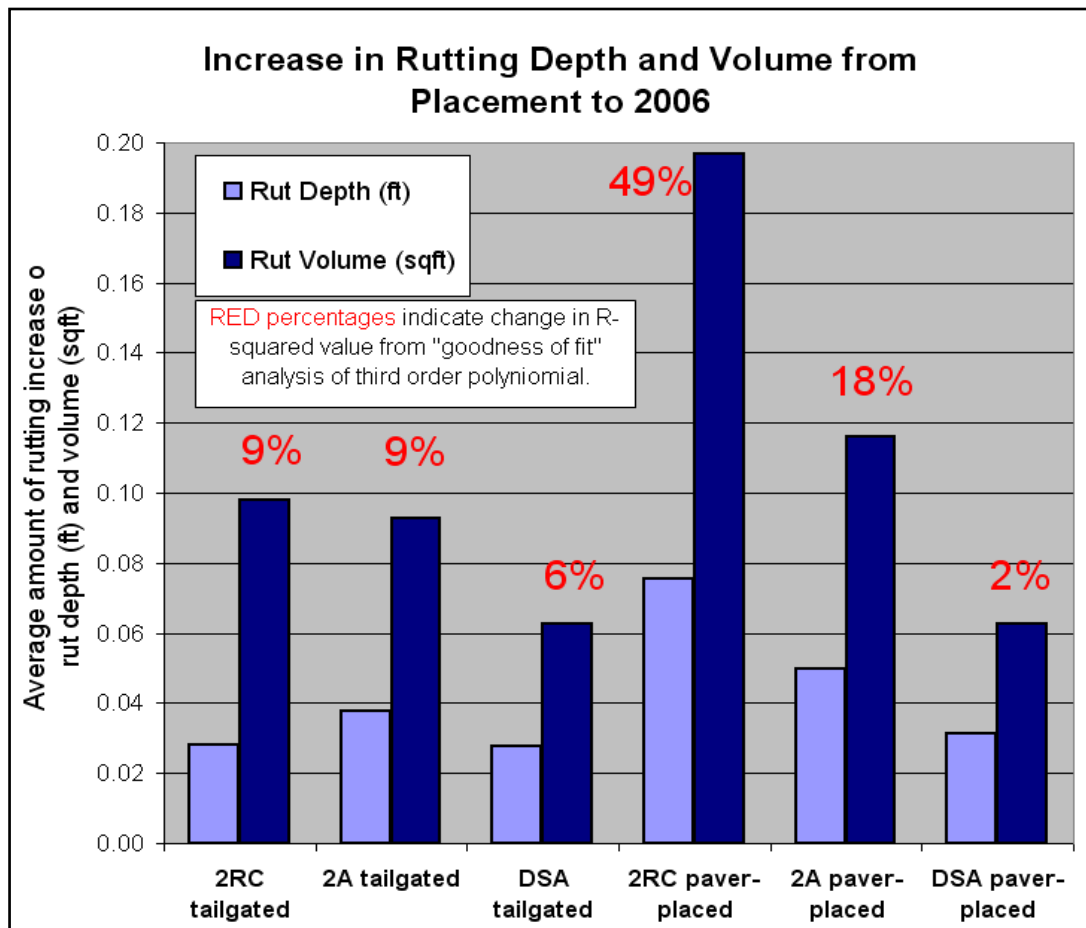
Figure 10. Rut depth and volume were measured for each cross-section. Three cross-sections for each aggregate placement were then averaged. This Figure represents the average increase in rut depth (ft) and rut volume (ft^2) over the course of the study. Red percentages indicate change in R^2 value from goodness of fit analysis for comparison.

Further quantification of the degree of rutting was done by measuring the depth and volume of the ruts on each cross-section as outlined in Figure 7. The results of the rutting measurements were averaged for the three cross-sections on each aggregate placement. Results of the rut depth and volume measurements are summarized in Figure 10 (full results in Appendix D). For comparison, the R^2 values obtained from the goodness of fit analysis are included in Figure 10. The results of the rut depth and volume measurements show a strong correlation with the goodness of fit analysis previously discussed. Once again, the two sections of DSA aggregate showed the least amount of rutting, with section 4, 2RC paver-placed, showing the most rutting.

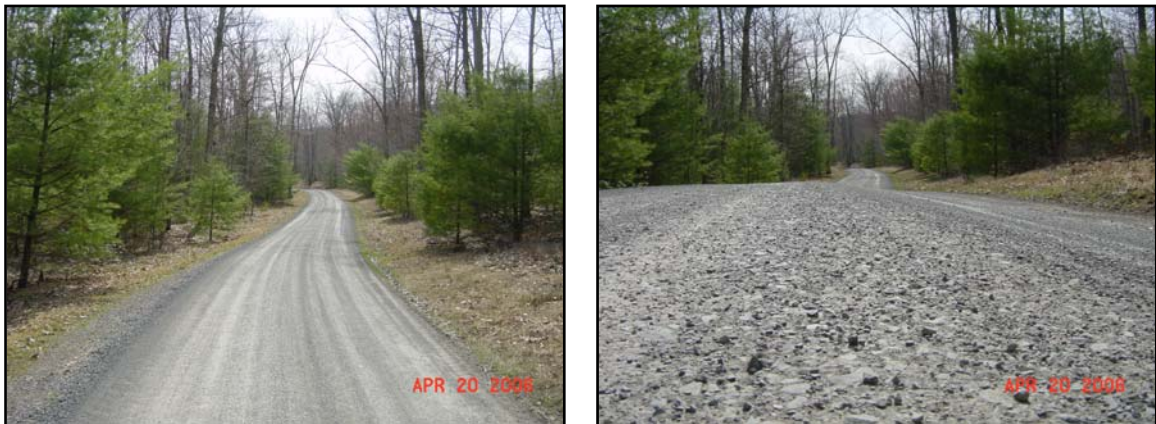
Figure 11. Section 1, 2RC Tailgated, shown in April of 2006. More pictures located in Appendix C.

Section 1 was graded in April 2003 because the surface was soft and slightly rutted. Field observations repeatedly found that the two sections of 2RC had a significantly smoother surface texture than the other two aggregates. The high amount of fines along with the presence of clay made the surface of this aggregate relatively soft and almost “soil-like” in appearance and feel. In general, the 2RC sections showed the least amount of loose stone both on the surface of the roadway and along the road edge.

Bulk aggregate loss analysis showed little signs of an overall drop in aggregate surface elevation in the time periods before or after grading in 2003. A moderate degree of rutting (average 9% drop in R^2 value) was found in this aggregate placement.

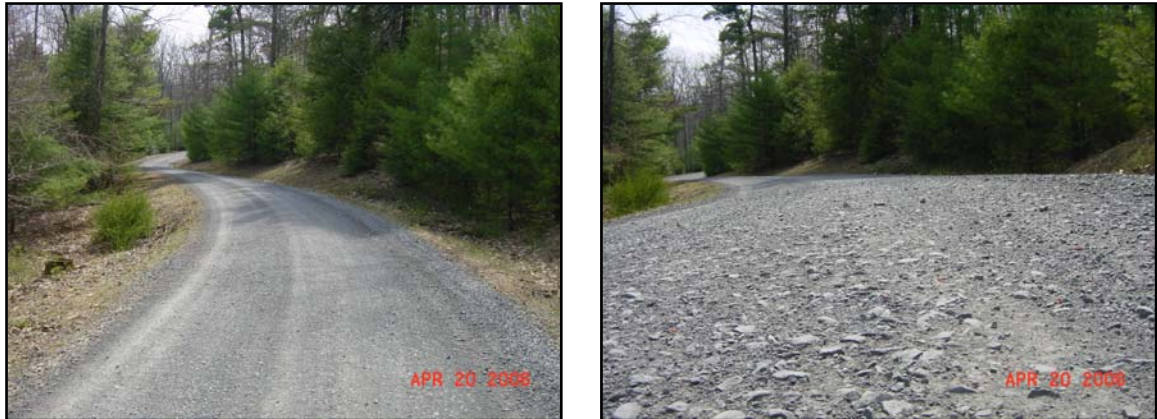
Figure 12. Section 2, 2A Tailgated, shown in April of 2006. More pictures located in Appendix C.

Field observations found that this section of 2A Tailgated consistently had a large amount of large loose stone between and beside the wheel tracks. The loose stone was typically several inches deep and could easily be moved with light foot pressure. The wheel tracks themselves were typically hard-packed. The 2A sections had the largest amount of large stone visible as part of the road surface. The large stone can be seen to in the picture to the right in Figure 12.

Bulk aggregate loss analysis showed a significant drop in surface elevation over the three years of study. A moderate degree of rutting (average 9% drop in R^2 value) was found in this aggregate placement.

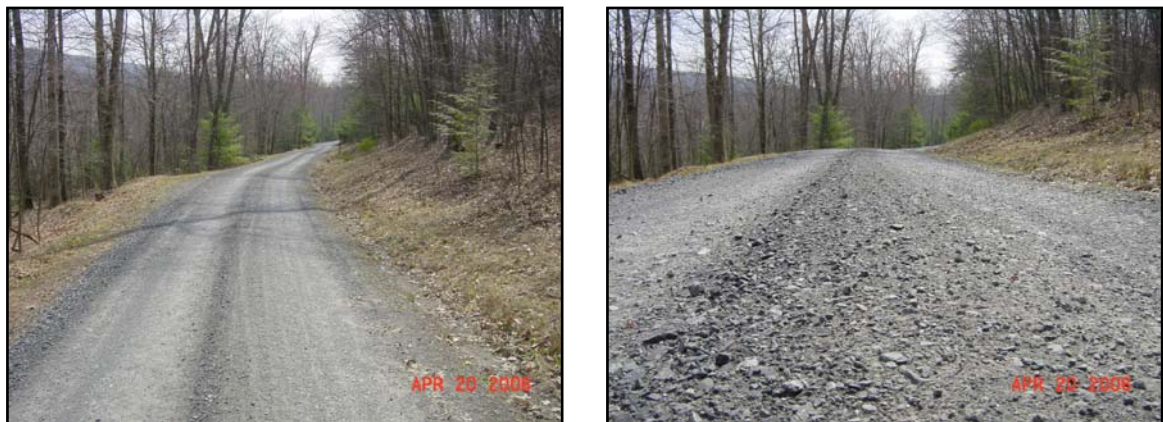
Figure 13. Section 3, DSA Tailgated, shown in April of 2006. More pictures located in Appendix C.

Field observations found that this section of DSA Tailgated had some loose stone between and beside the wheel tracks. The wheel tracks were typically hard packed with some exposed large stone (~1”) embedded in the driving surface. Road crown was more pronounced in this section than most others.

Bulk aggregate loss analysis showed that two of the three cross-sections did not have a statistically significant drop in elevation. This was the only un-graded aggregate placement to show no significant change in surface elevation. A low degree of rutting (average 5% drop in R^2 value) was found in this aggregate placement.

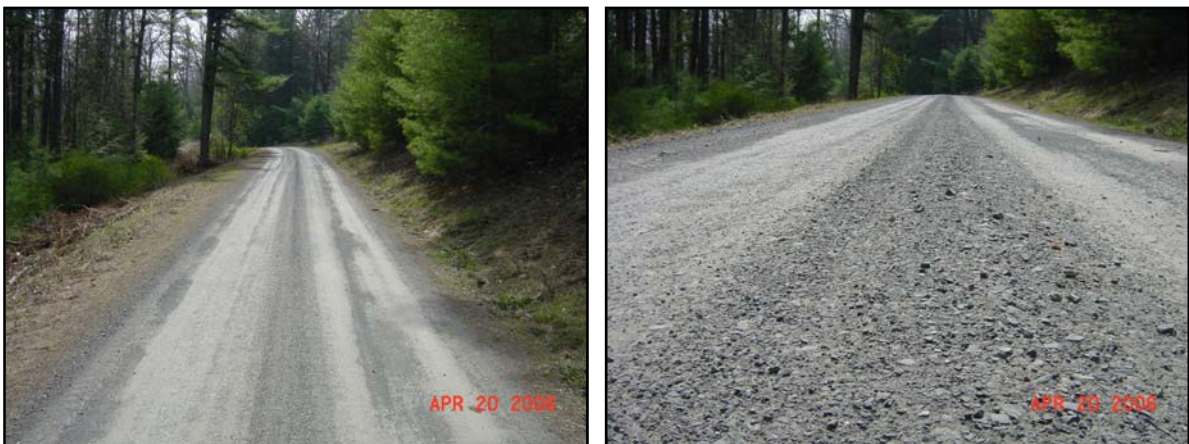
Figure 14. Section 4, 2RC paver-placed, shown in April of 2006. More pictures located in Appendix C.

Field observations found that this section of paver-placed 2RC was consistently the softest and most rutted of the aggregates. This section was graded in April of 2003 because 4-6 inch ruts had formed in the aggregate which made the road impassable to low-clearance vehicles. The surface of the aggregate was typically smooth with very little loose stone. During dry weather, dust was more noticeable on this section than any of the others.

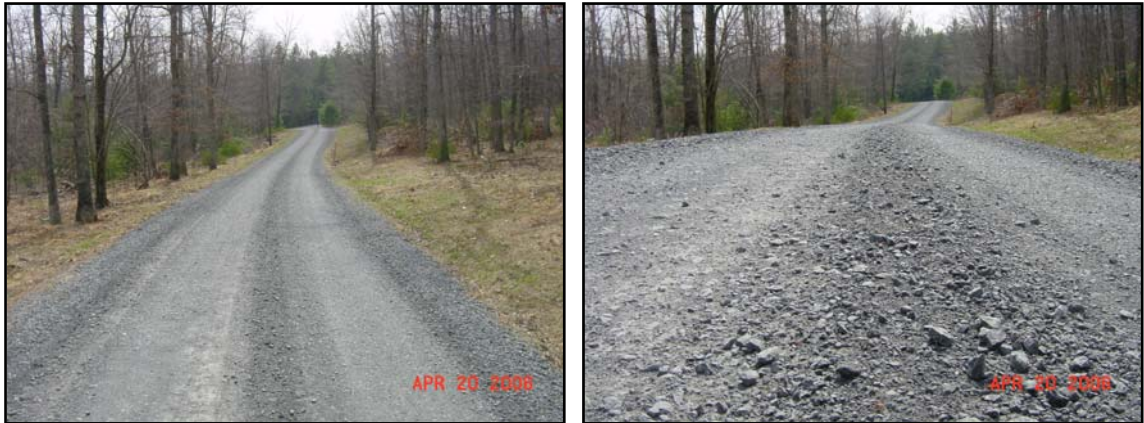
Figure 15. Section 5, 2A paver-placed, shown in April of 2006. More pictures located in Appendix C.

Field observations found that this section of 2A paver-placed consistently had the largest amount of large loose stone between and beside the wheel tracks. The loose stone was typically several inches deep and could easily be moved with light foot pressure. The wheel tracks themselves were typically hard-packed. This section showed the largest degree of elevation difference between the lowered wheel tracks and the piles of loose aggregate.

Bulk aggregate loss analysis showed a significant drop in average road surface elevation through the three year study. A high degree of rutting (average 17% drop in R^2 value) was found in this aggregate placement.

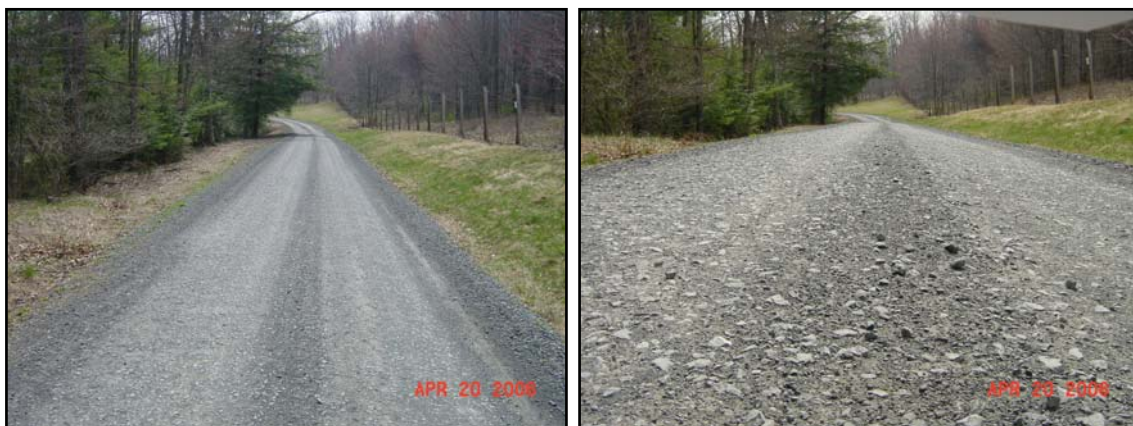
Figure 16. Section 6, DSA paver-placed, shown in April of 2006. More pictures located in Appendix C.

Field observations found that this section of paver-placed DSA had minor amounts of loose stone between and beside the wheel tracks. The entire surface of this section was hard packed and uniform with no visible rutting.

Bulk aggregate loss analysis showed a significant drop in average road surface elevation through the three year study. The lowest degree of rutting (average 2% drop in R^2 value) was found in this aggregate placement.

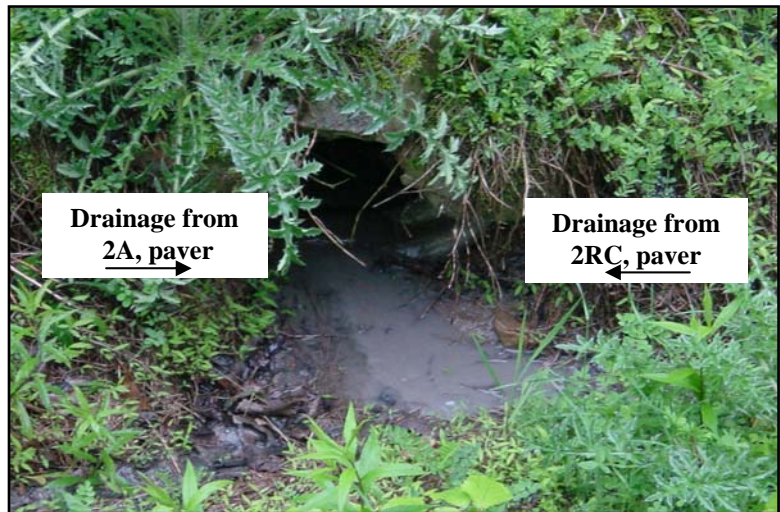
Figure 17. This culvert is located at the boundary of two aggregate placements. Clear runoff on the left of the image is runoff from “Section 5: 2A, Paver.” The sediment-laden water on the right of the image is runoff from the clay containing aggregate on “Section 4: 2RC, Paver.”

In addition to rutting, several observations during the course of this study support the idea that the clay in the 2RC aggregate is more available to detachment. First, the 2RC sections of aggregate consistently had more dust than other aggregates by visual

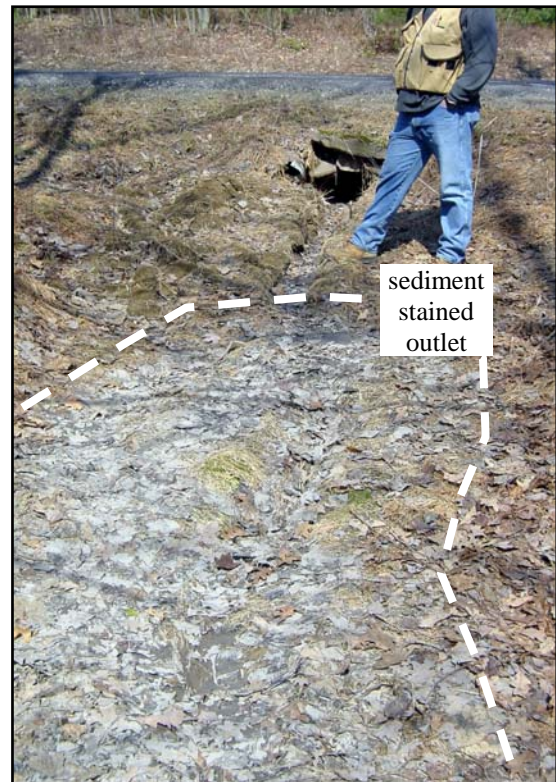
Figure 18. This culvert outlet located on “Section 4: 2RC, Paver” is visibly stained with sediment from runoff. Other aggregate sections had minimal visible sediment or outlet staining.

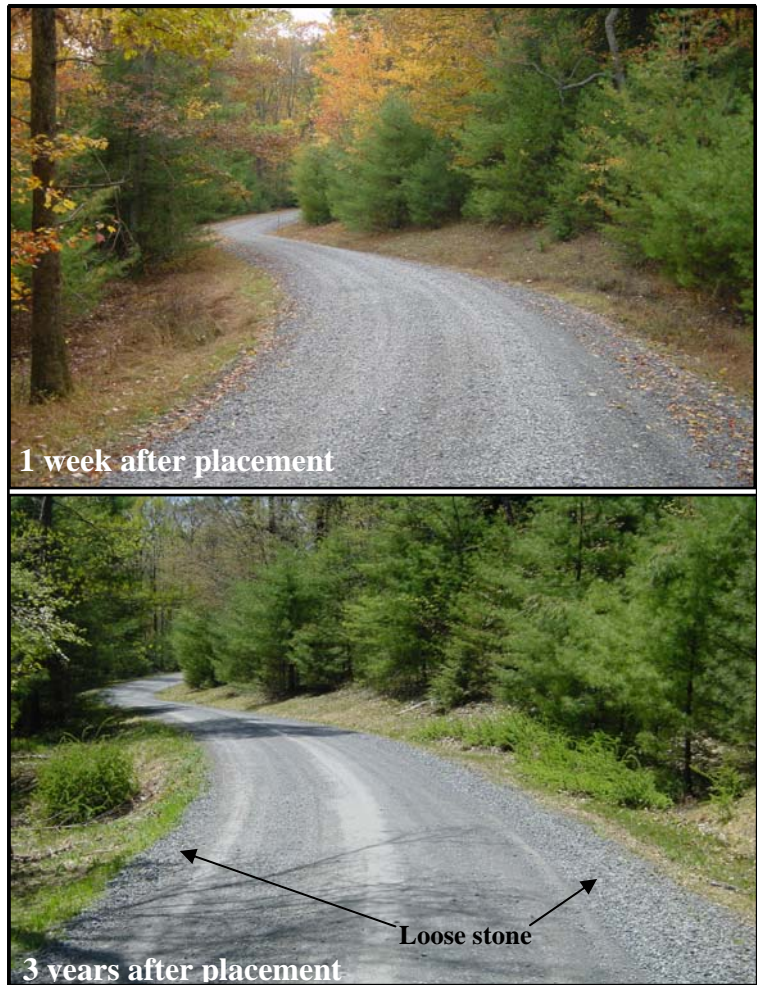
Figure 19. “Section 2: 2A, Tailgated” illustrates the outward migration of larger size aggregate. Larger stones are mobilized and windrowed on the centerline and shoulders of the roadway.

of loose stone that line the edges of the 2A placement sections (Figure 19).
