# Research Update

## Real-time Dust Monitoring

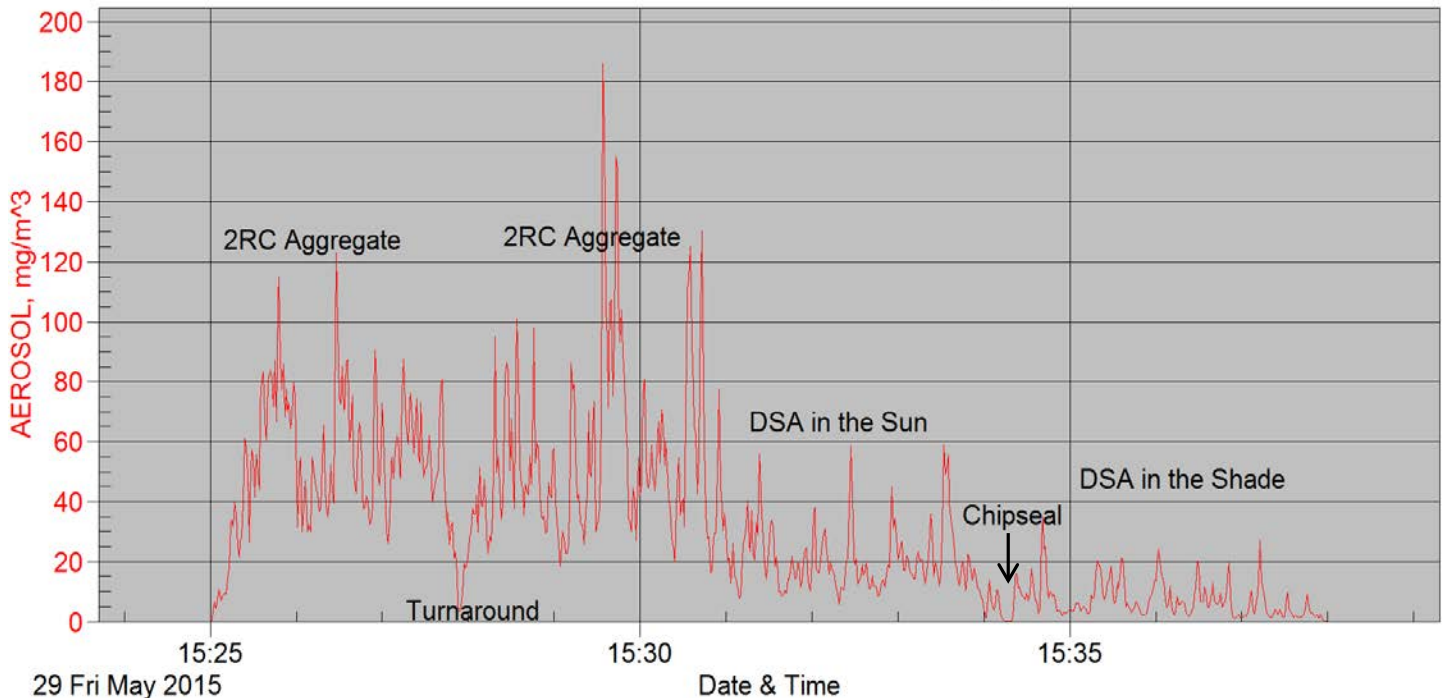
In May of 2015 the Center began testing the vehicle-mounted dust monitoring system. Initial testing was conducted on Scotia Road in State Game Lands 176 comparing a 3 year old placement of the Center's DSA to a more commonly used road surface aggregate mix (2RC) that typically contains clay and silt fines. Monitoring started on a 2 mile long 2RC loop with a halfway turnaround. After completion of the loop the vehicle was driven immediately onto a 3 mile stretch of DSA surfaced road with both open and shaded sections. The results showed that the DSA section in the sun produced 2/3 less dust than the comparable 2RC road in the sun. The DSA section shaded by the tree canopy produced less than 1/7 of the dust as the 2RC section of road and approximately ½ the dust of the DSA in the sun (Figure 3). After processing the data and making minor changes to the monitoring setup, testing was repeated in July.

2RC in the sun – 53.3 mg/m<sup>3</sup>

DSA in the sun – 17.5 mg/m<sup>3</sup>

DSA in the shade – 7.0 mg/m<sup>3</sup>

**Figure 2.** Initial dust monitoring results, Scotia Road May 29, 2015.

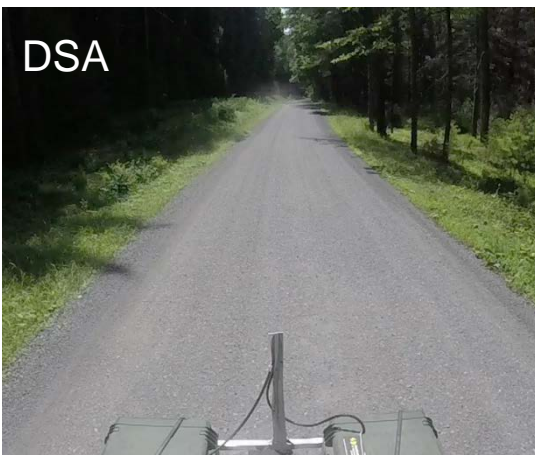
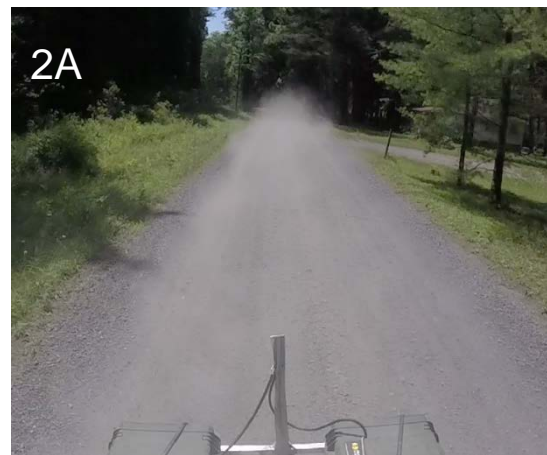
**Figure 4.** A GoPro camera was mounted on the rear of the vehicle to visually track dust production and canopy openings. The photograph on the left shows the dust production from the DSA 1-2015 section of Laurel Run Road compared to the 2A section on the right.
