Dirt, Gravel, and Low
Volume Road Program

2023 Project Showcase

2023 QAQC Project Showcase

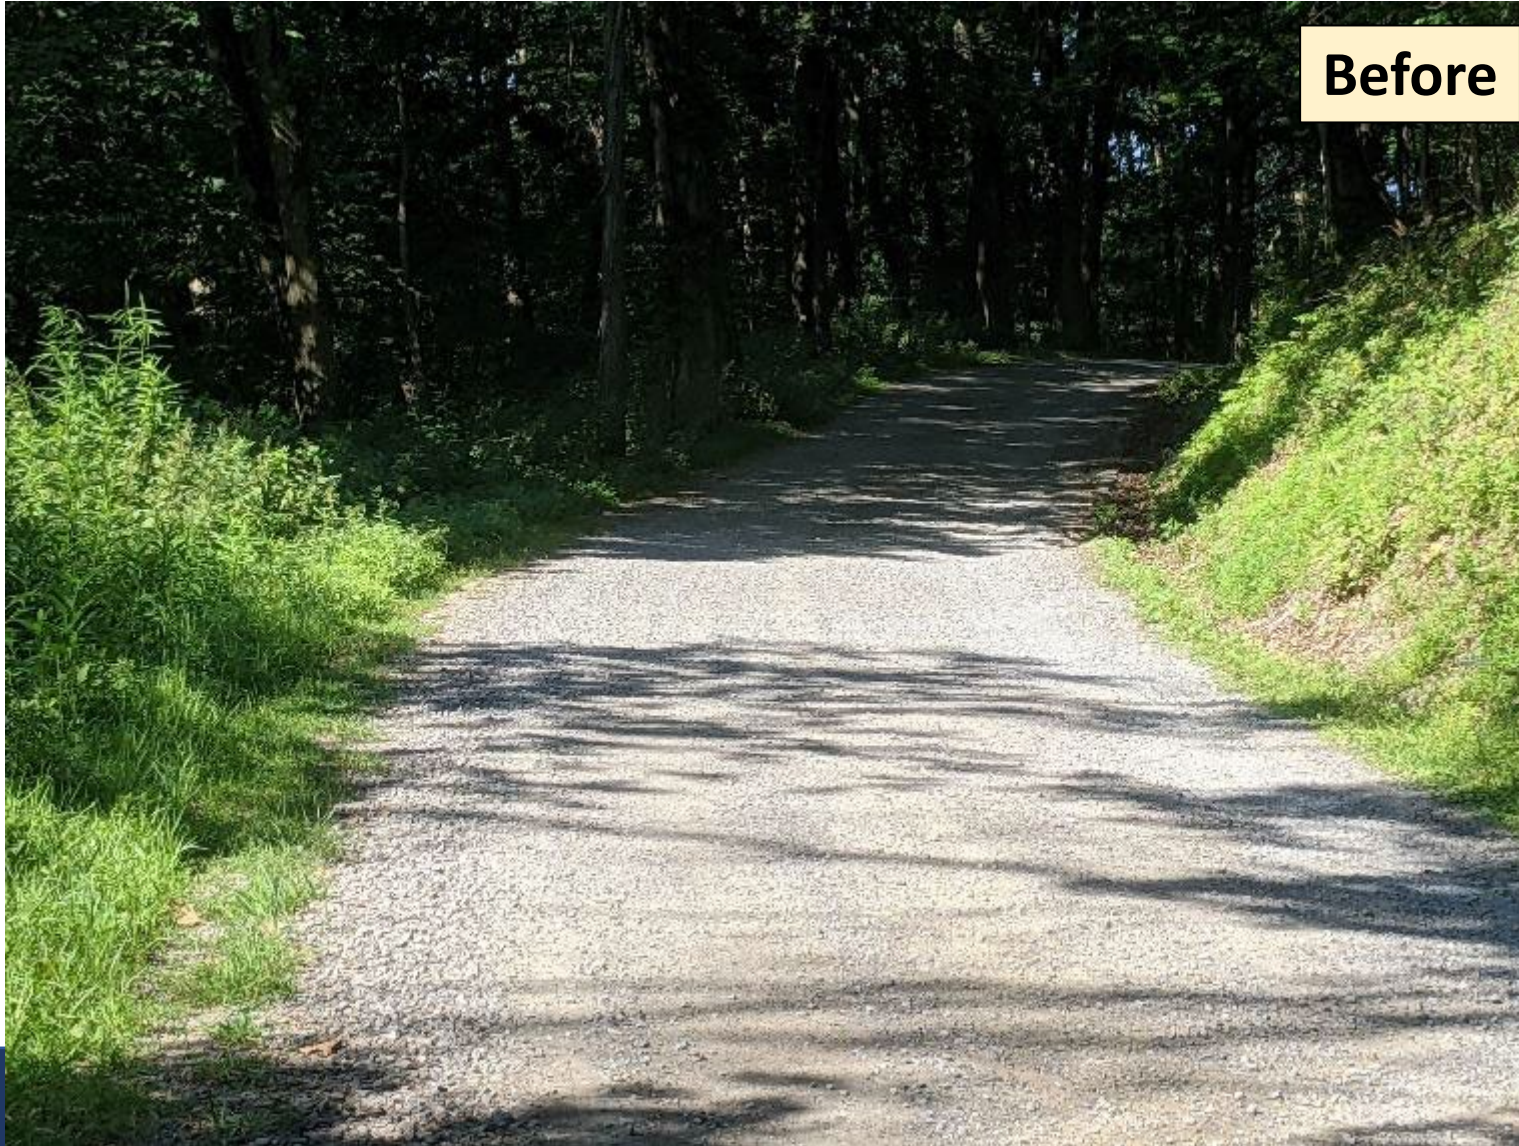
Before

Problem being addressed:
The road was entrenched with insufficient stormwater drainage outlets.

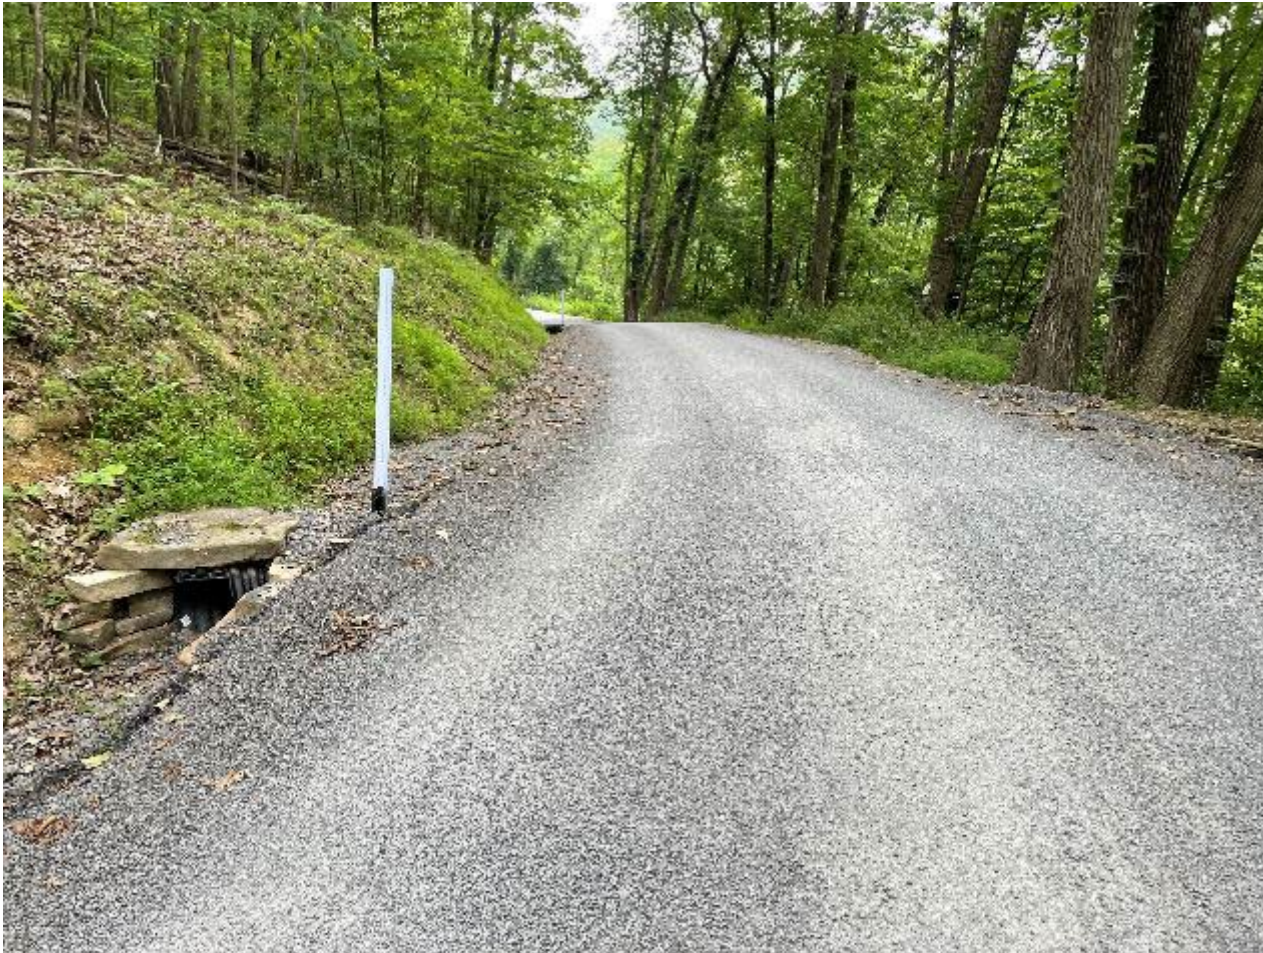
Project Description: (Site Length: 1,196 ft) **“classic” fill and drainage project**

- 7 new cross pipes and 1 cross pipe replaced
- 3,050 tons of road fill was placed to raise the road out of entrenchment and provide downslope sheet flow off the road.
- The project site was chip sealed by the township following completion of the project.

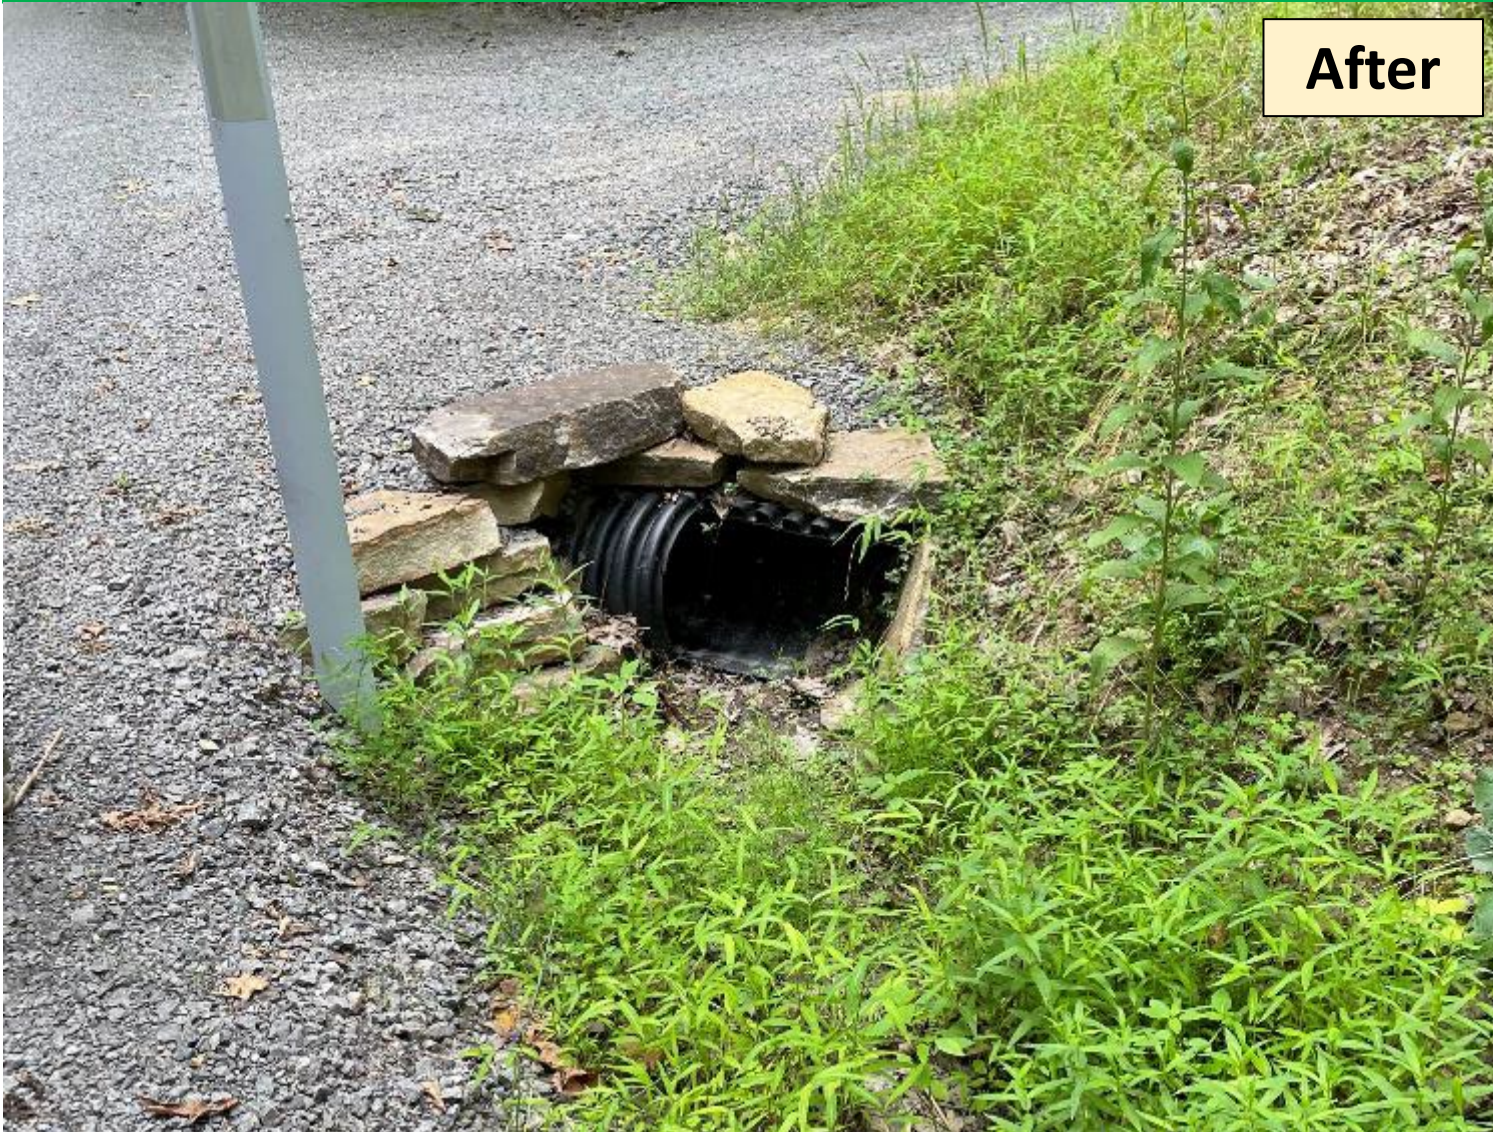
After

- Stable inlets
 - No bank gouging
 - Solid headwall material stacked well
 - Inlet of pipe cut to help direct water into it
- Frequent, stable outlets
- Road fill elevates surface high enough to achieve sheet flow

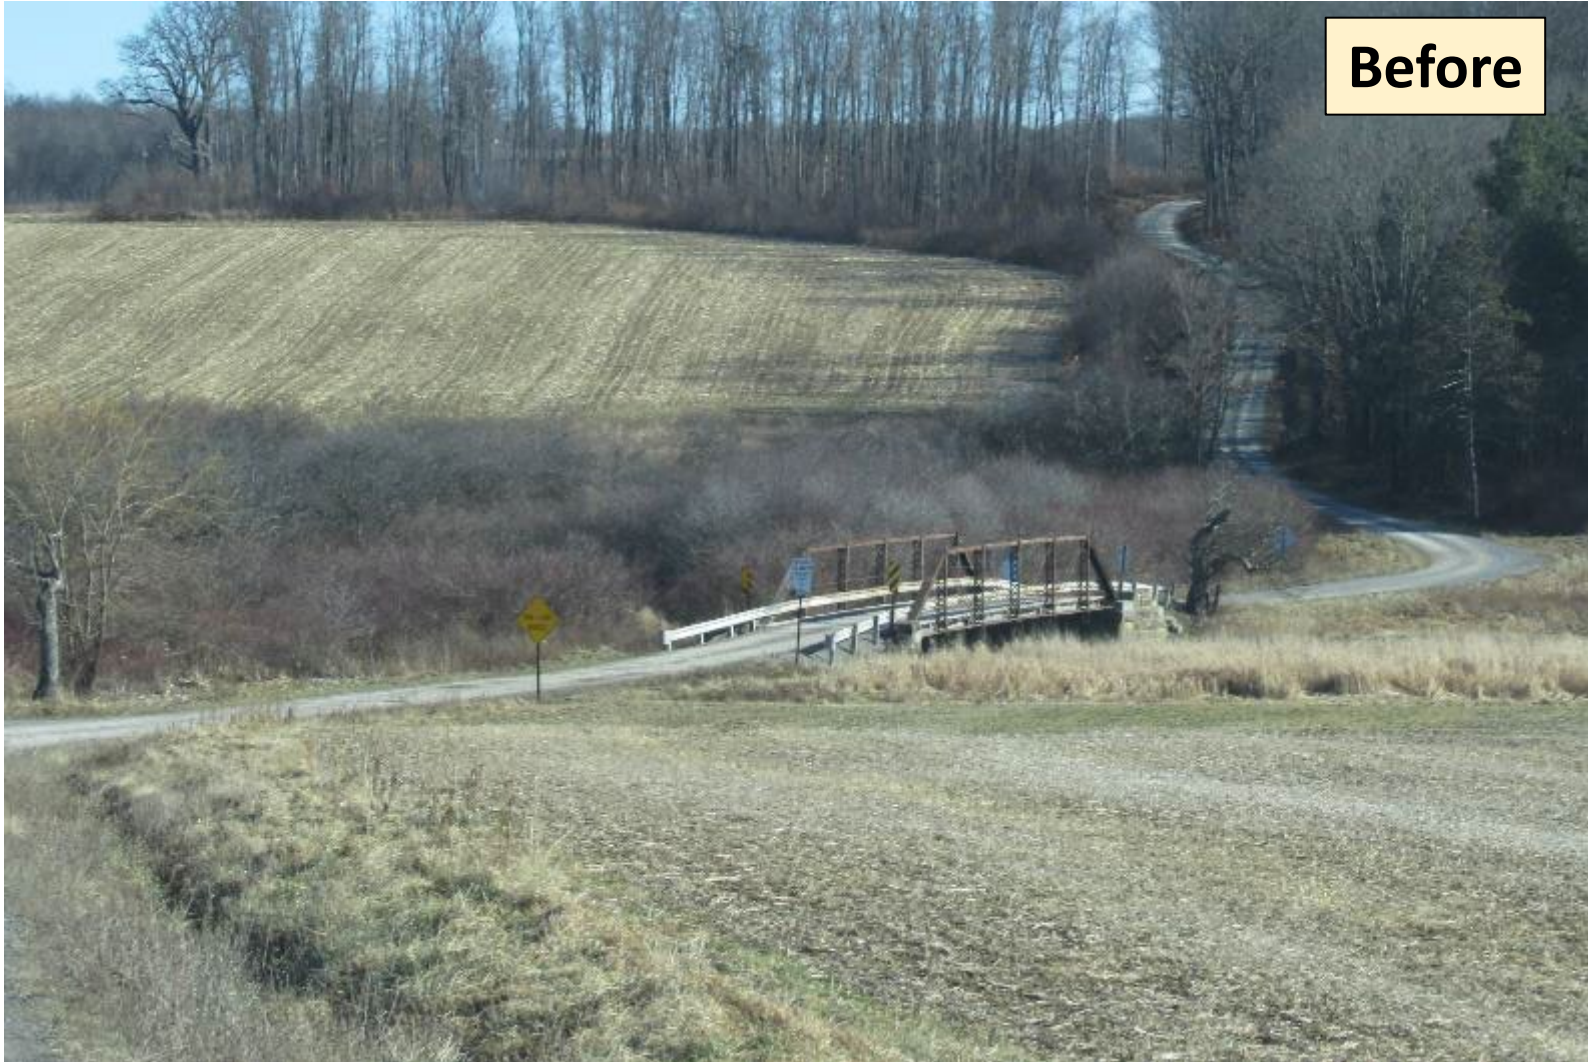
Before

- Yonai Road traverses an expansive floodplain in the head waters region of the Stonycreek River.
- During even modest rain events and snow melts, the floodplain fills with water, ponding on the road.

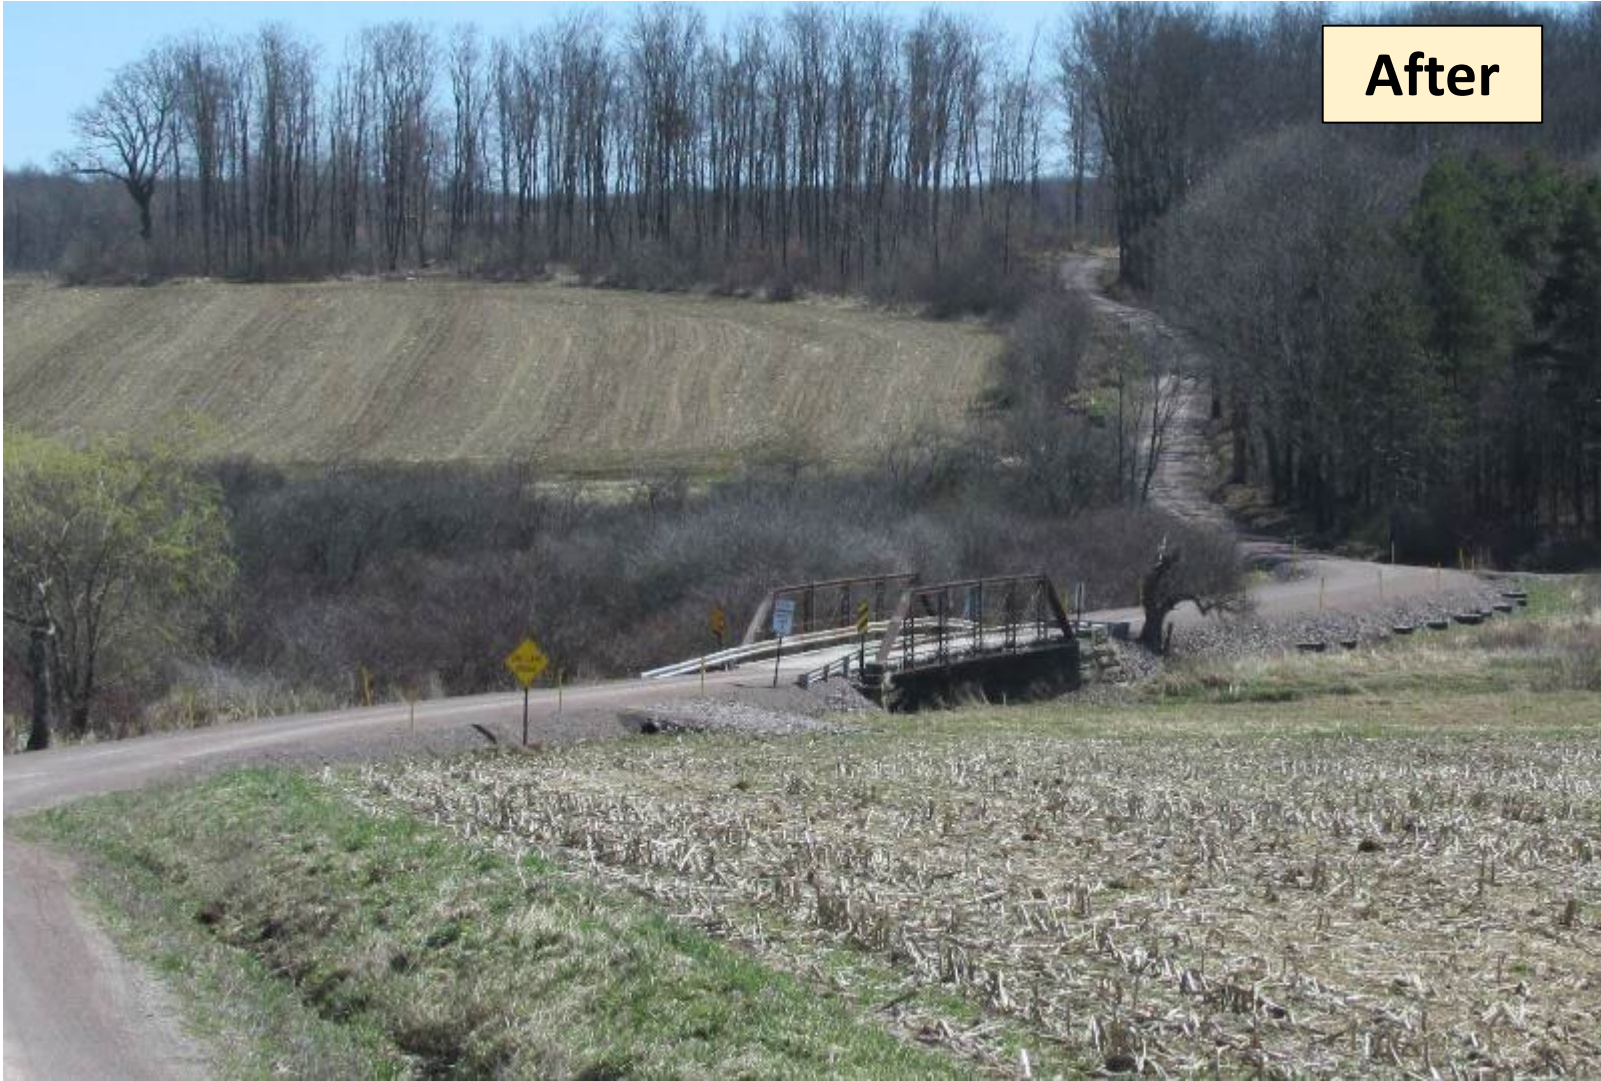
After

- The Township installed a 500' x 24' x 3' thick French Mattress with twelve (12") relief pipes through the mattress.
- Roadside ditches turned out to discharge away from the stream and mattress

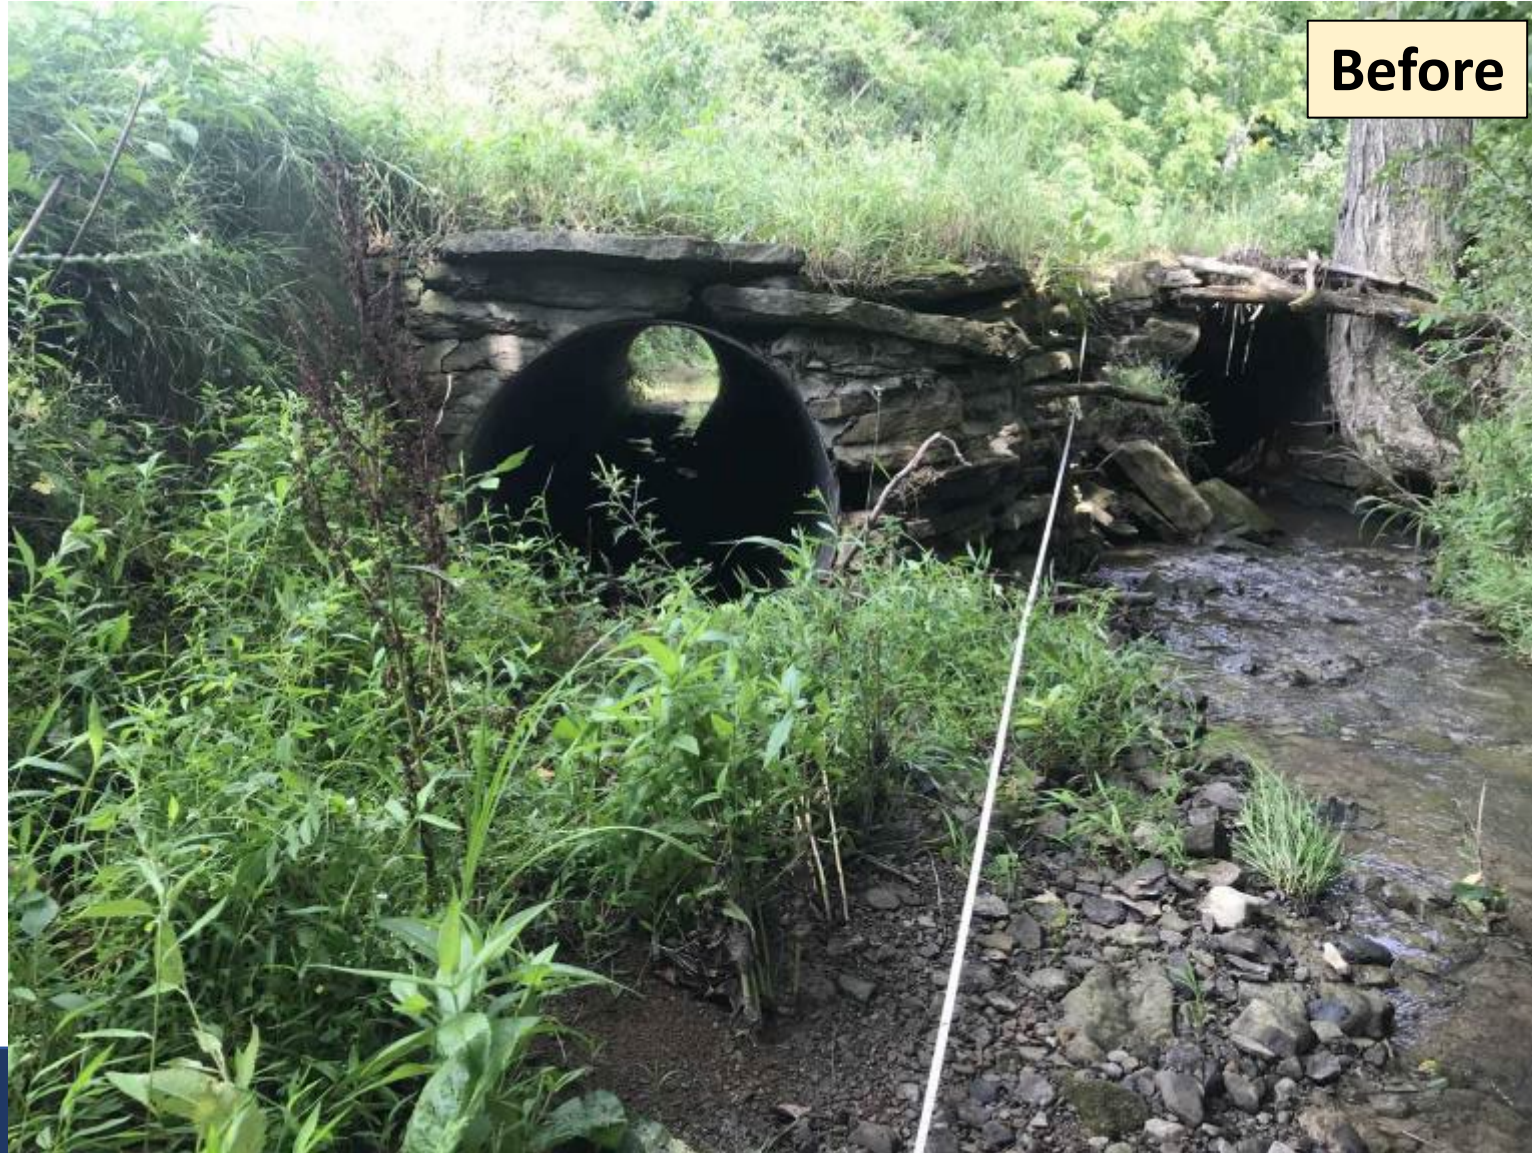
Before

- The existing stream crossing was multiple pipes
- the stream's bankfull width is 12.9 ft

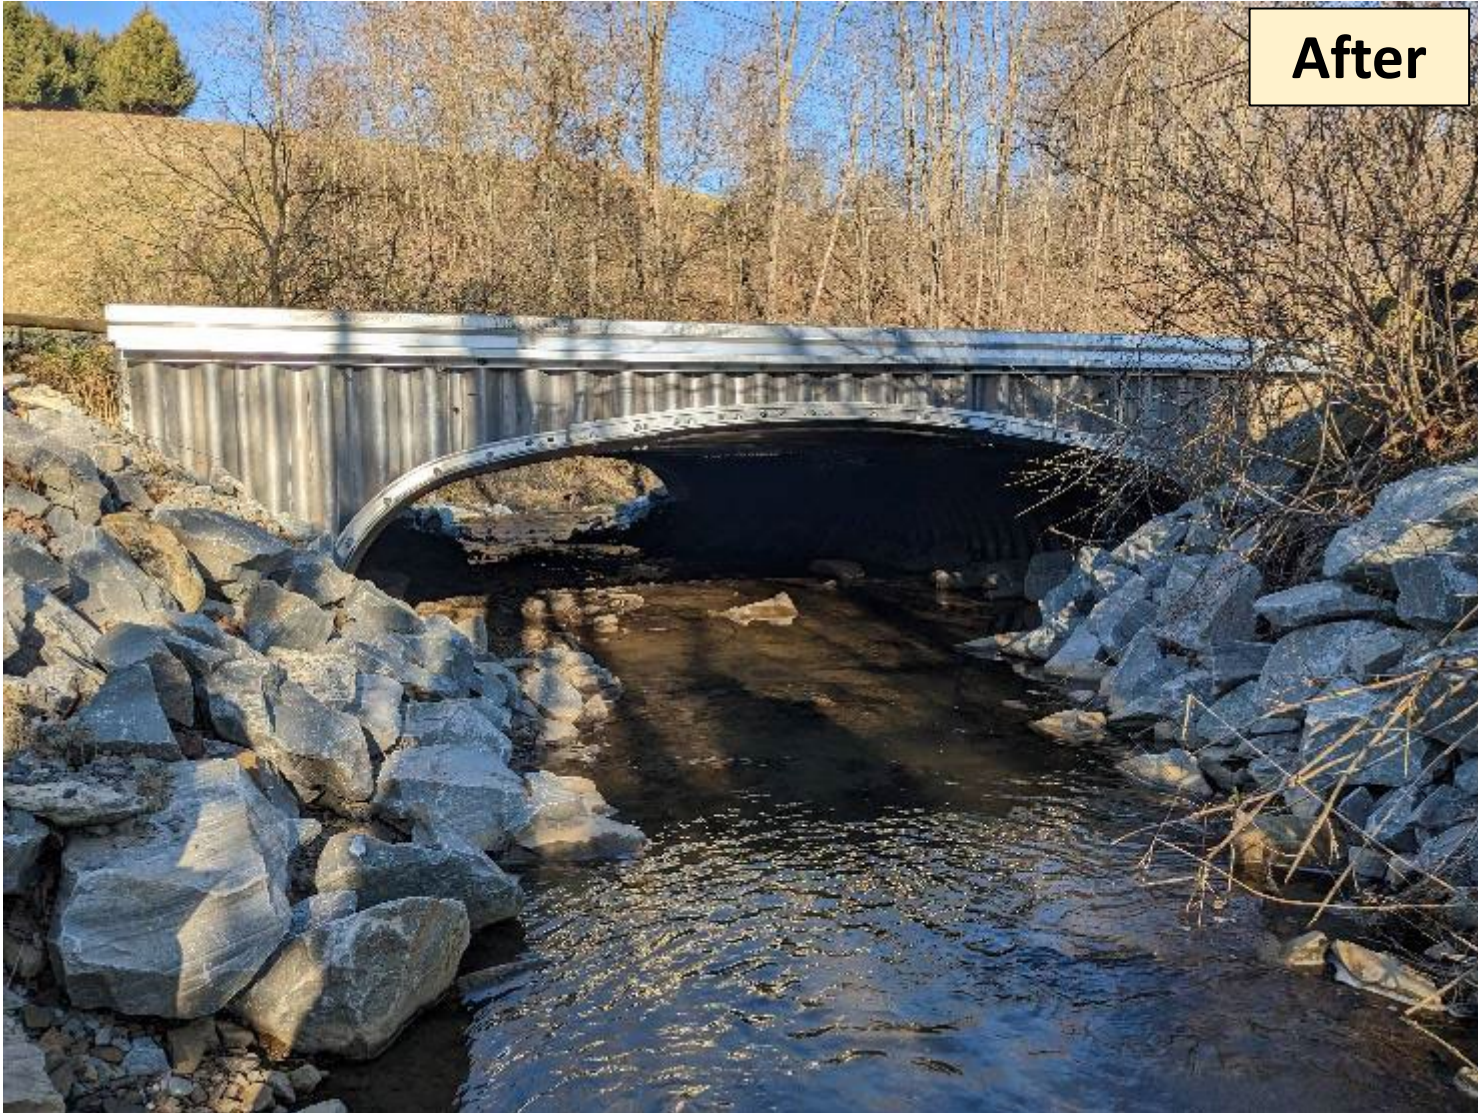
After

- A 16' W x 4'3" H aluminum bottomless box culvert on express foundations was installed.
- Road ditch turnouts were also installed to disconnect road drainage from the stream crossing.

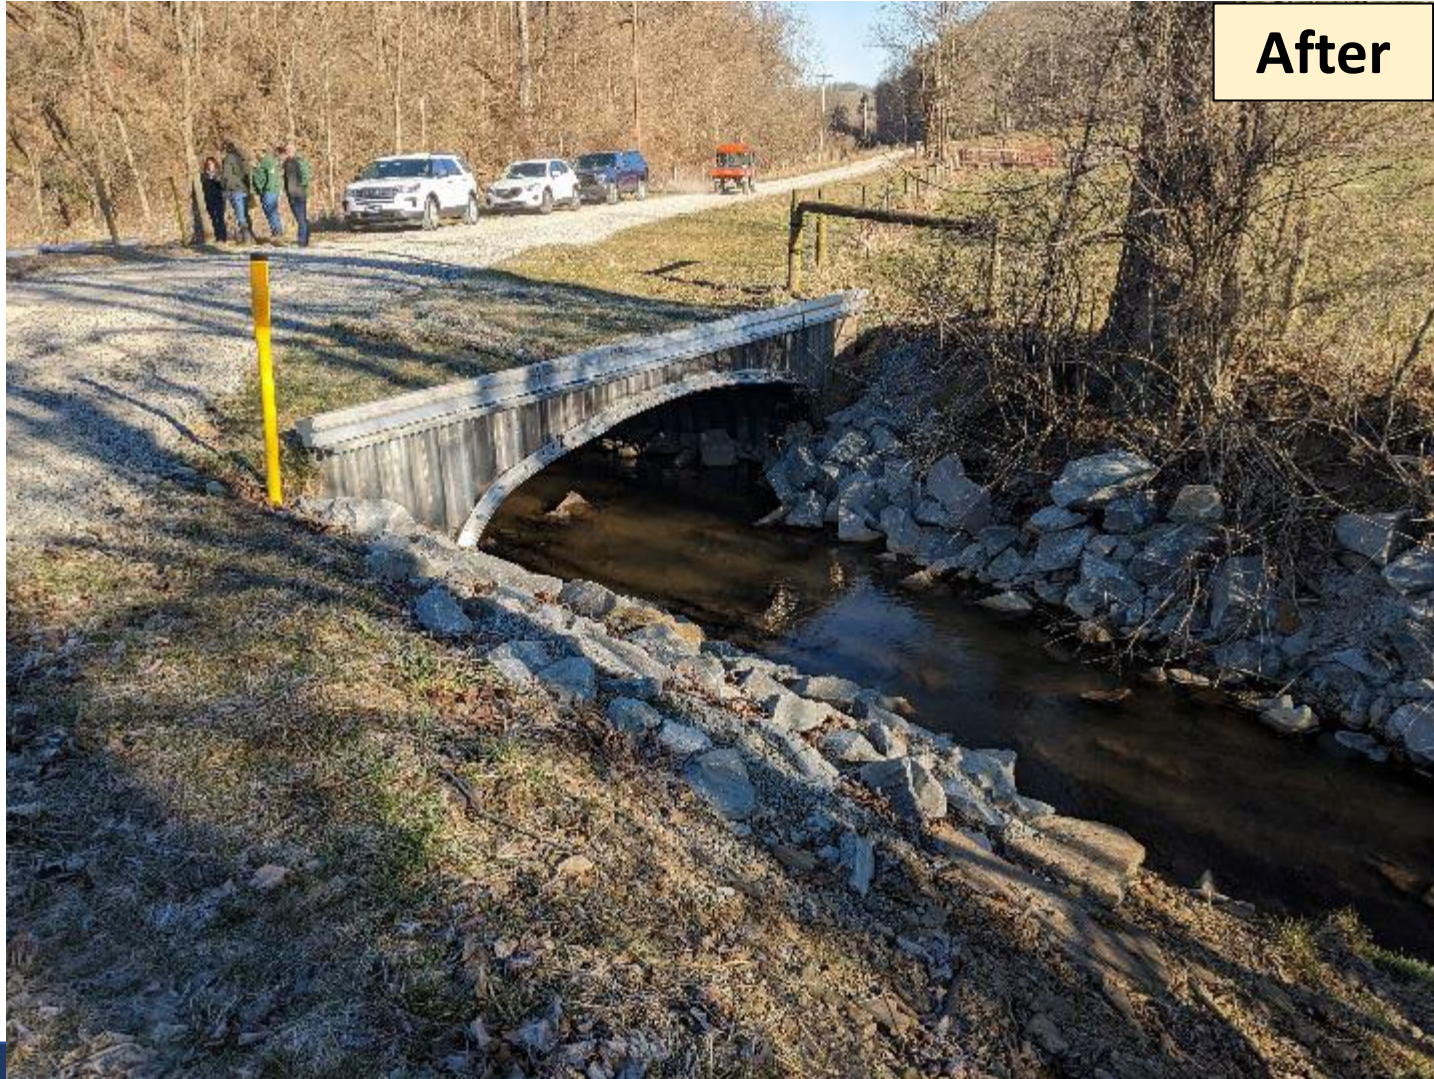
After

- The district worked closely with the CDGRS to incorporate updated guidance into the stream crossing design.
- Bank margins, a low flow channel, and 3 riffles were constructed to establish a stable, continuous stream channel upstream, through, and downstream of the road crossing.

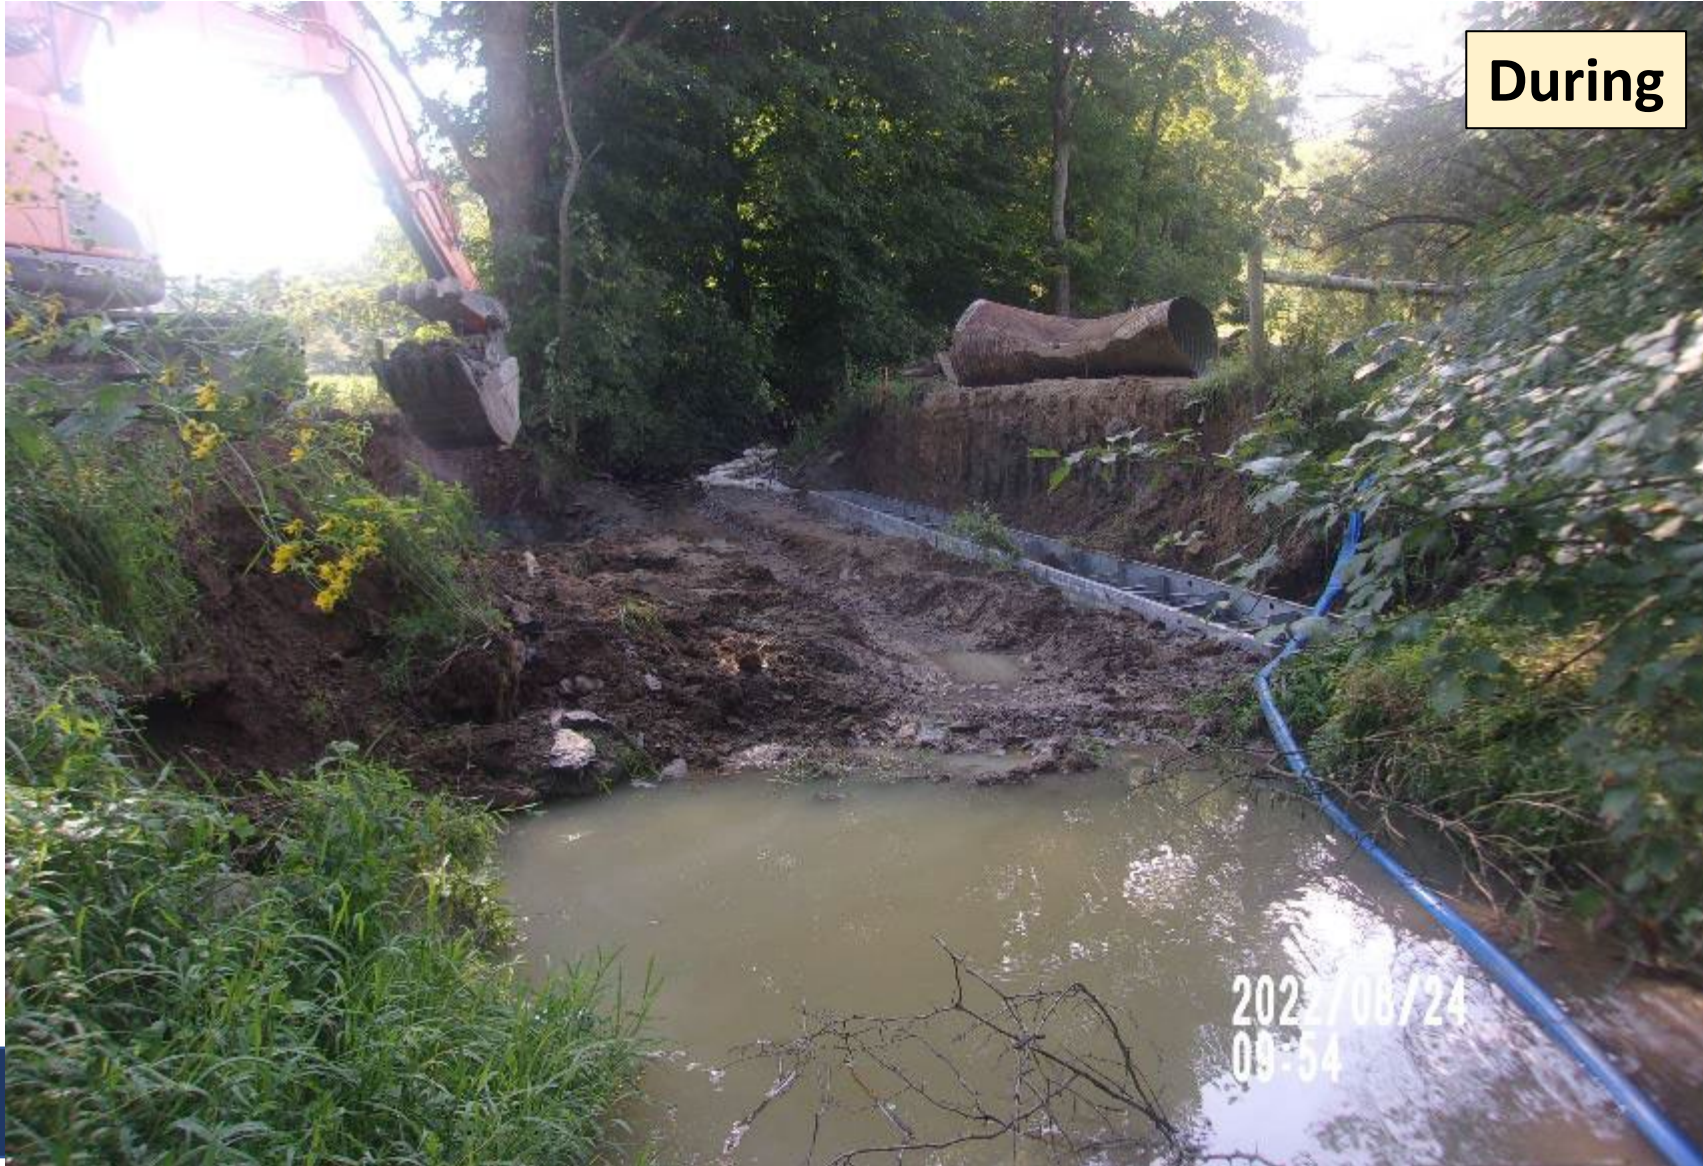
During

Excavation, pump around,
and setting footings

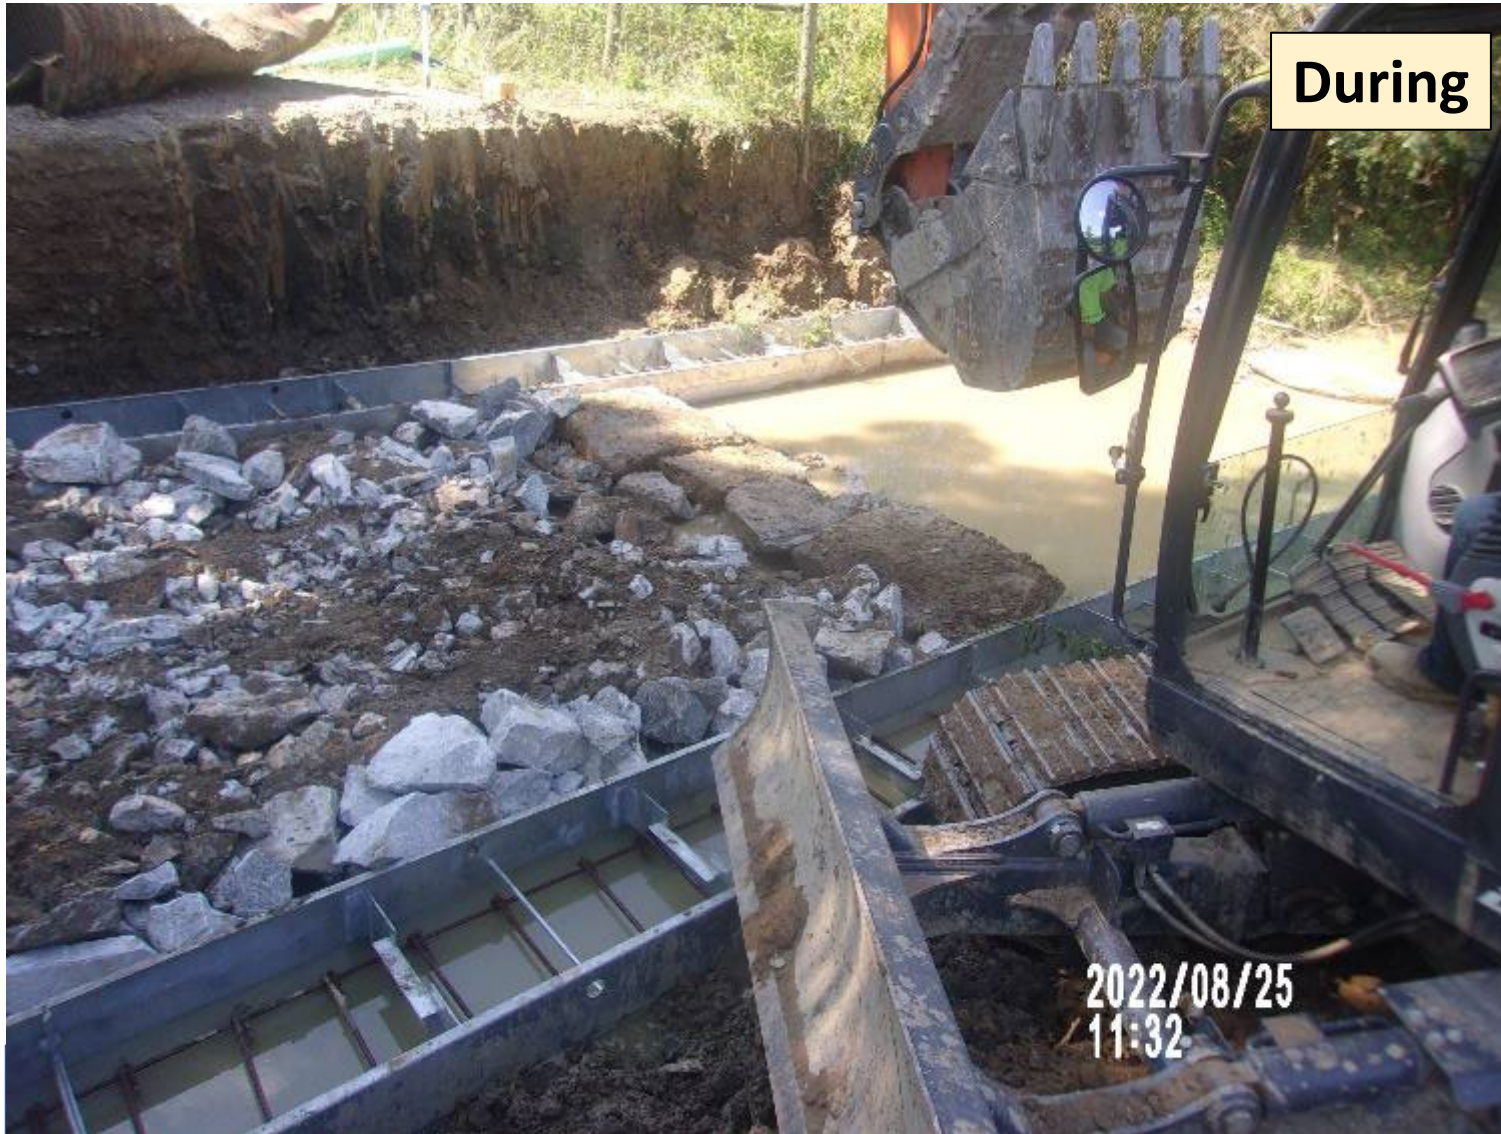
During

Stream bed reconstructed between footers

- Note:
 - Large rock is used to build riffles (grade control) and is intended to be stable during storms
 - The rest of the stream bed is a mix of big stone/rip rap and fine material
 - Mixed before being placed
 - Fines help “glue” the bed material

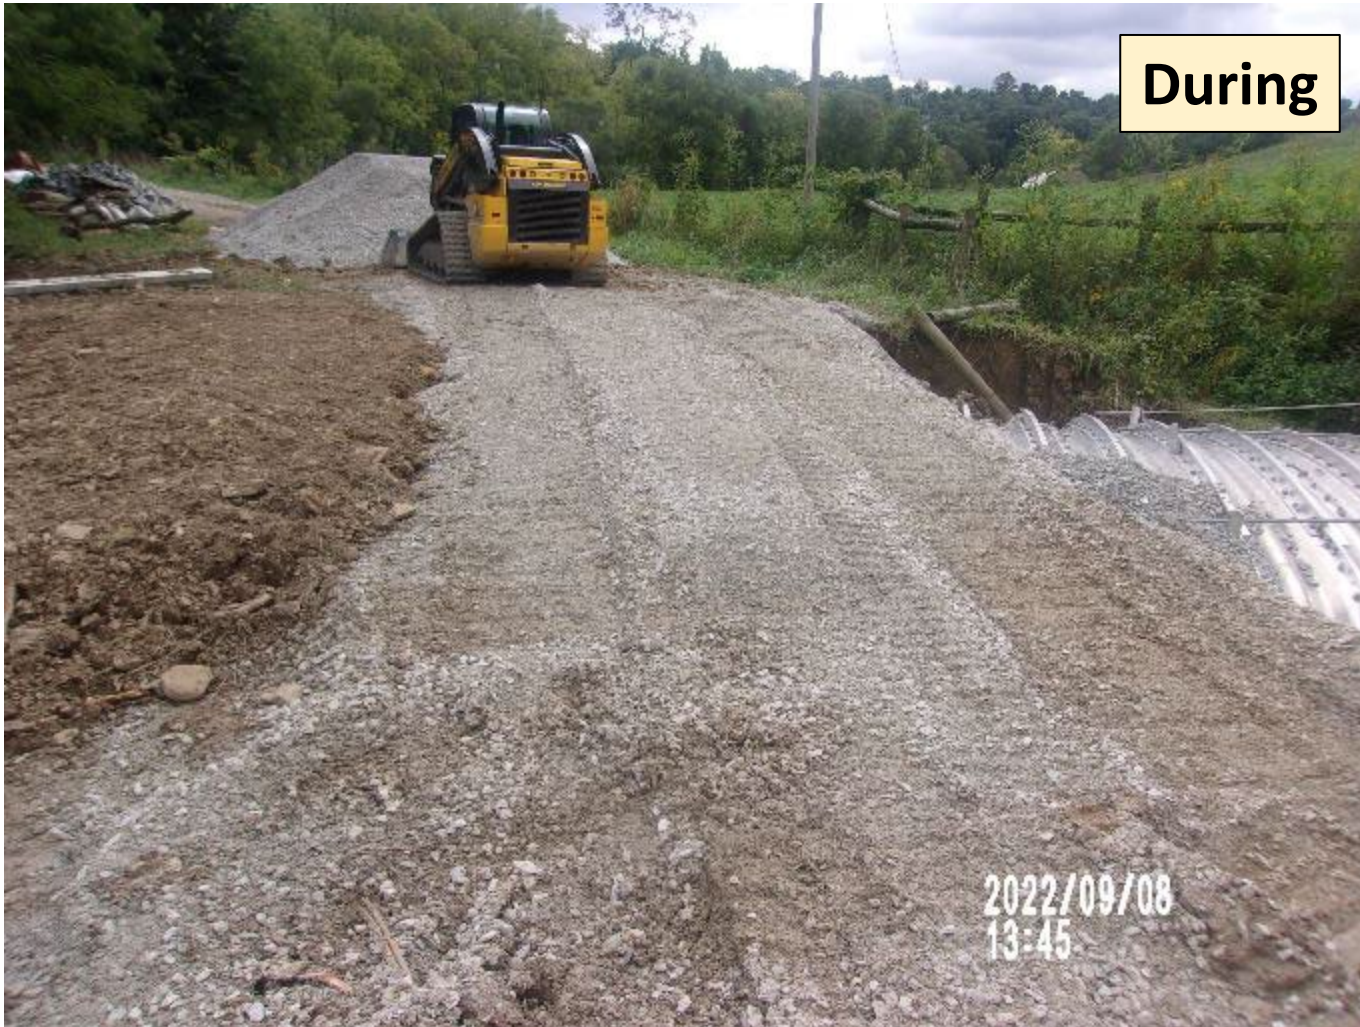
During

Back fill being placed and compacted

- ~6-10" thick layers ("lifts")
- Fill both sides of structure evenly
- Headwall tie-backs

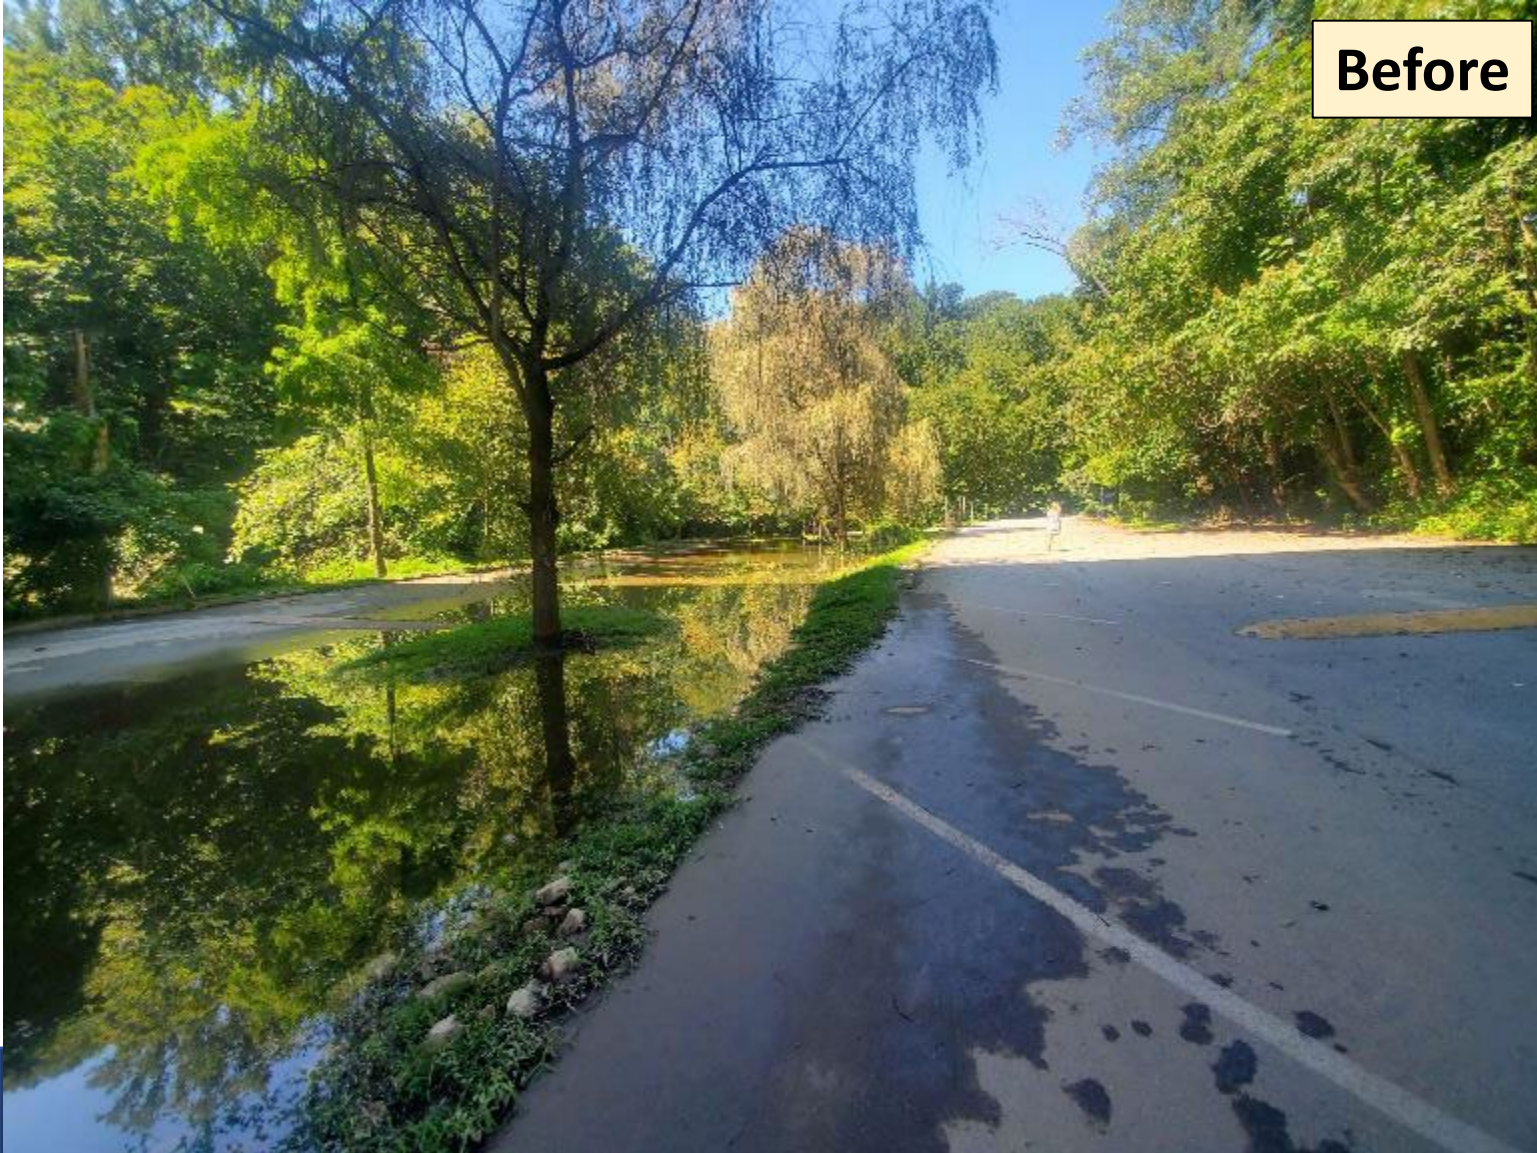
- An existing stormwater basin collected water from a looped road but was not functioning properly.
- Before photos show Sept 2021 flooding

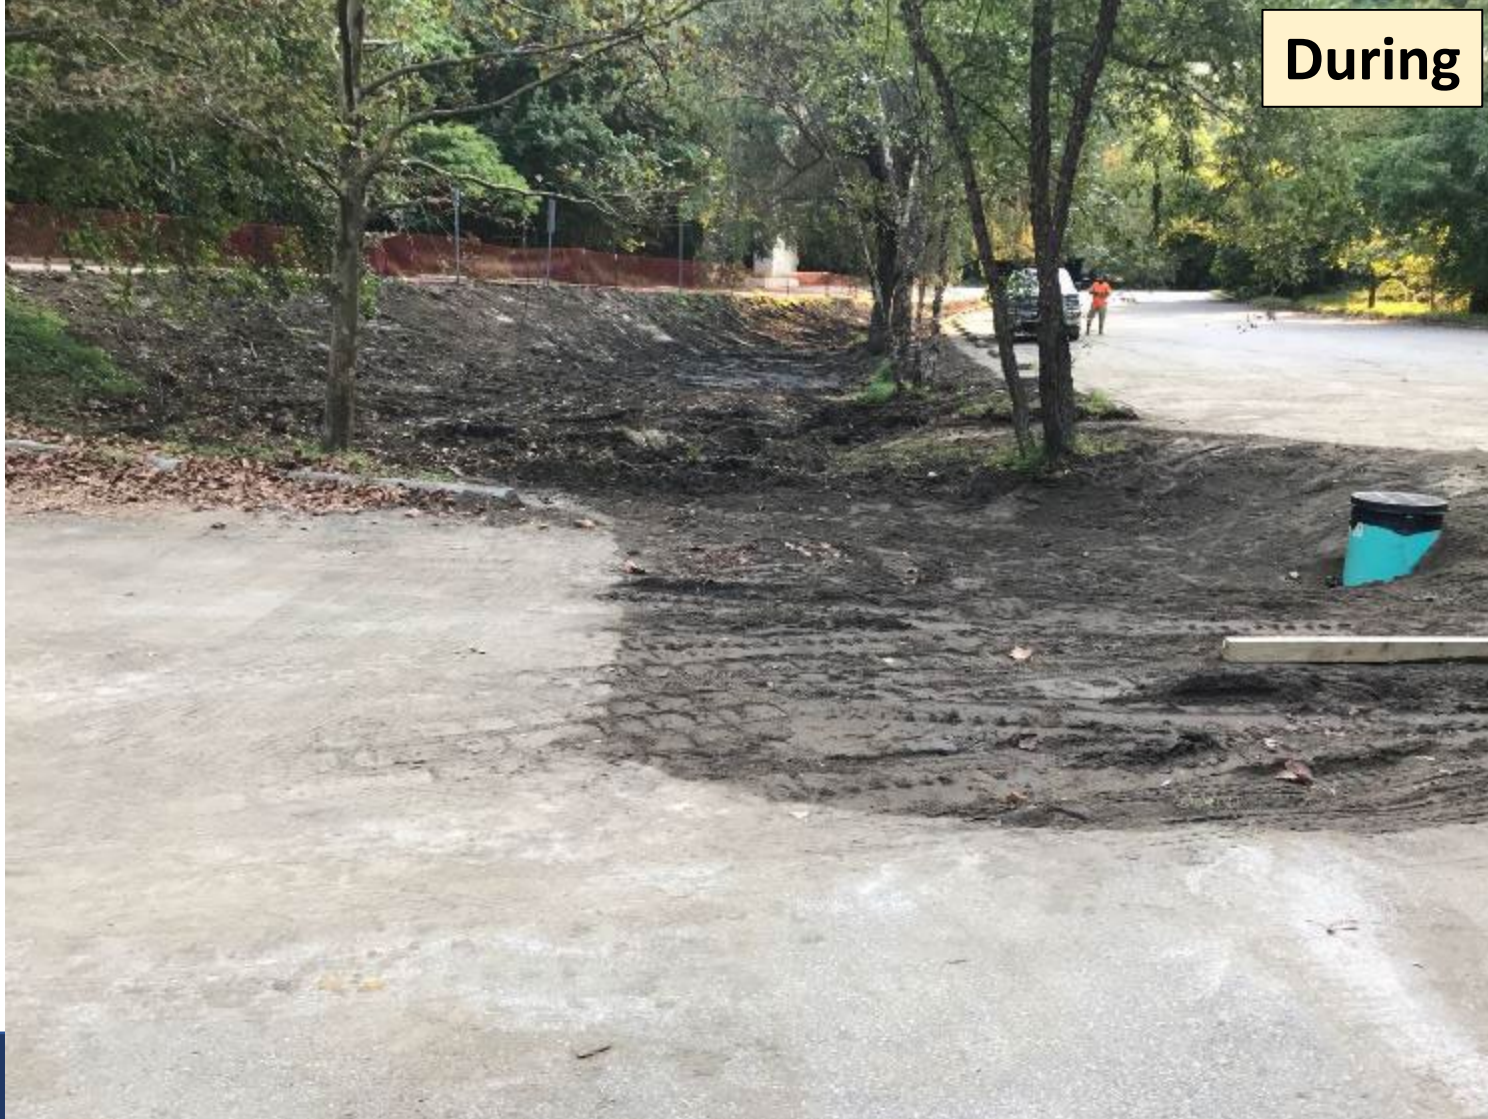
During

Excavated basin (Sept 2022)

- Re-graded the existing basin back to the original contours
- installed a 24" outlet riser with trash rack
- installed an 18" drainpipe with a backflow preventer valve and riprap apron at the outlet
- re-vegetated the basin.
- Guiderail was installed around the basin to prevent vehicle traffic from entering the basin.
