Dirt, Gravel, and Low
Volume Road Program

2023 Project Showcase

2023 QAQC Project Showcase

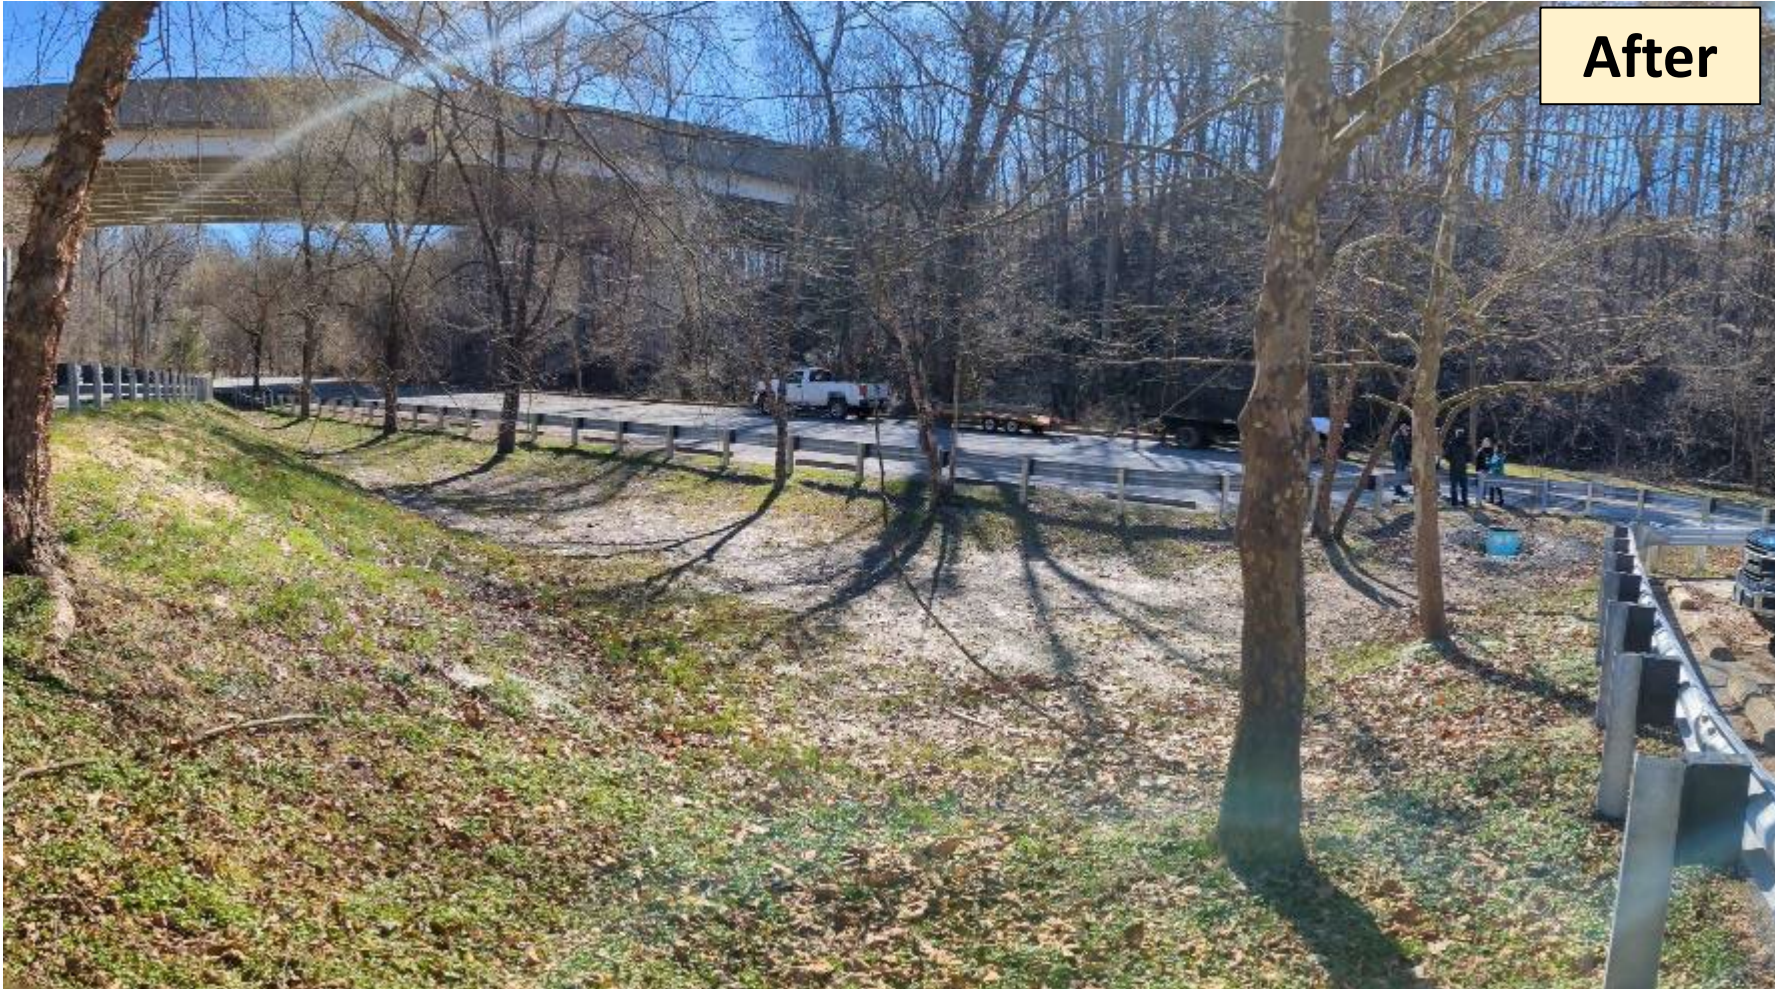
After

The basin now functions

- Promotes water infiltration
- Captures sediment
- Provides water detention
- filters out pollutants before water enters Crum Creek

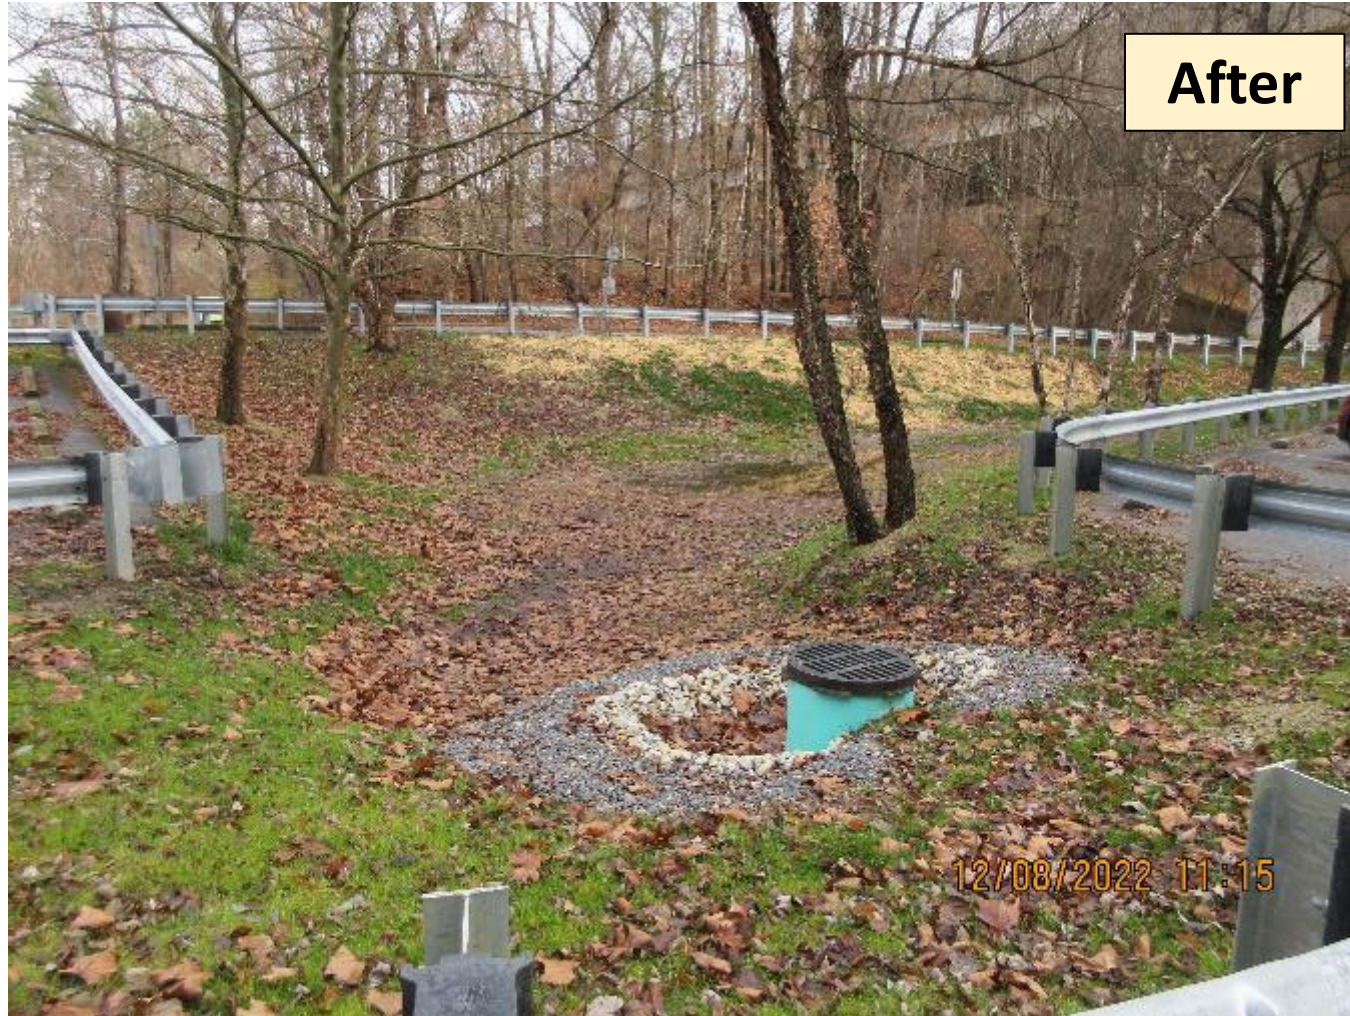
After

24" outlet riser
with trash rack

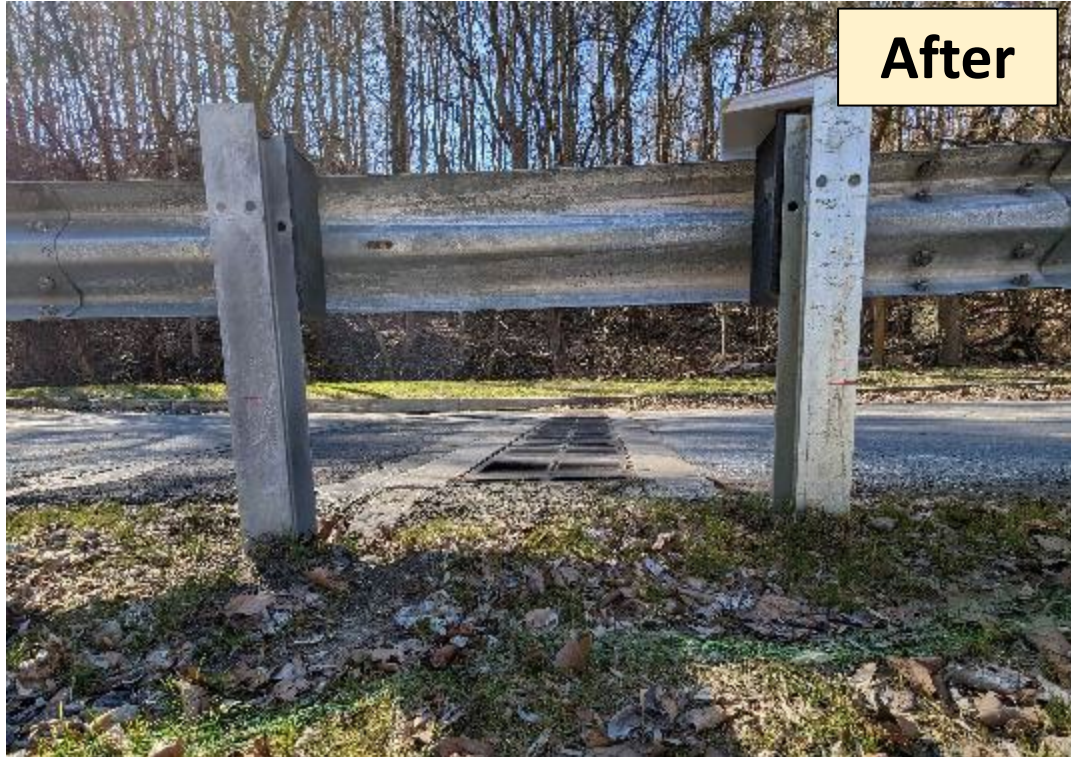
installed an 18" drainpipe with a backflow preventer valve and riprap apron at the outlet

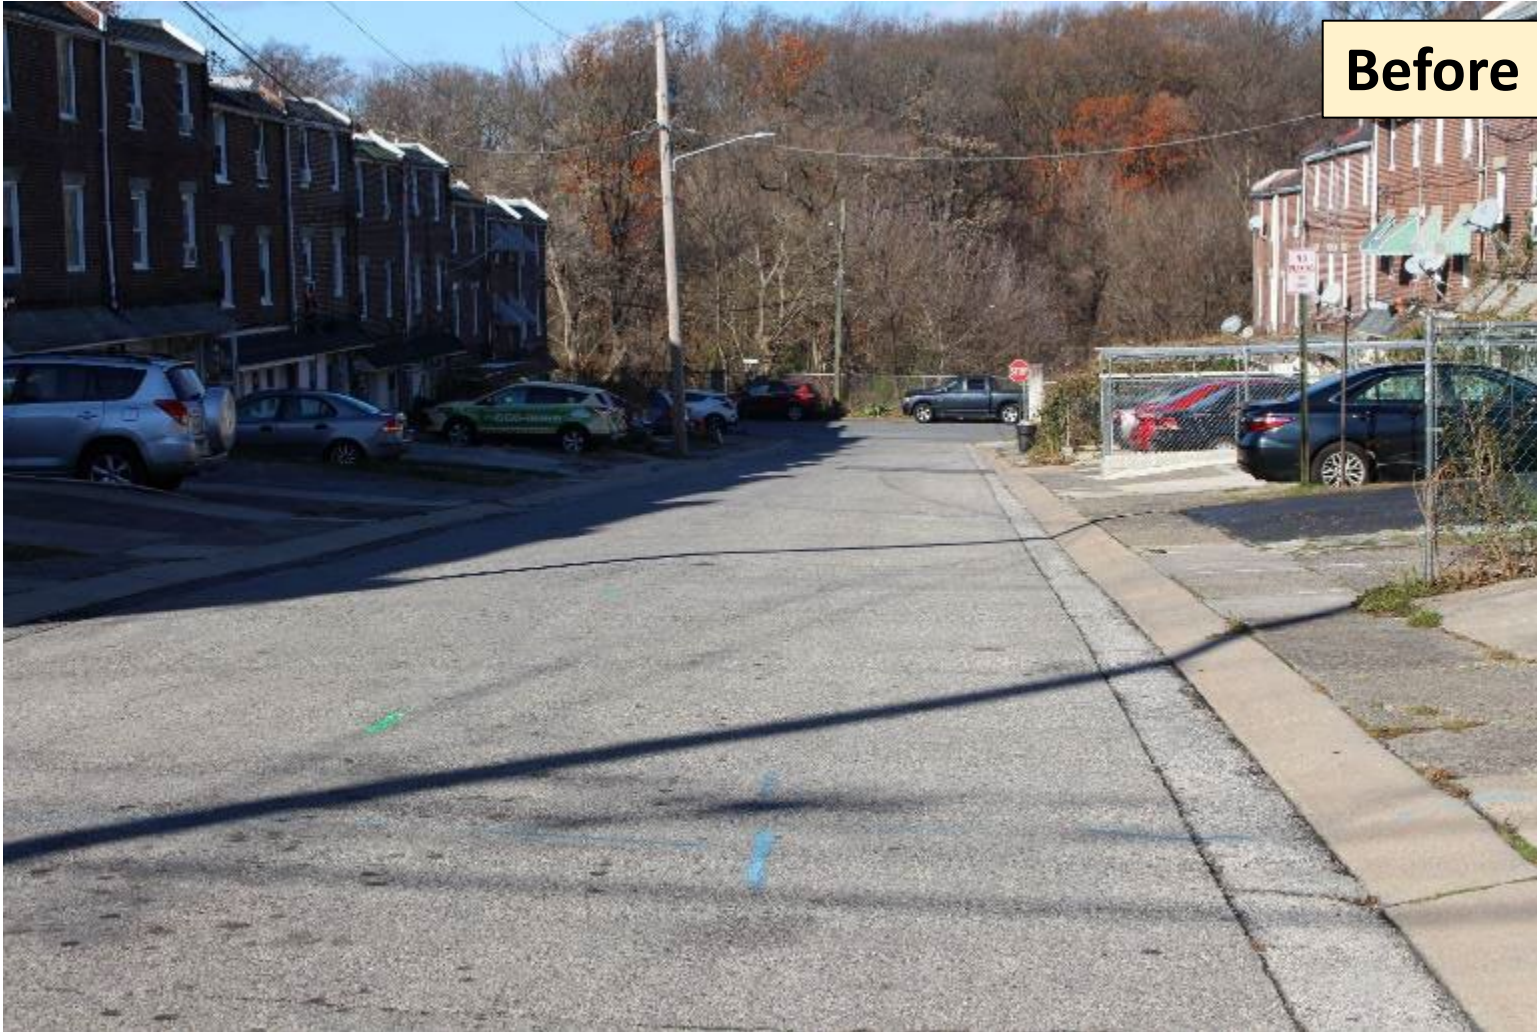
Before

- Stormwater flowed down Aster Road along the curb line to city inlets in Wister Drive.
- The storm sewer system outfalls directly to Cobbs Creek.

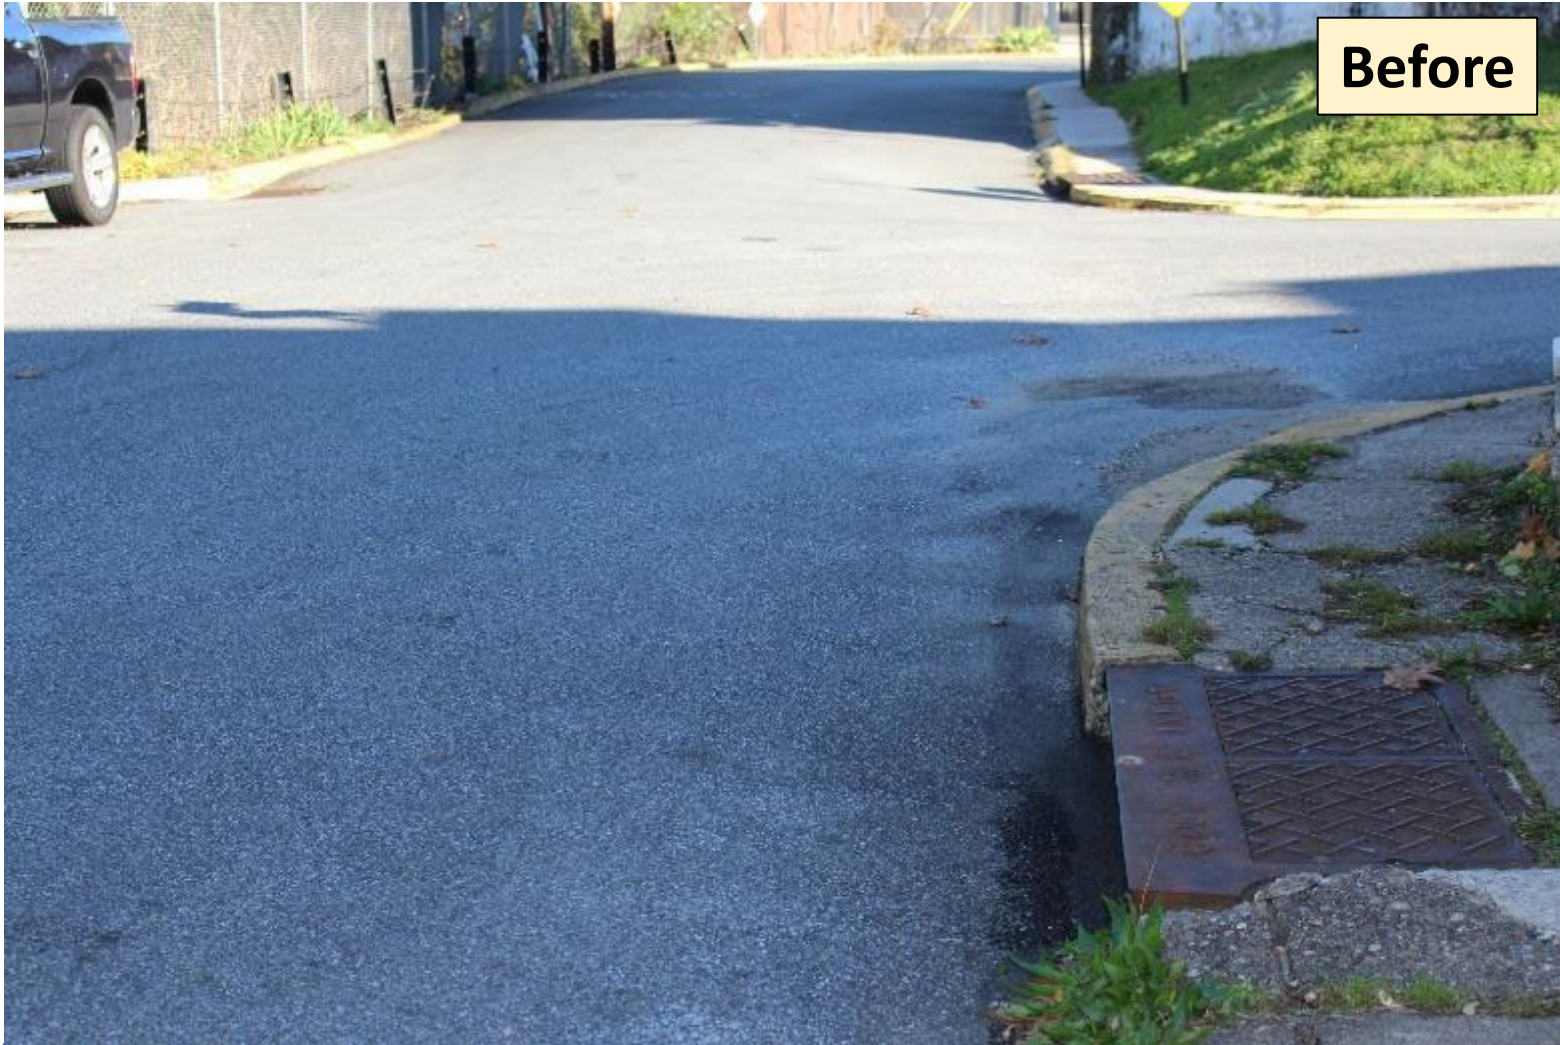
Before

- Due to the slope of Aster Road, much of the stormwater did not follow the curb line to the inlet, but rather crossed Wister Drive and ponded along the curb.

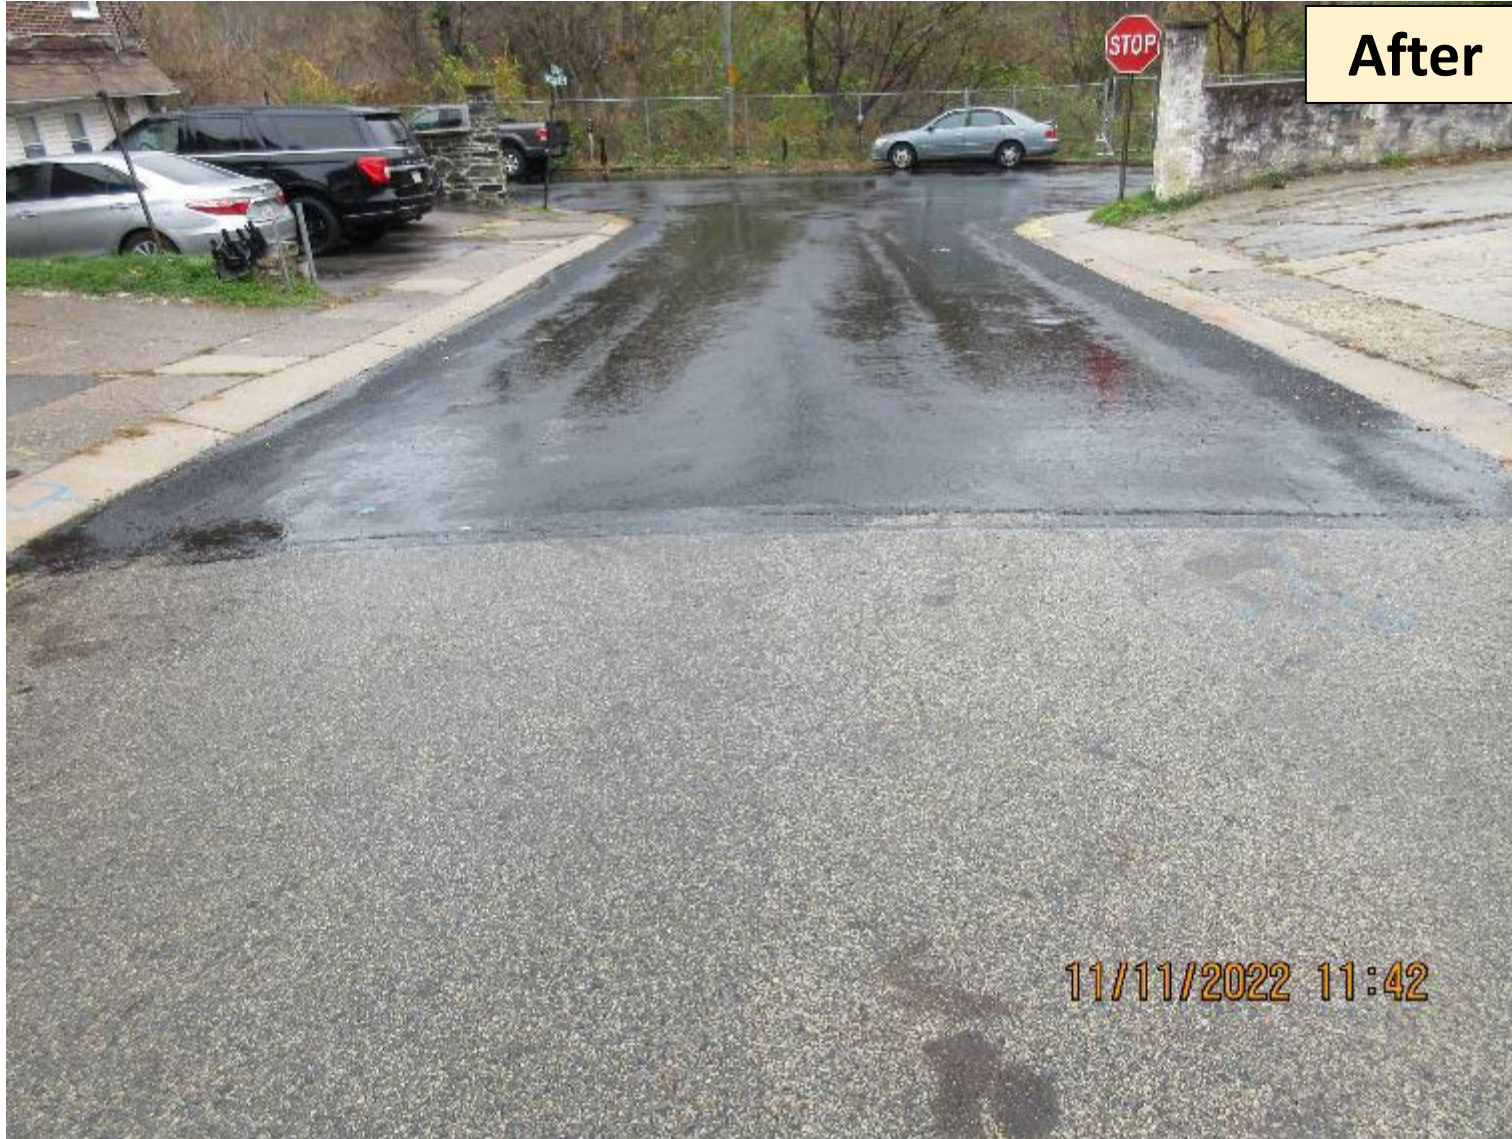
After

- Replaced 2 city inlets with type "C" inlets
- replaced 65 LF of reinforced concrete class 3 pipe
- Permeable pavement on both road edges
- Proper road crown directs stormwater to permeable pavement and storm sewer inlets

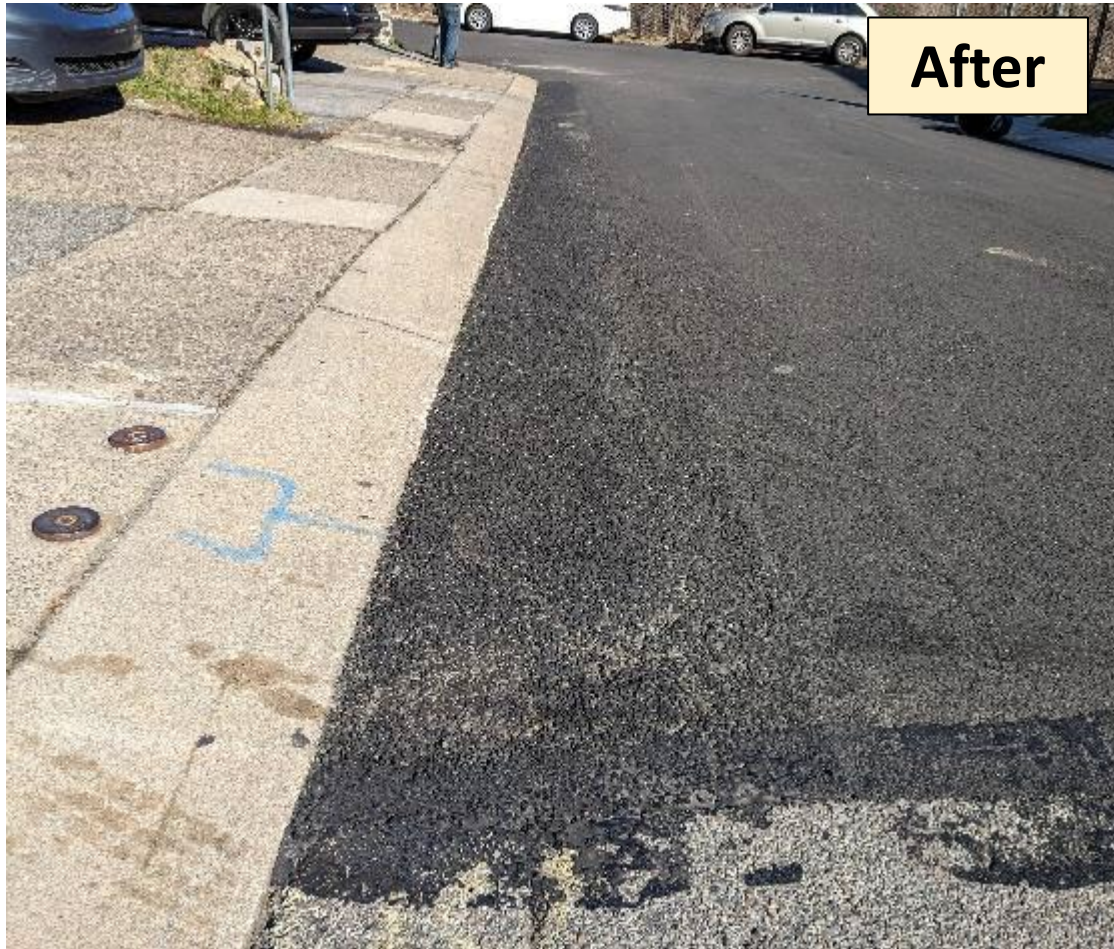
- Permeable pavement strips along the curb line on each side of the street capture stormwater flowing along the curb (25 sq yd total)
- installed 100 LF of perforated pipe in a stone bed underneath the porous paving

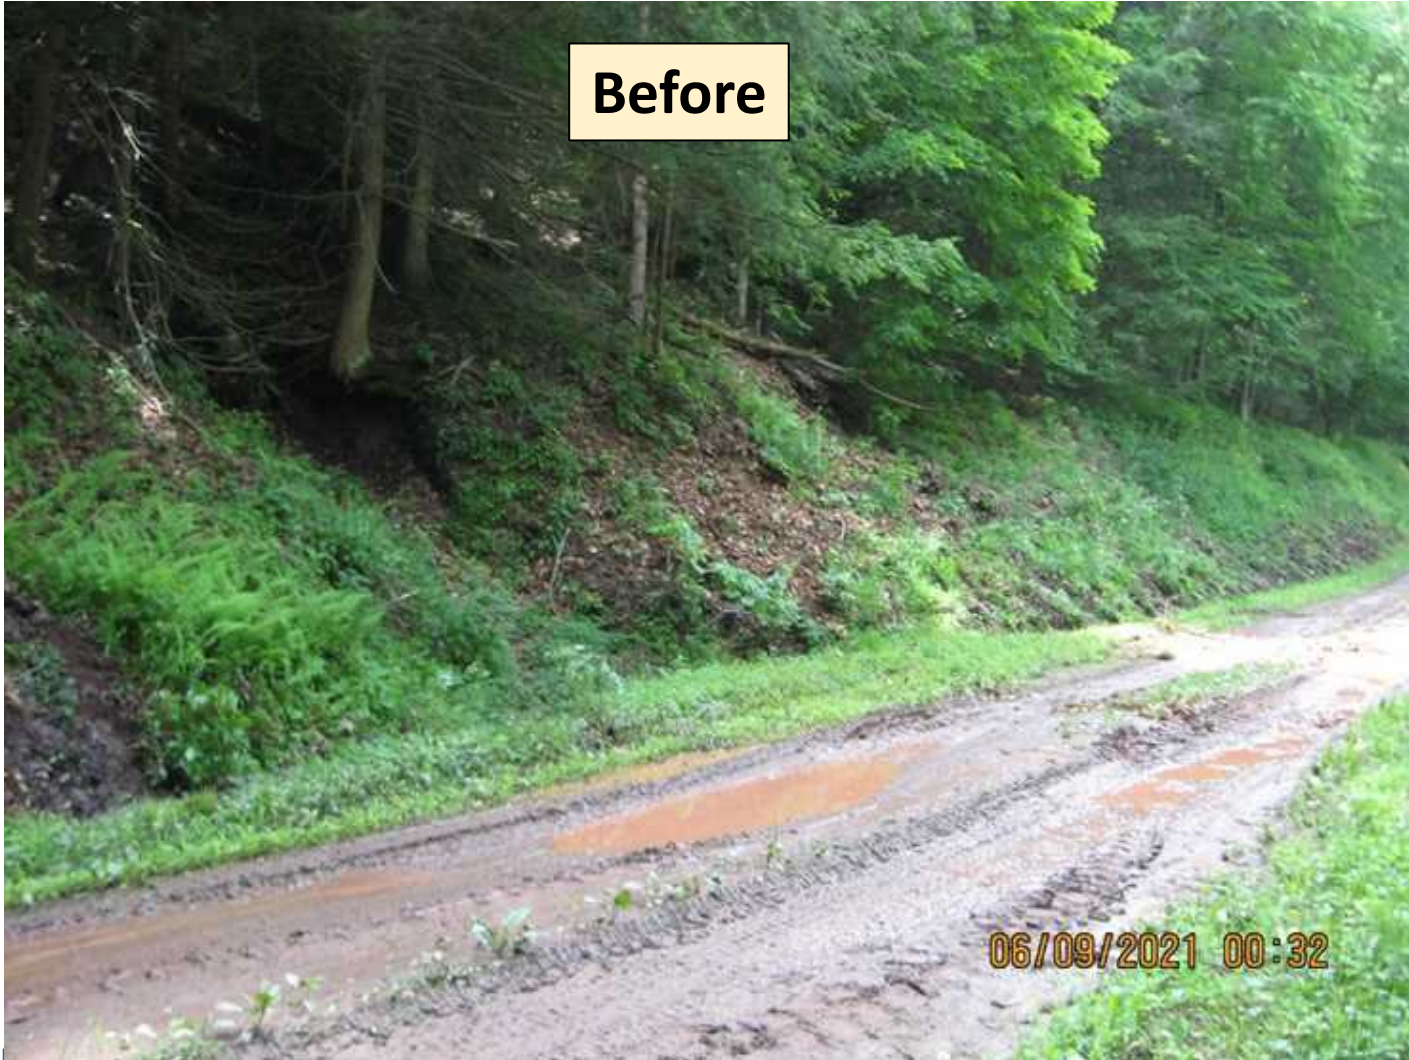
Before

- Traditional drainage issues:
 - Lack of ditch outlets, groundwater influences, entrenchment, erosive outlets
- Stream overtopping the road

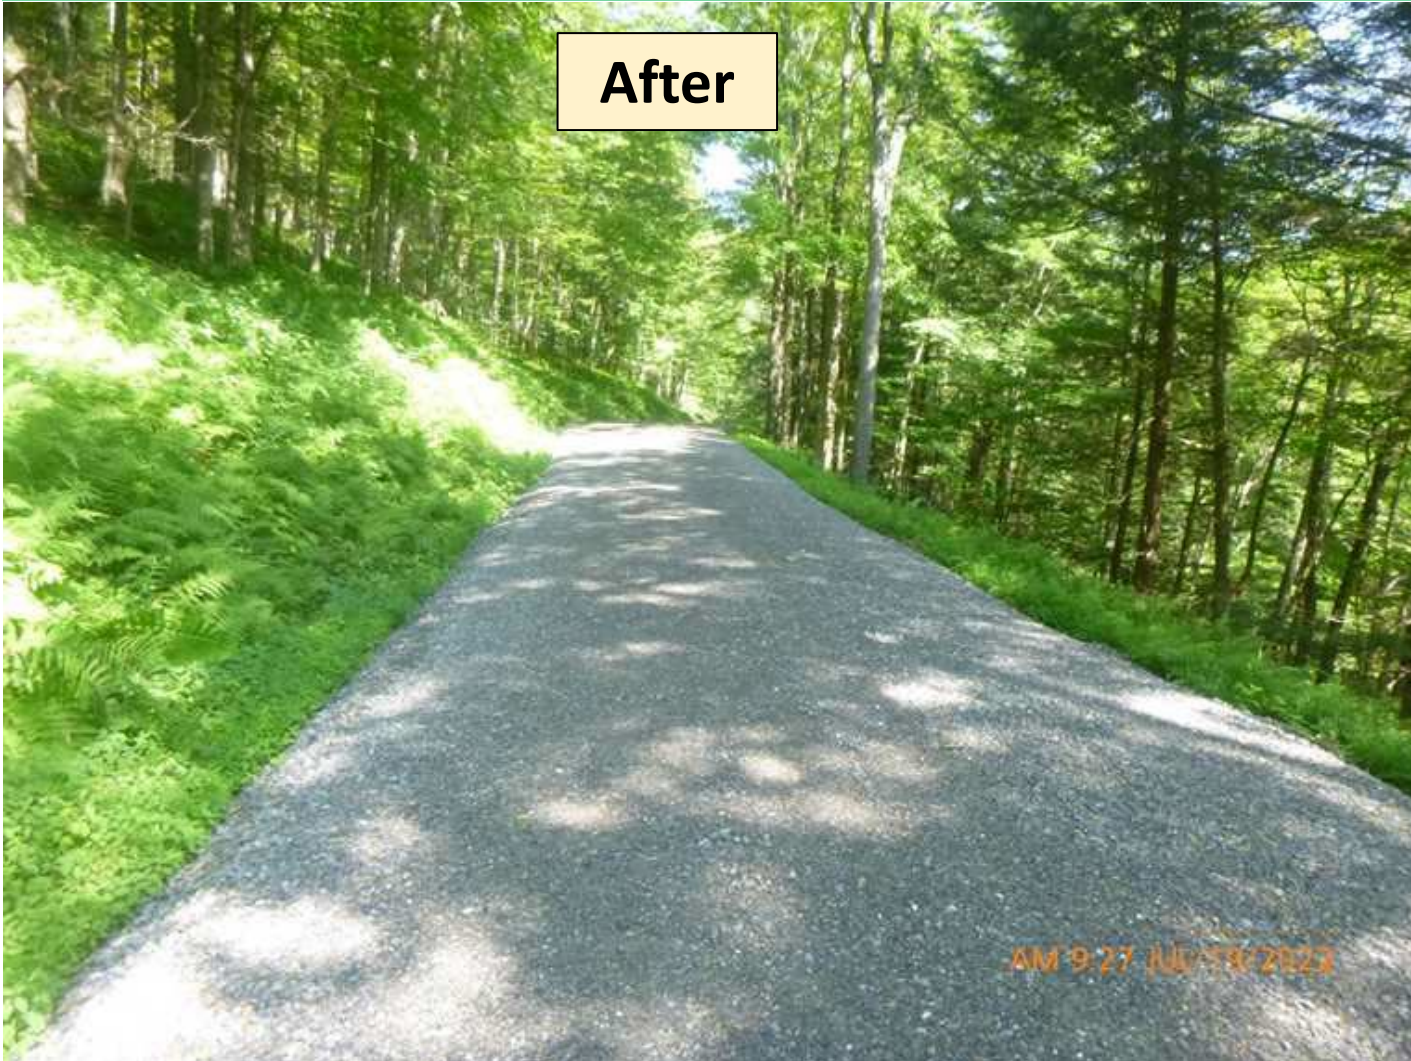
After

- 20 new cross pipes, 13 replacement cross pipes
 - Stacked stone end treatments
 - Solid outlet protection
- 1,544' of underdrain
- 15,770 tons of road fill
 - 2,040 SY of geo-fabric
- Highwater bypass

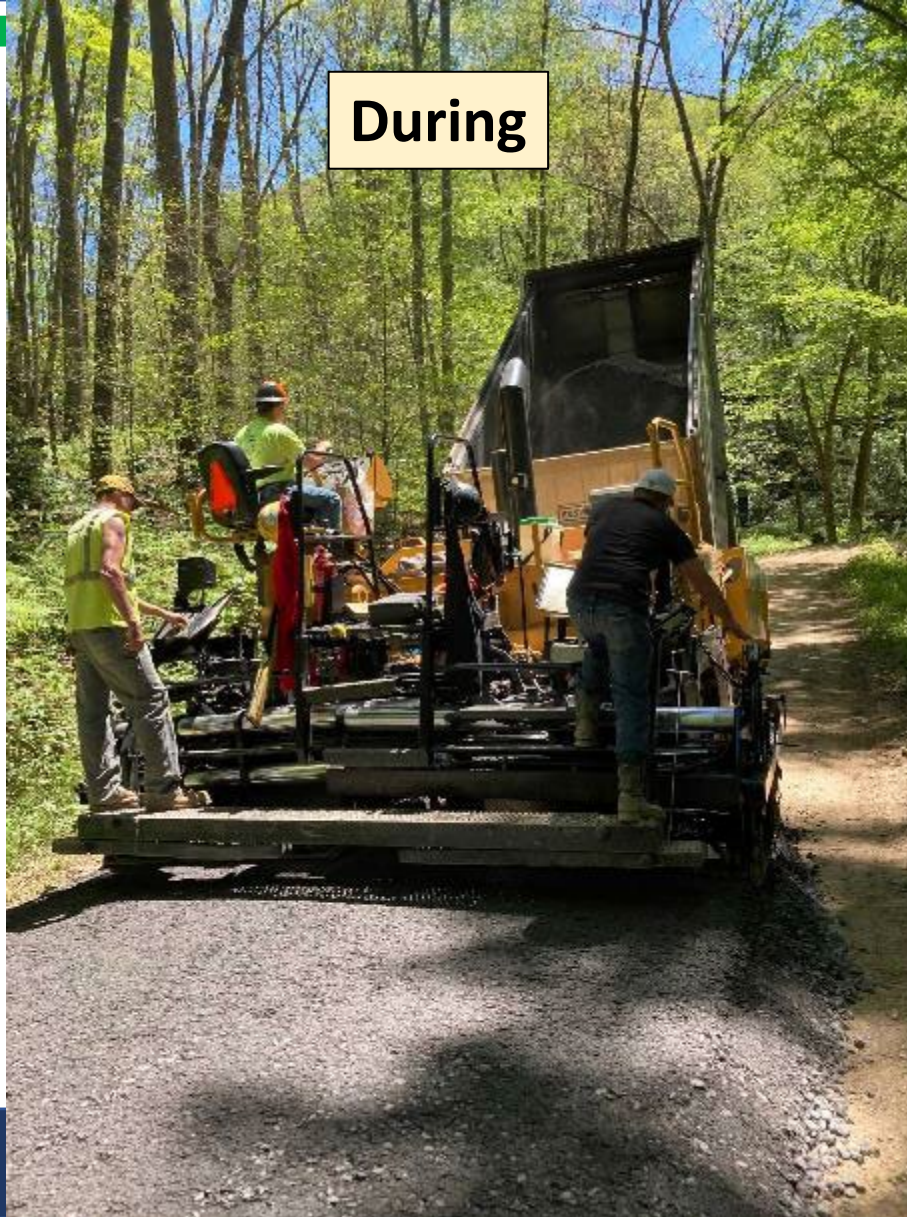
During

- 2 new cross pipes
 - most drainage improvements completed through previous projects
- 2,000 tons of road fill
- 10,000 tons of DSA placed

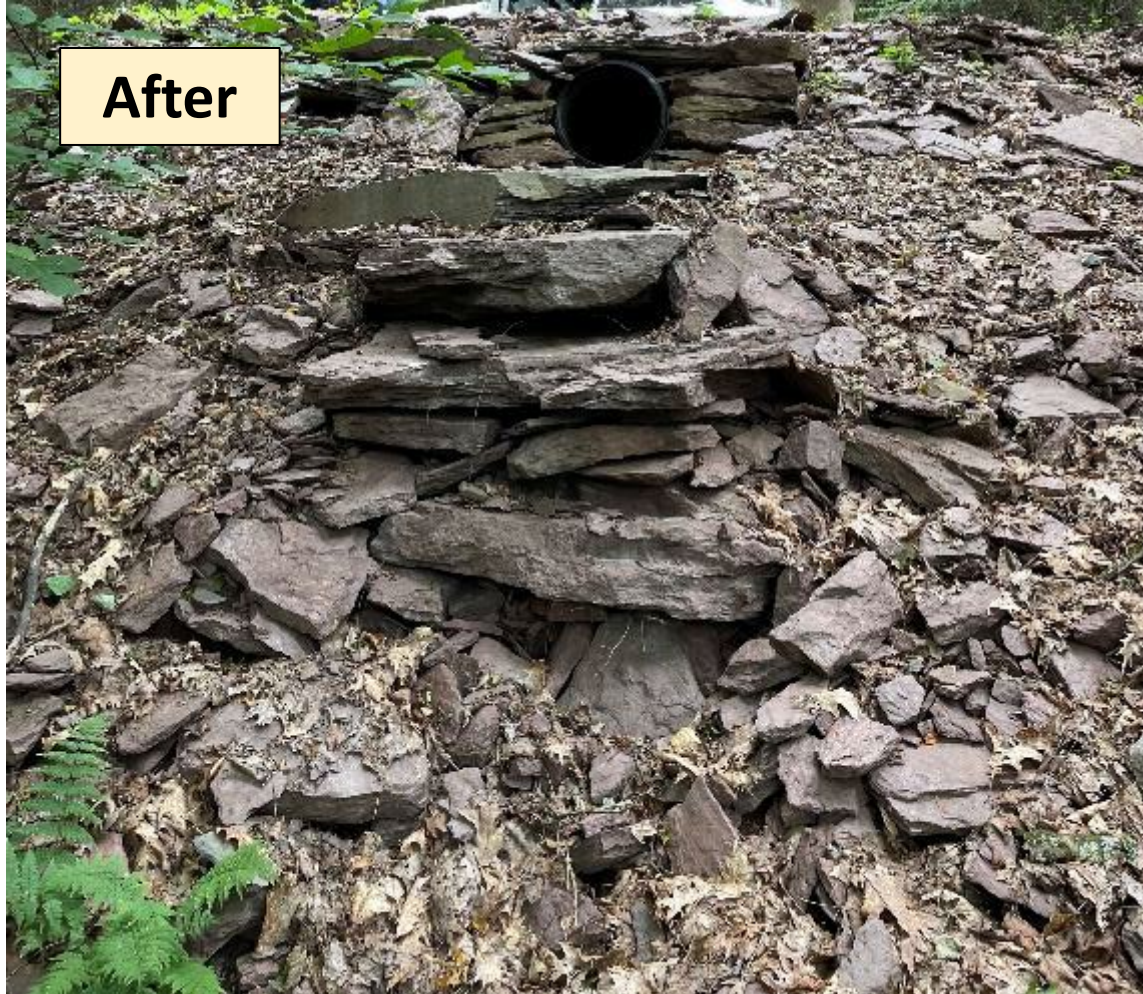
After

- Lack of ditch outlets, eroded ditches, saturated/flowing ditches, entrenchment, poor road base

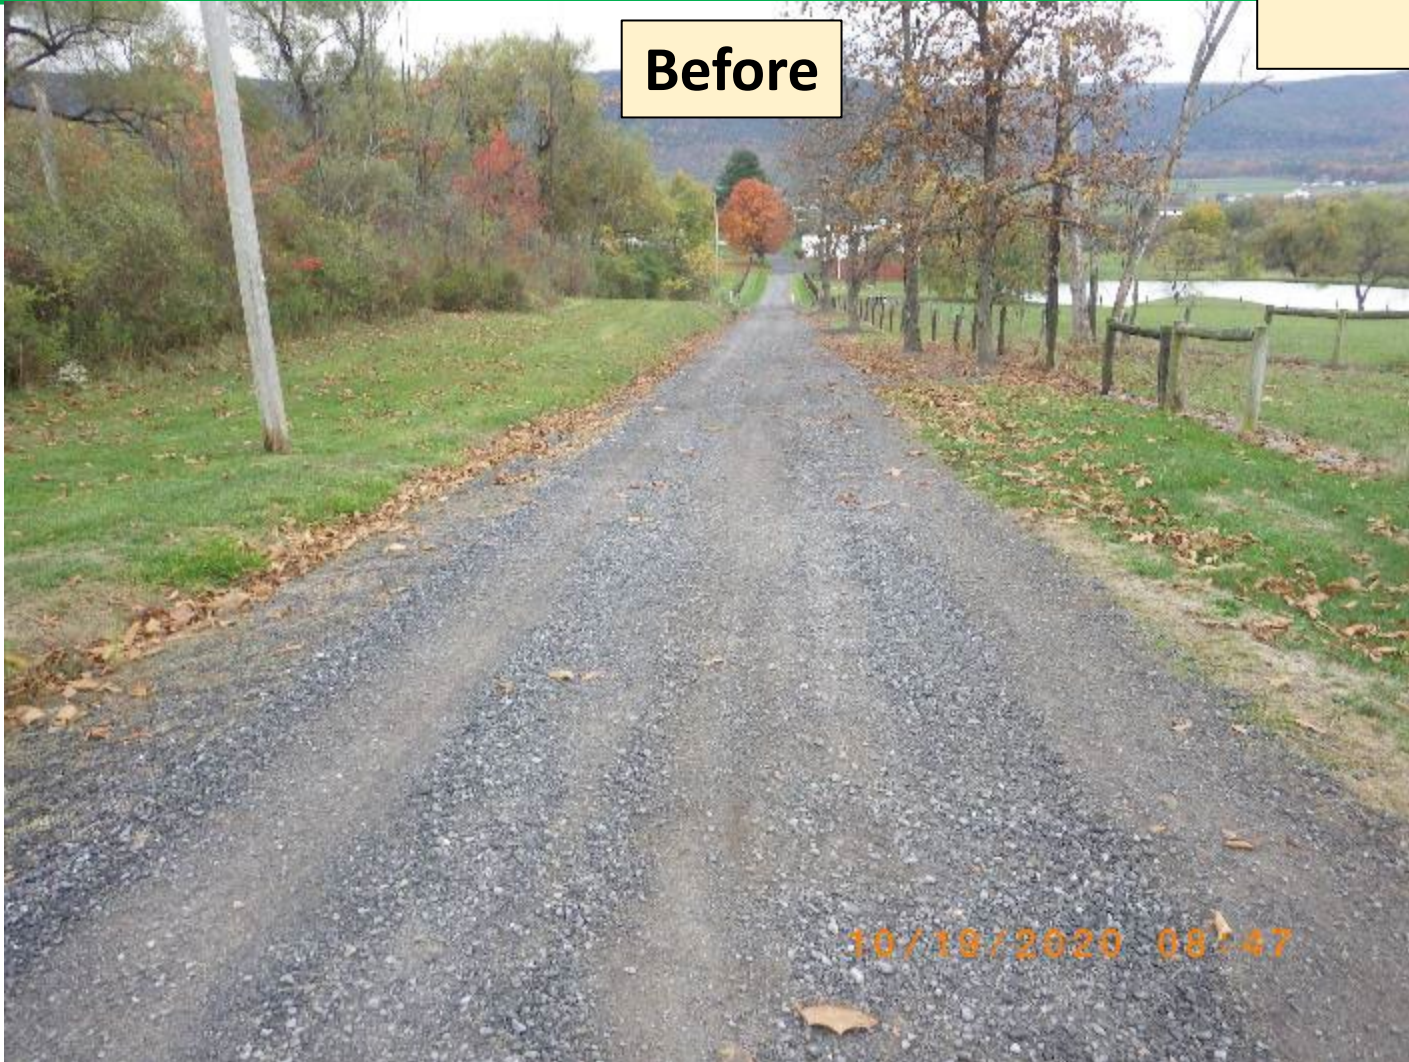
Before

- Steep, entrenched road
- No drainage outlets with entire road and driveway draining to stream crossing
- Off-ROW drainage issues
- Groundwater issues

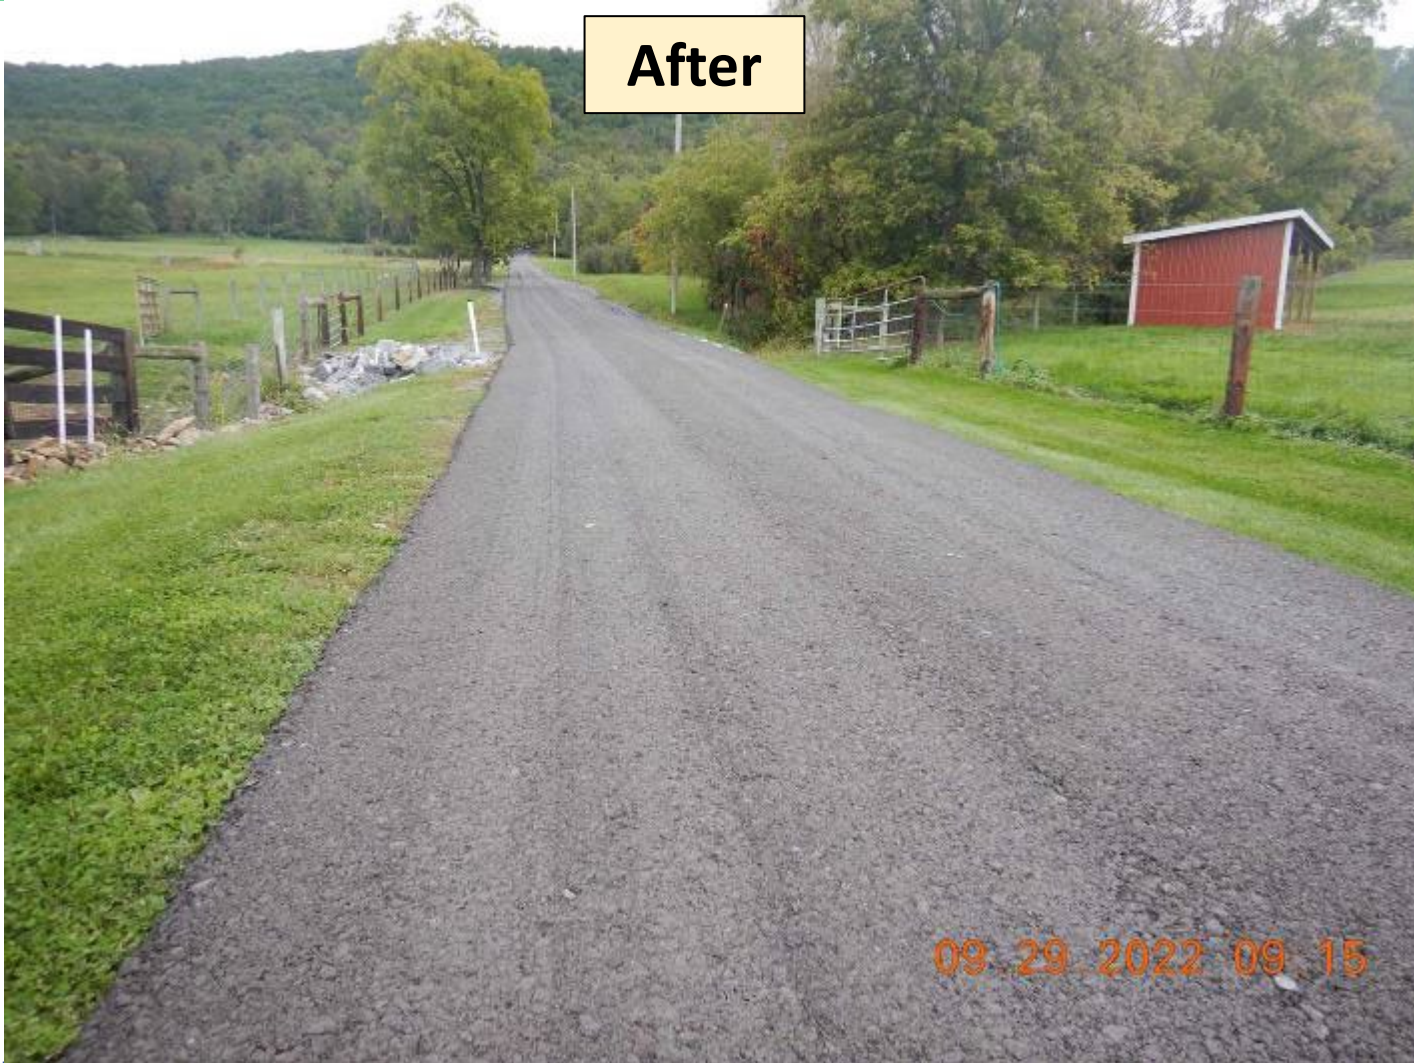
After

- 1 new cross pipe
- 305' of underdrain
- 1 diversion swale
- 390 tons of road fill
- 623 tons of DSA
- Work completed by a combination of township and contractor work

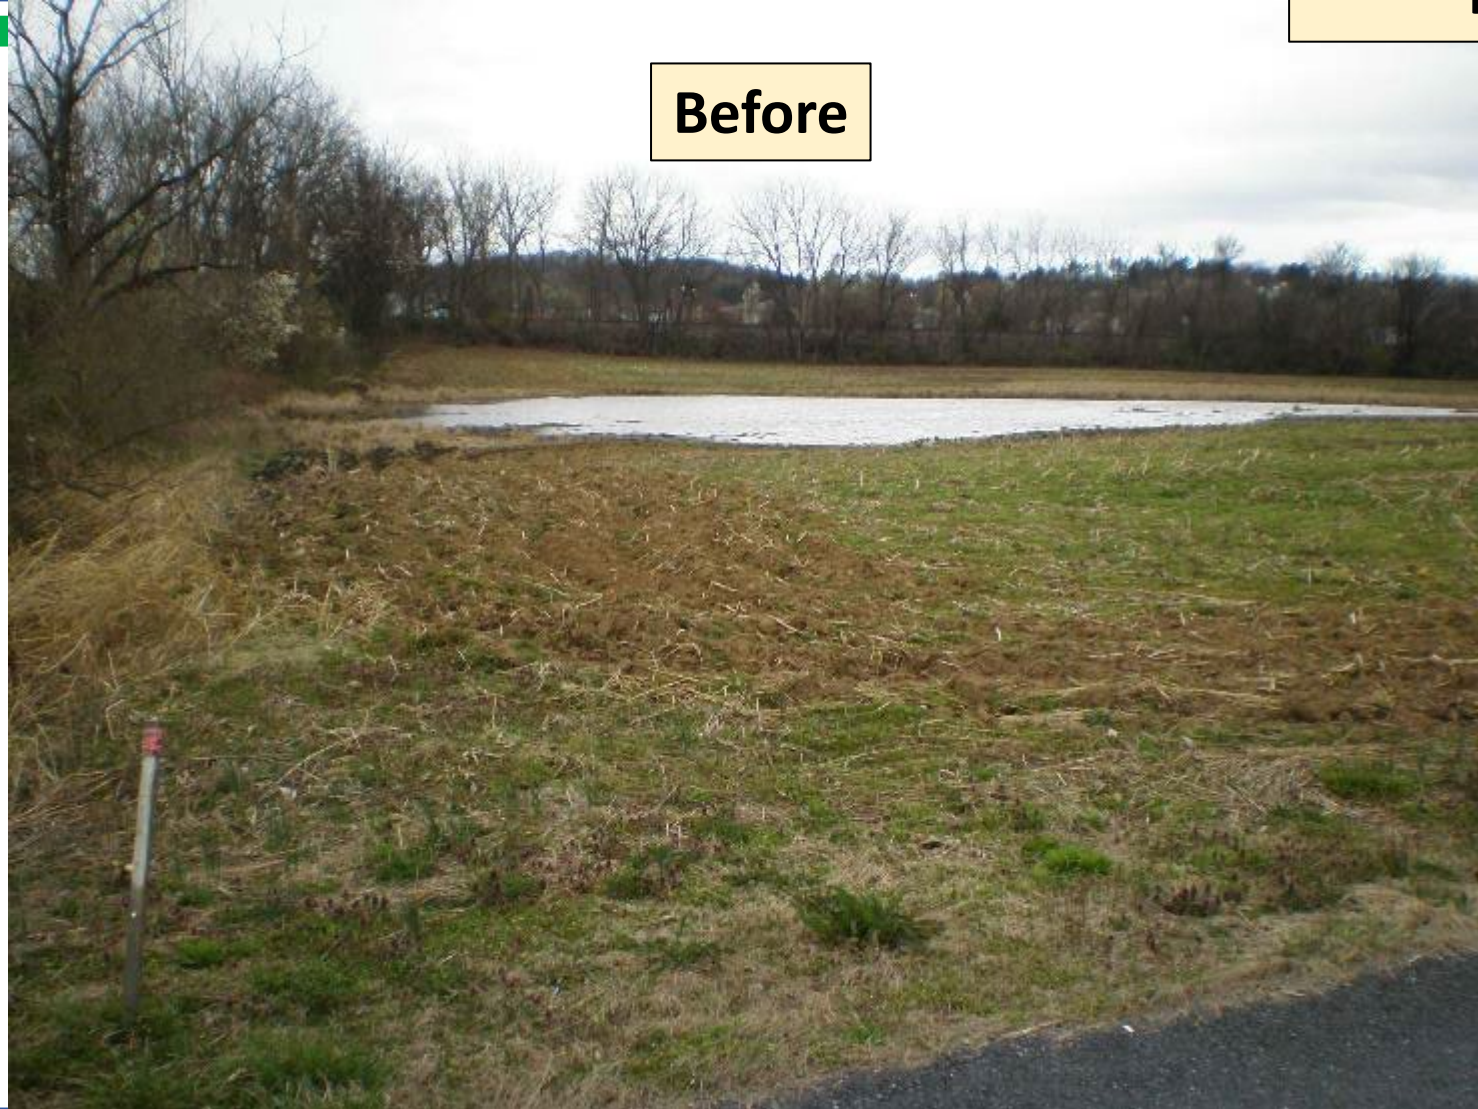
Before

- The roadway and the adjacent fields and driveway would flood in larger storm events due to the area being a low point in the topography
- No drainage

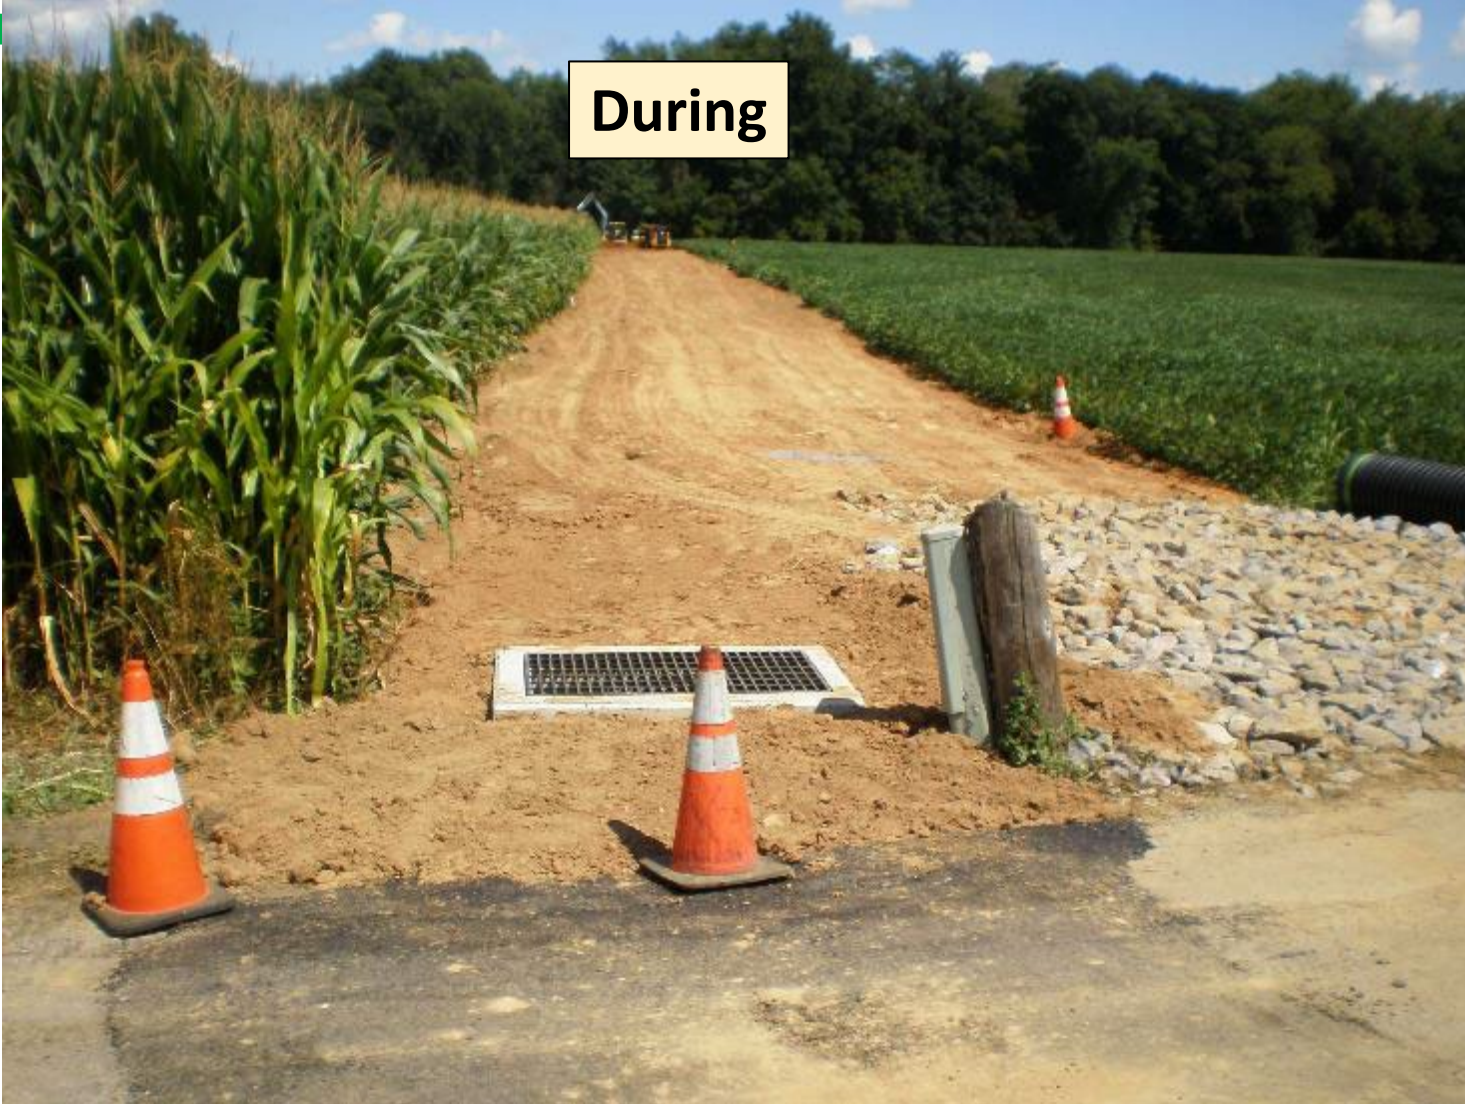
During

- 1 infiltration/bioswale
- 2 inlet boxes
- 800' of off-ROW 18" HDPE pipe
- 360' underdrain
- Rock sump/energy dissipation
- Repaving
