Dirt Gravel and Low
Volume Road Program
January 26, 2023
9am

Small Slip and Slide Repair

A User Guide to Diagnosing and Repairing Failing Road Banks

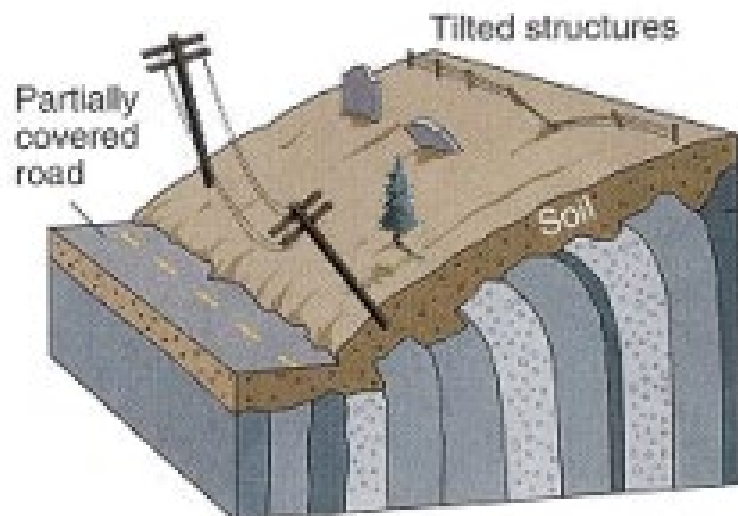
CREEP

Creep is the slow downslope movement of soil and loose rock fragments. Features on the surface will be tilted. Trees may show bent "pistol-butt" trunks.

Common causes of creep failure are seasonal freeze-thaw cycles and inadequate shear strength properties in soil. Bent trees or signs can indicate creep failure.

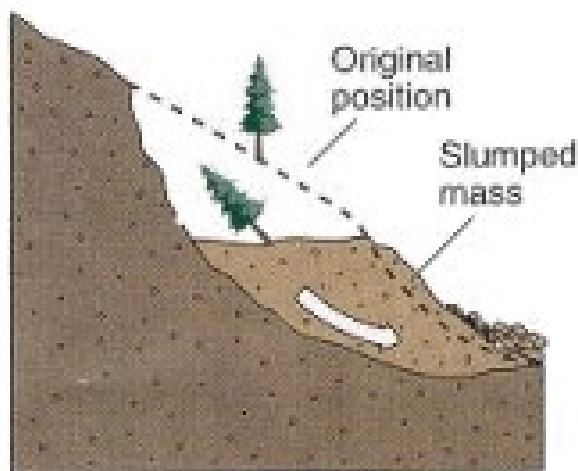
SLUMP (Rotational Slide)

Slump is the slow to moderate movement of materials on a slope. In most cases the materials are unconsolidated or poorly consolidated. The motion is rotational, and the plane of movement is curved.

Surface cracking can indicate the slope is nearing a rotational slide failure.

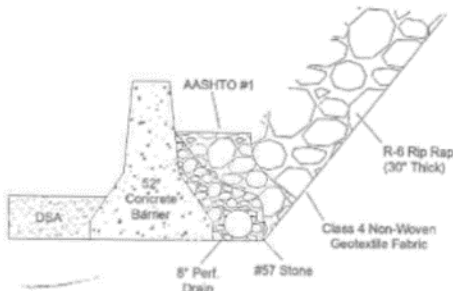
Concrete Barrier Backed with Rip Rap Detail
N.T.S.

Surface cover is very important for slopes with granular soil because erosion is a concern. Surface erosion can cause geometric inconsistencies that lead to failure. Erosion can often cause washout failure. Use a hard armor surface cover (riprap or coarse gravel).

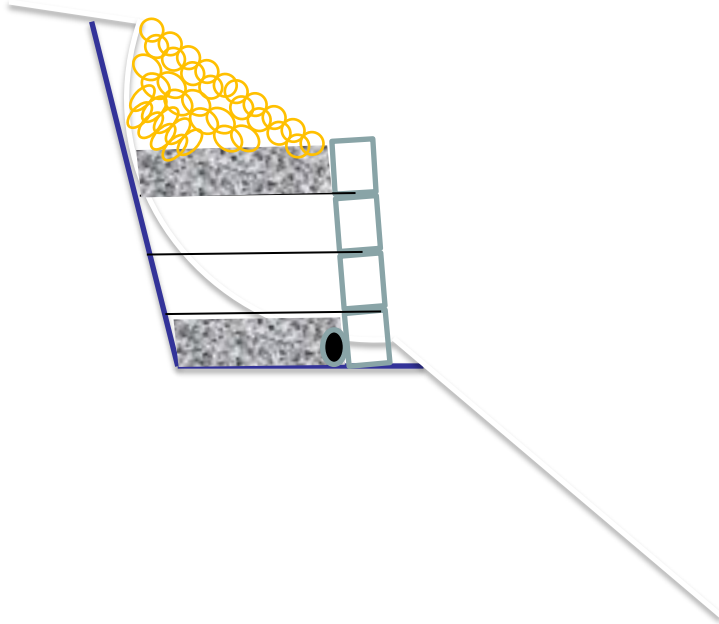
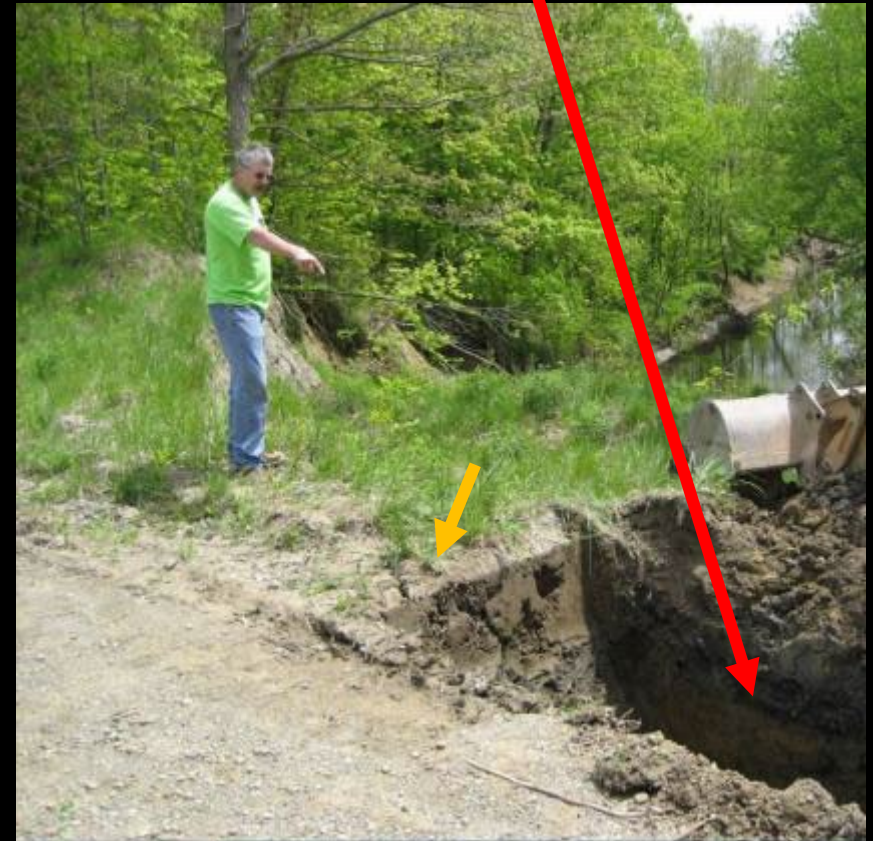
Repair for Rotational Failures (Slumps)

With blocks, geosynthetics,
competent fill, drainage, and cover
(to control erosion)

Must excavate below slip

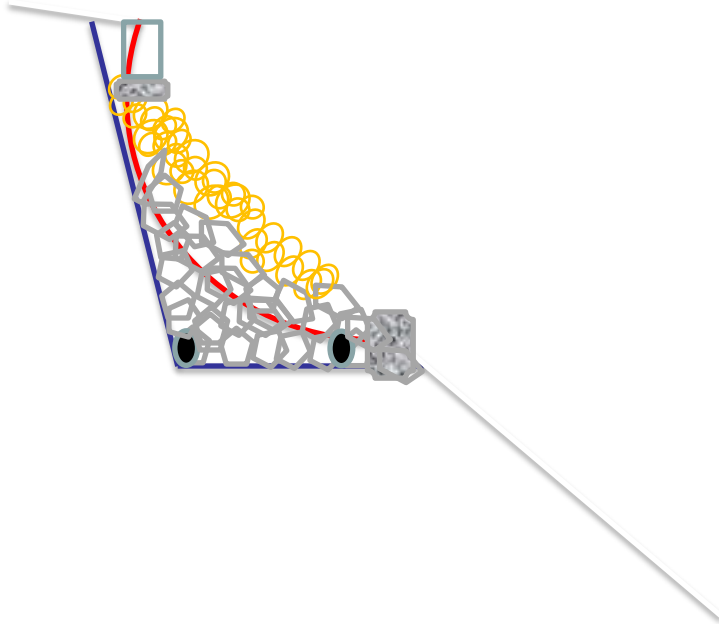
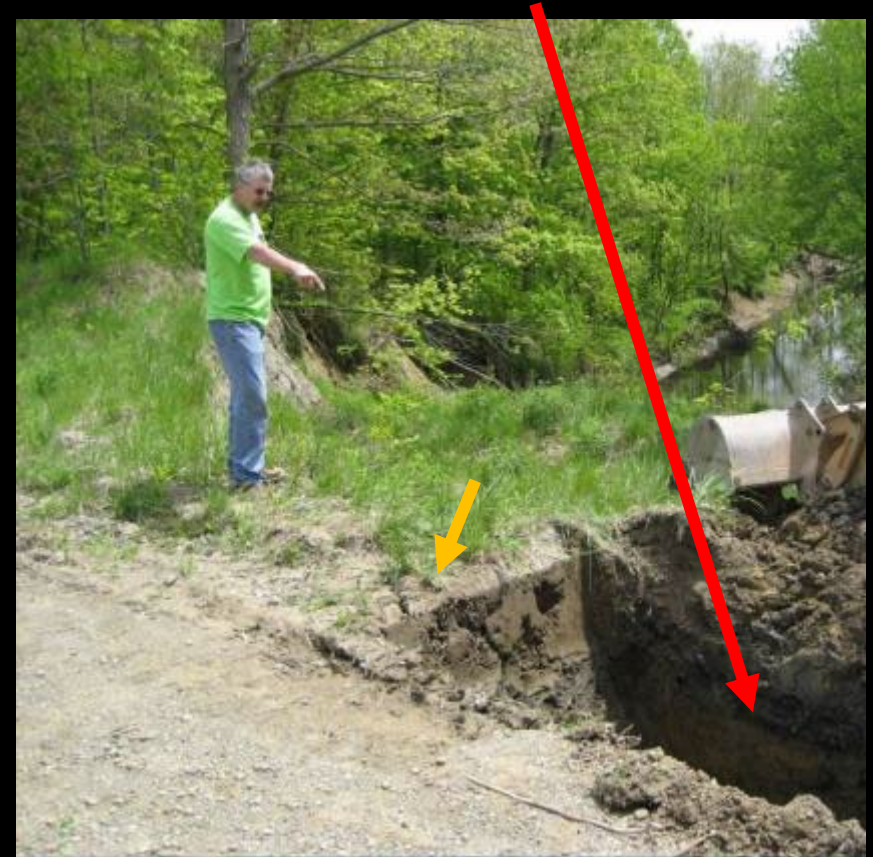
Repair for Rotational Failures (Slumps)

With Riprap, geosynthetics, drainage

Must excavate below slip plane

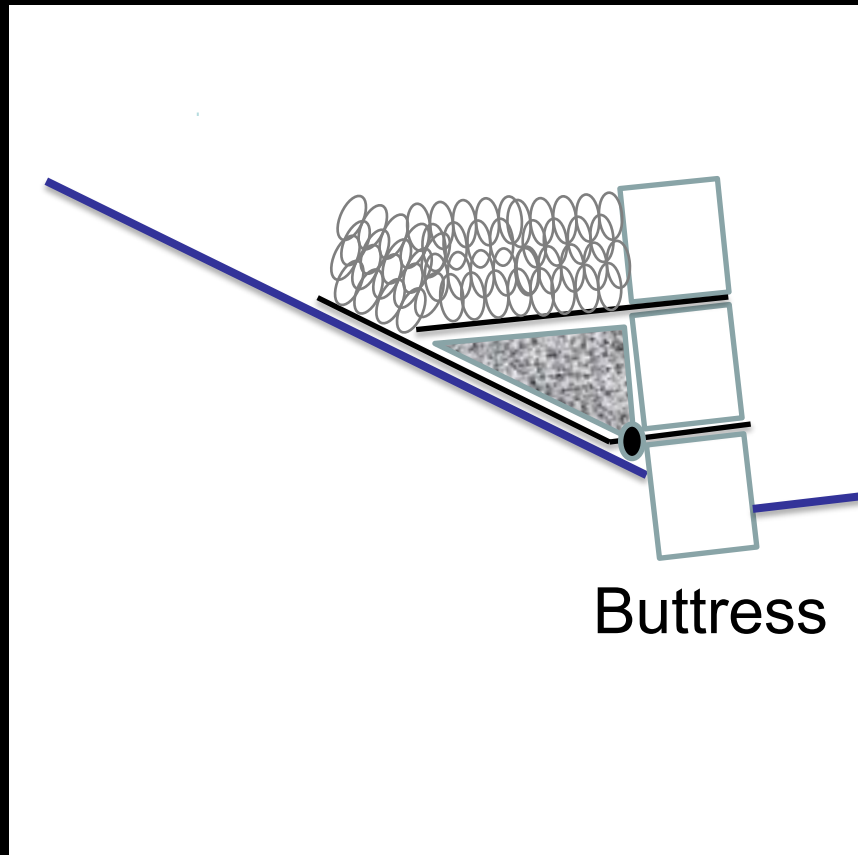
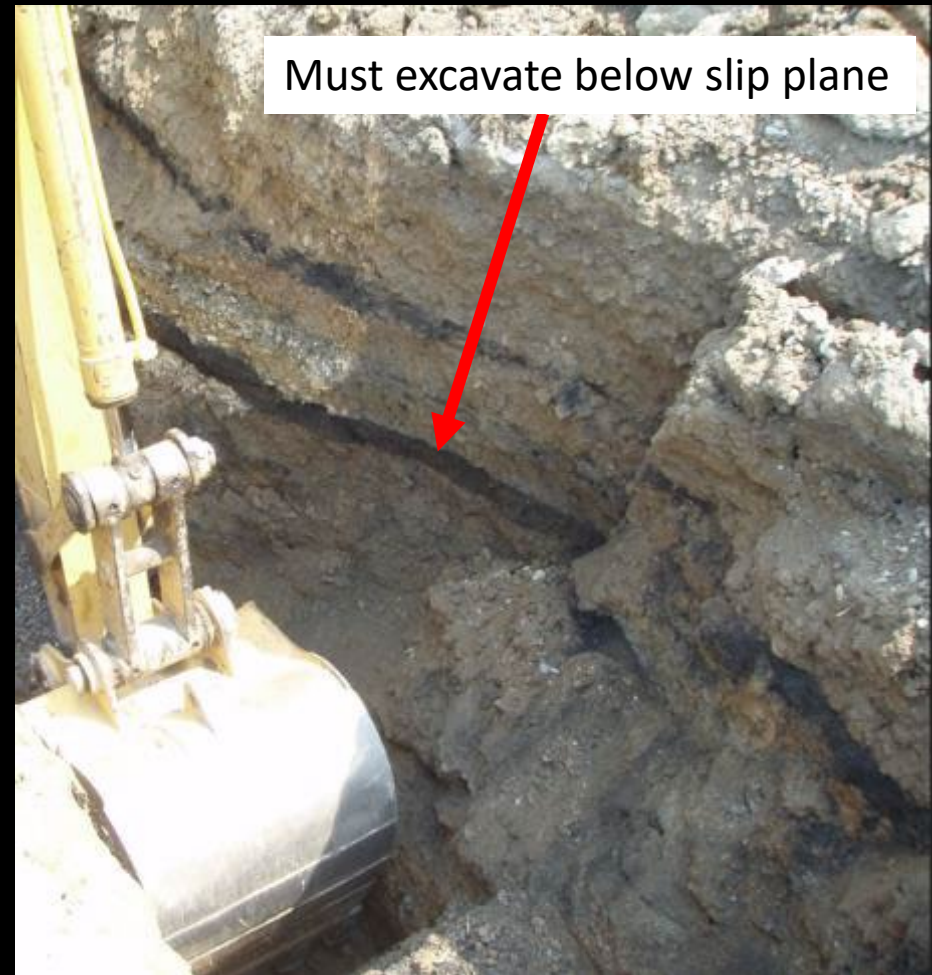
Repair for Creep Failures (Ooze)

With block, riprap, geosynthetics, drainage

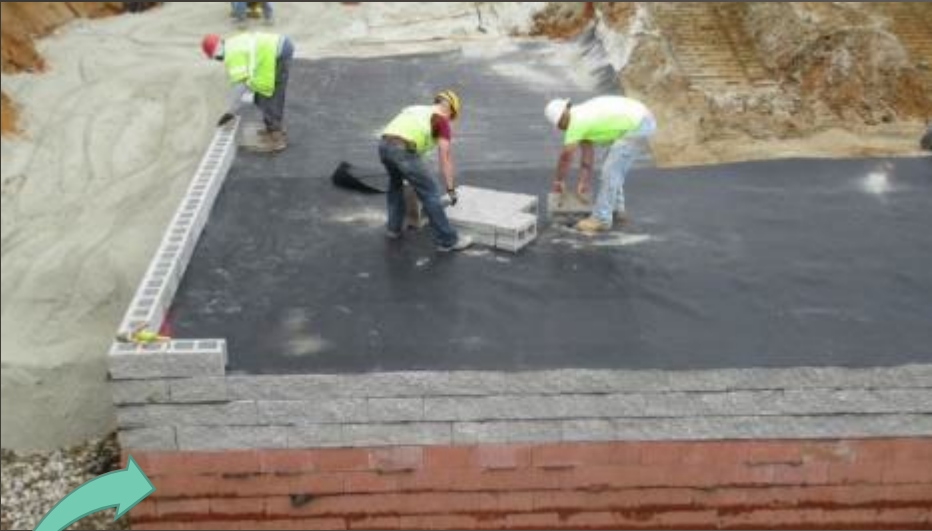
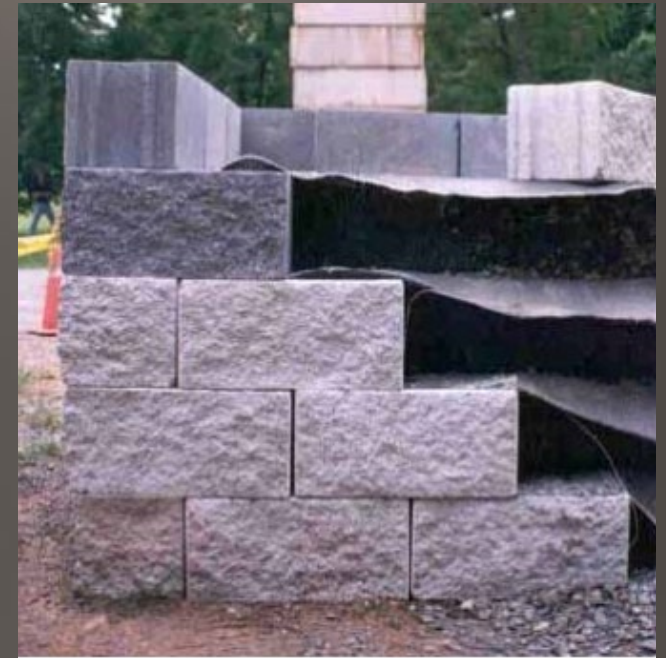
Geosynthetic can be wrapped or pinched between facing block/rock

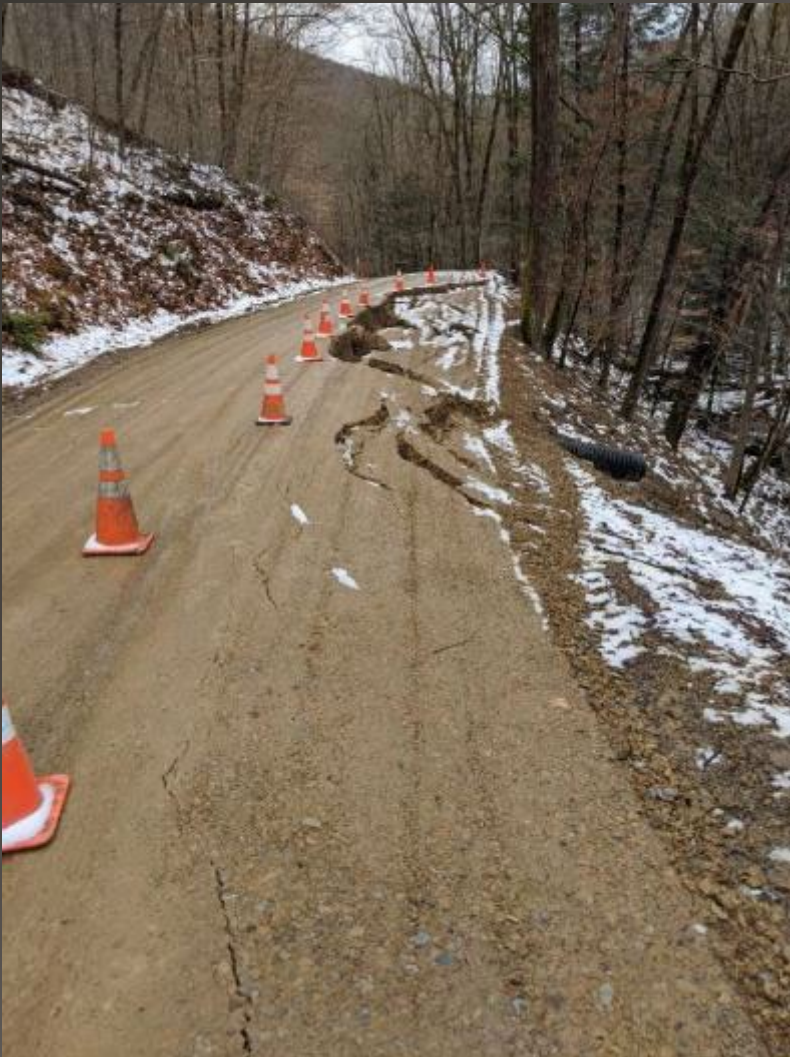
Sizer Run – Shippen Township

- 200' long 8' high
- Used Contractor for implementation
- 90 concrete blocks
- 2 new pipes
- 24 loads of 2RC
- 4 Days to complete
- \$23,200.00

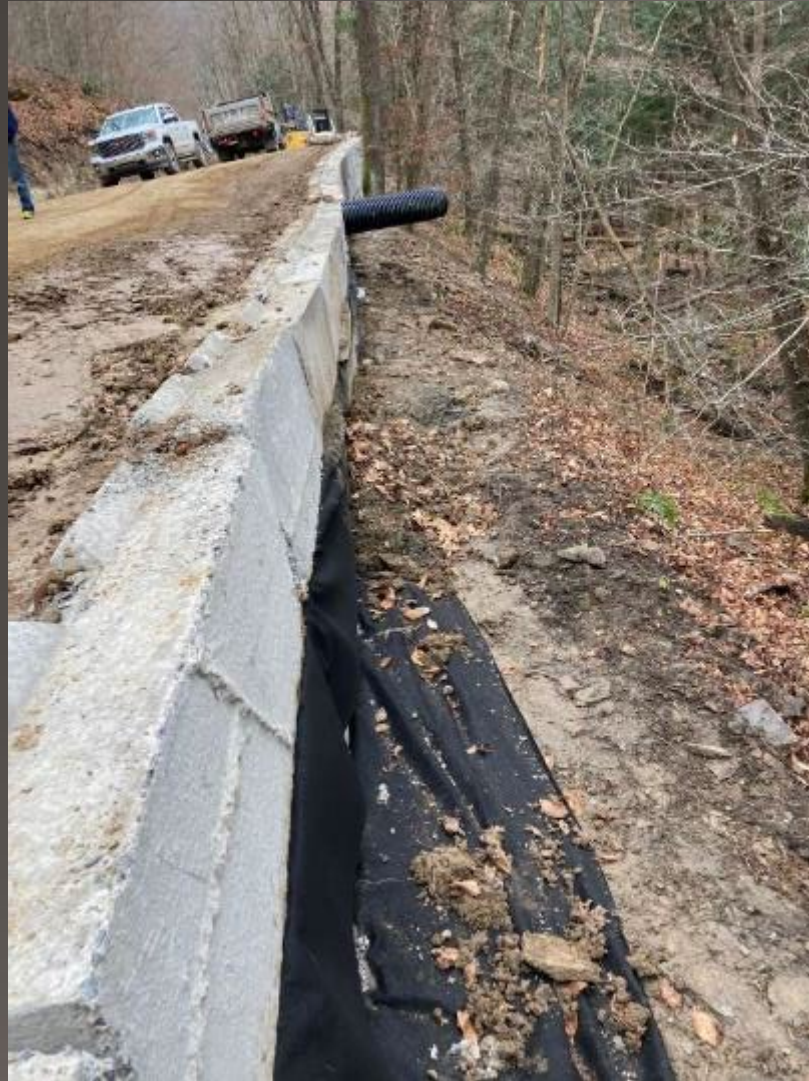
Sizer Run

GRS stabilization method used
block wall extends to slip plane

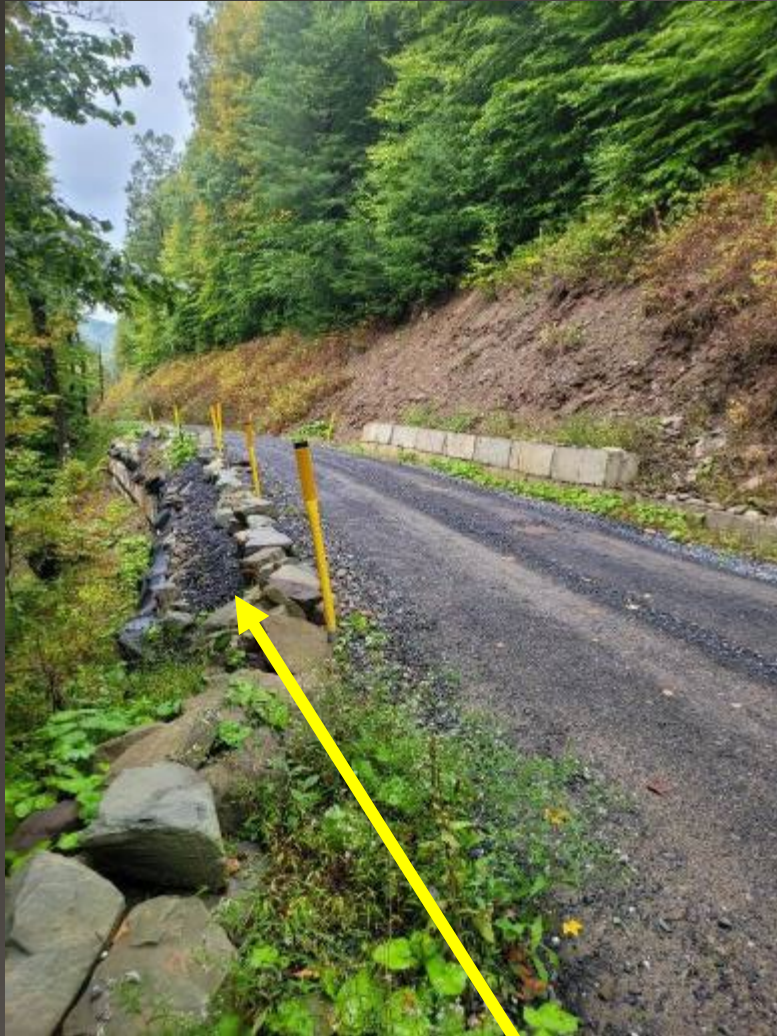
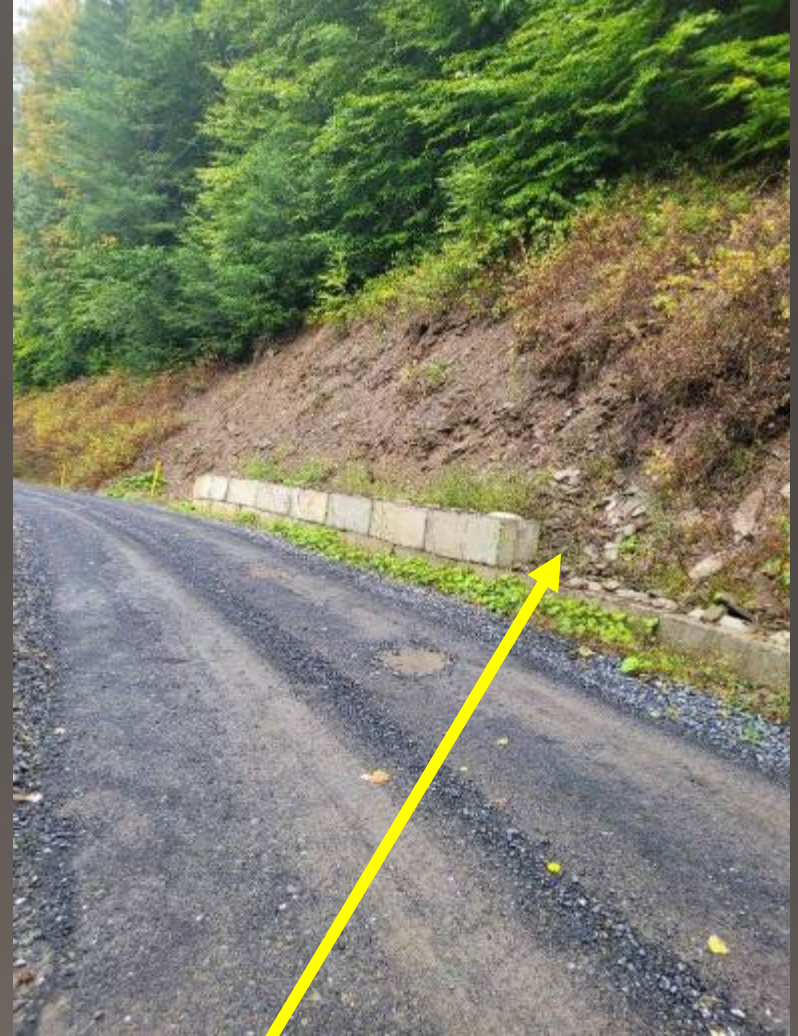
Hunts Run Road

Stabilized both upslope
and downslope banks

- 2 different slides along road
- Hunts Run Class A Wild Trout
- Completed with Township Labor
- Both approximately 140' x 6'
- 100 mafia block
- 30 loads of 2RC
- Approximately \$29,000.00

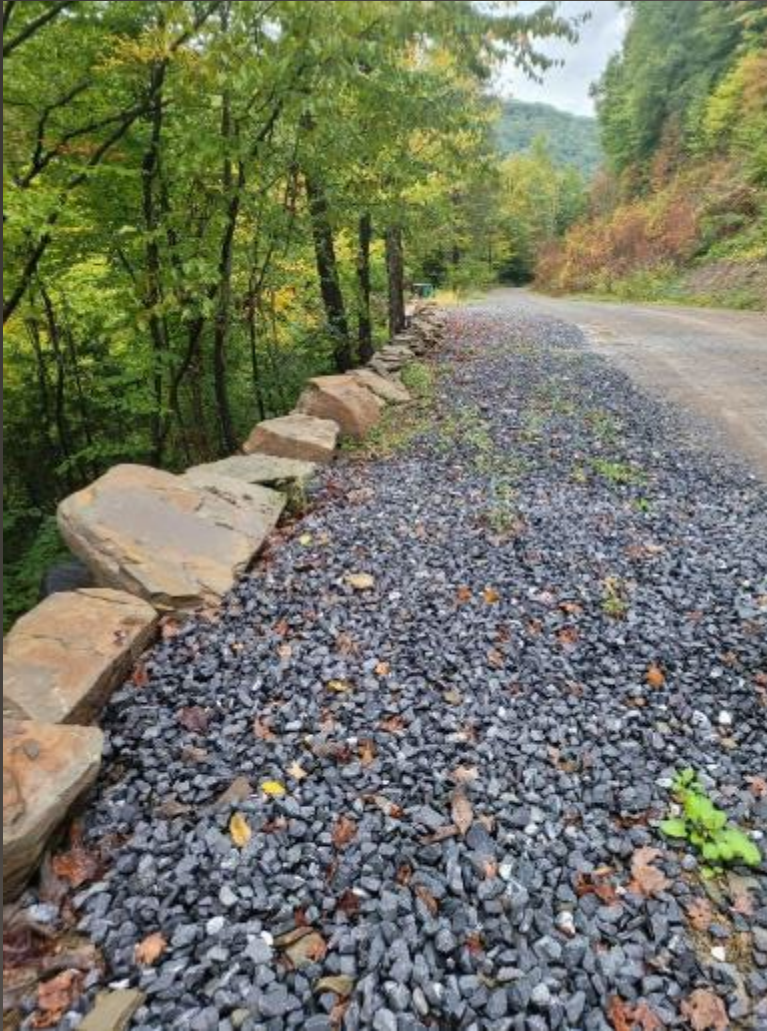
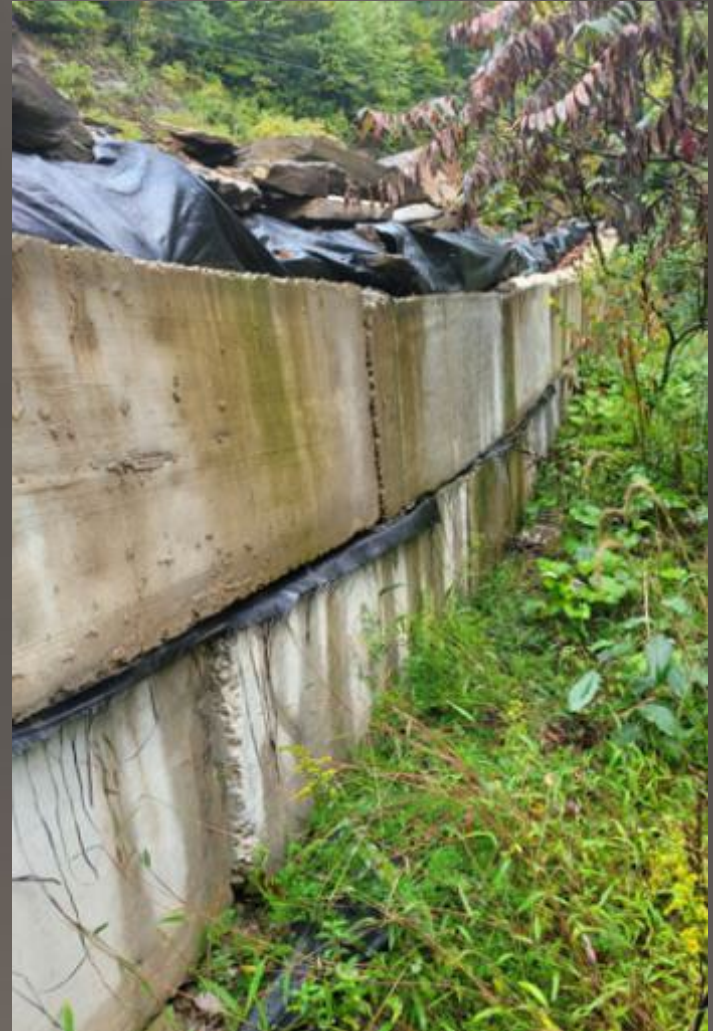
Hunts Run Road

Lower bank repair used GRS
method with block wall

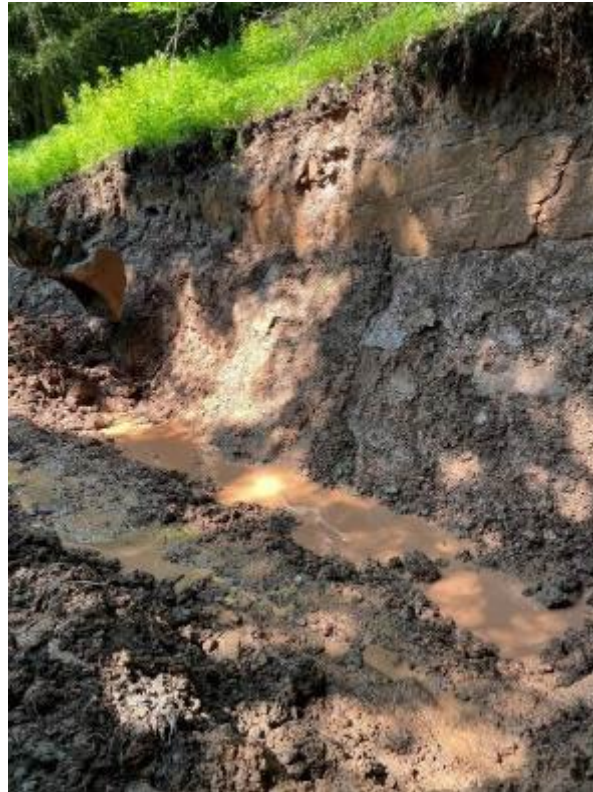
Bank sloughing onto roadway

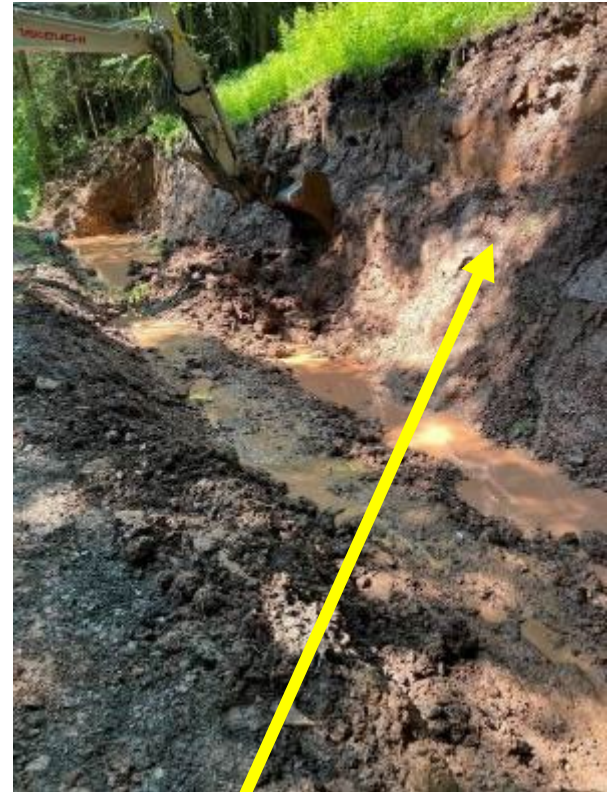
Excavating for drain and rock overlay

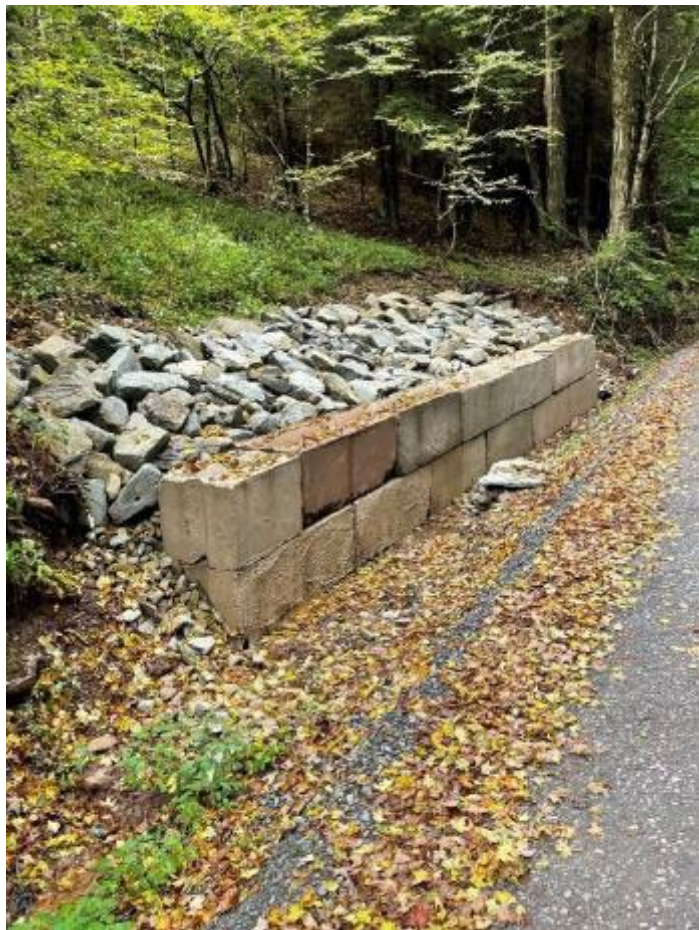
**Rock overlay
replaces poor soils**

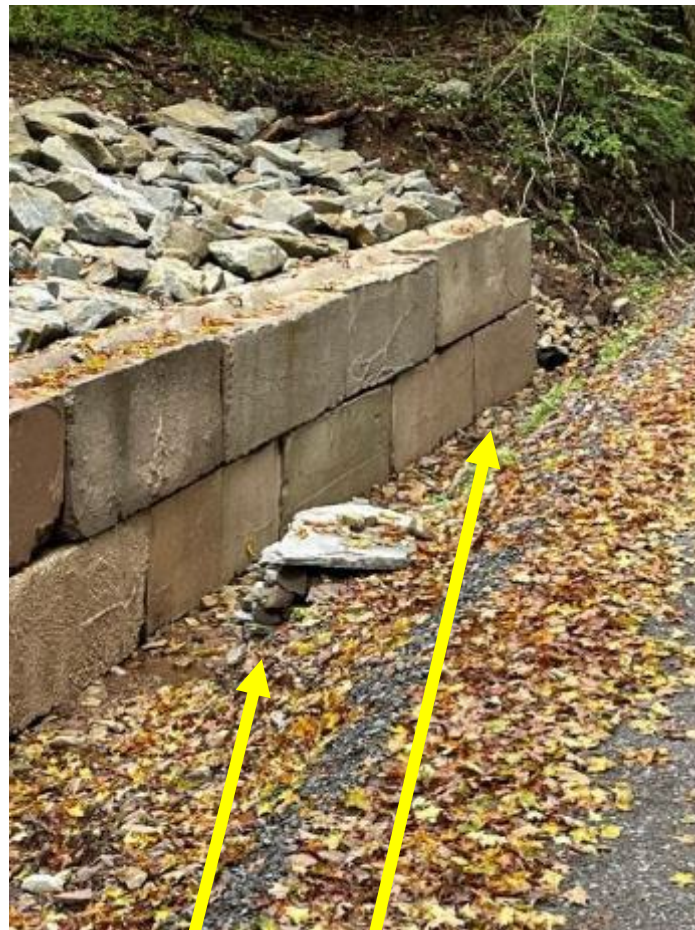
**Footer drain and
pipe remove water**

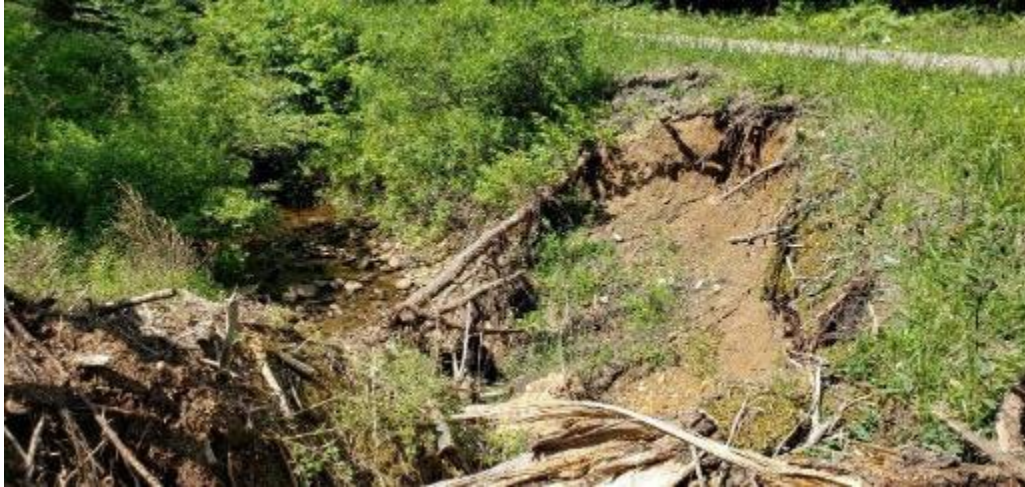
**Slip Encroaching
on Road**

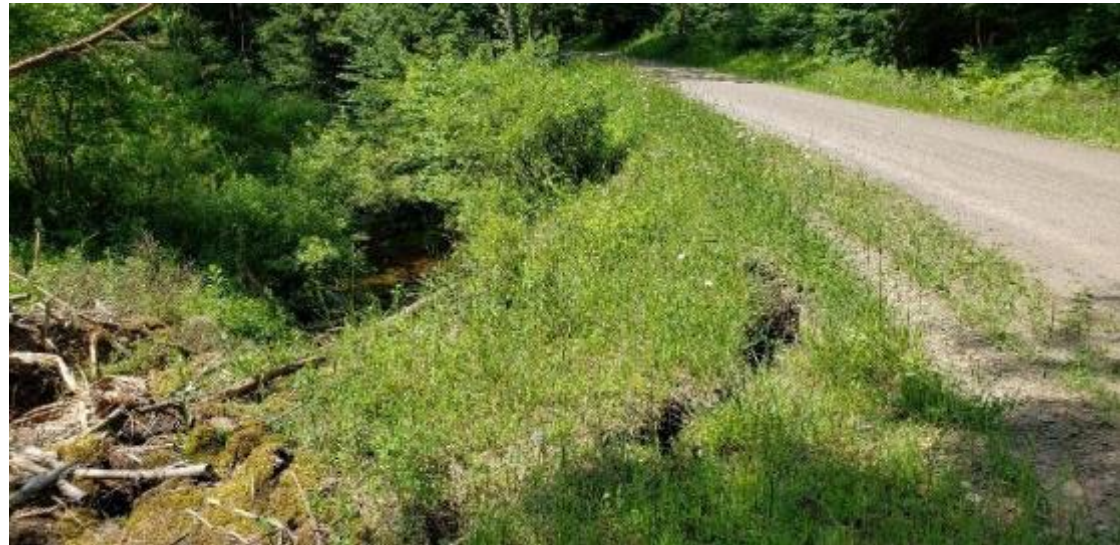
**Road Bank / Stream
Bank Failing**

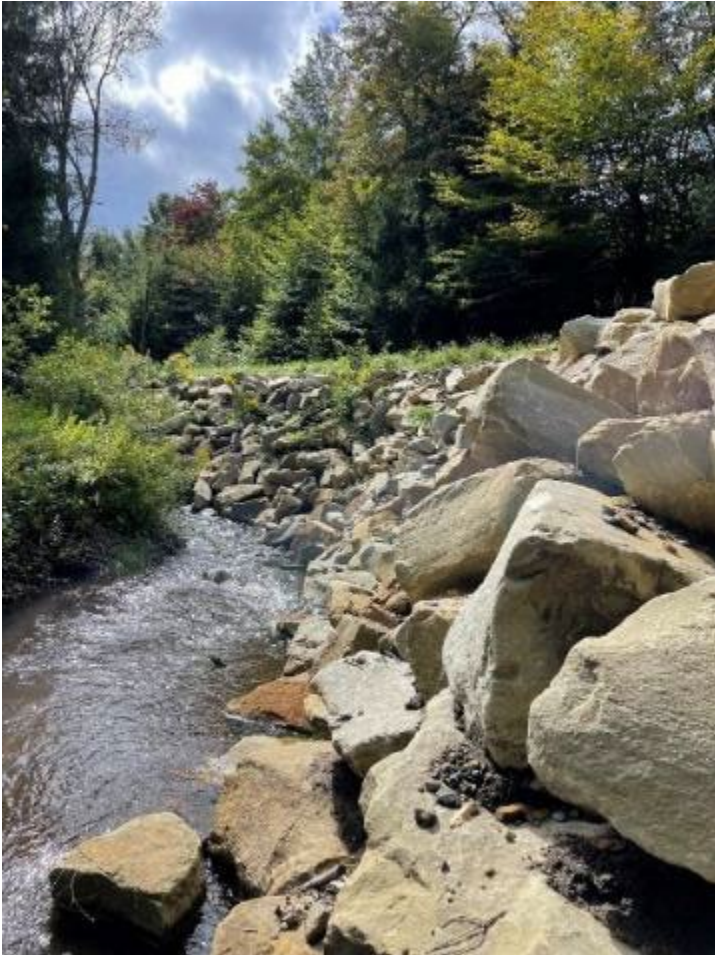
**Large Rock embedded
into channel make
stable toe**

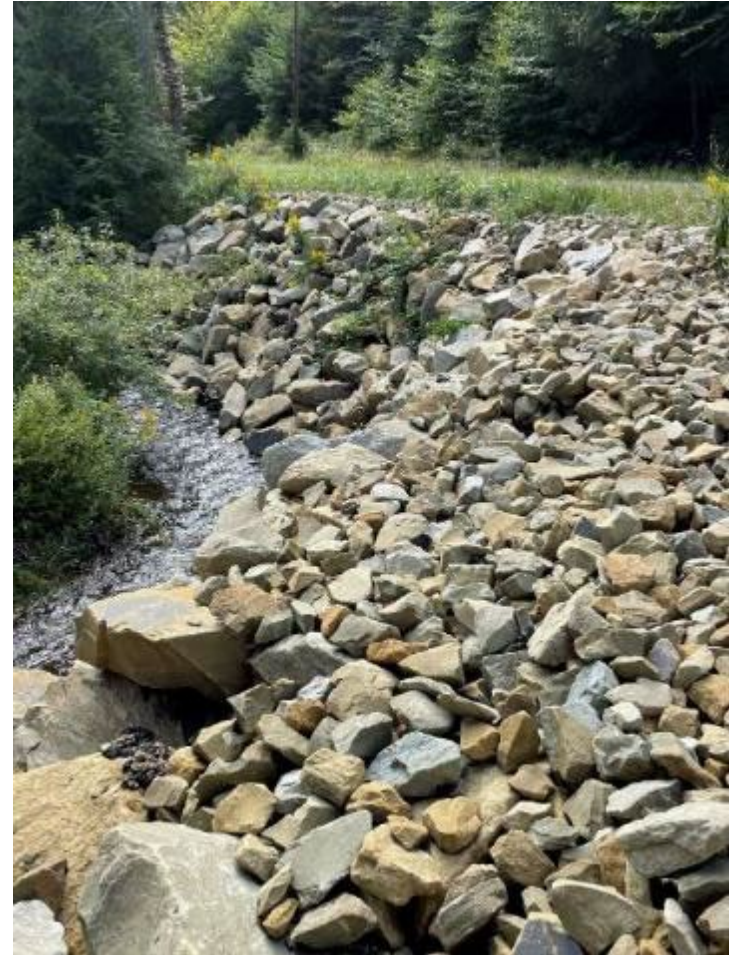
**Road shifted for stable
bank angle without
stream encroachment**

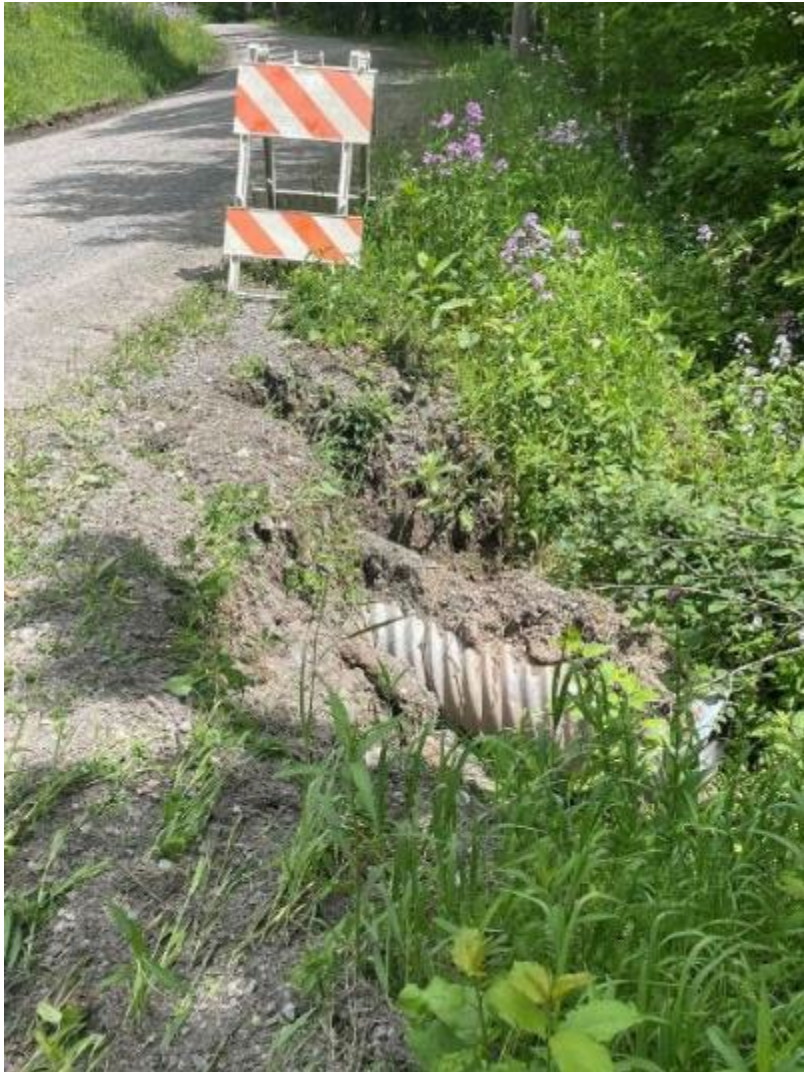
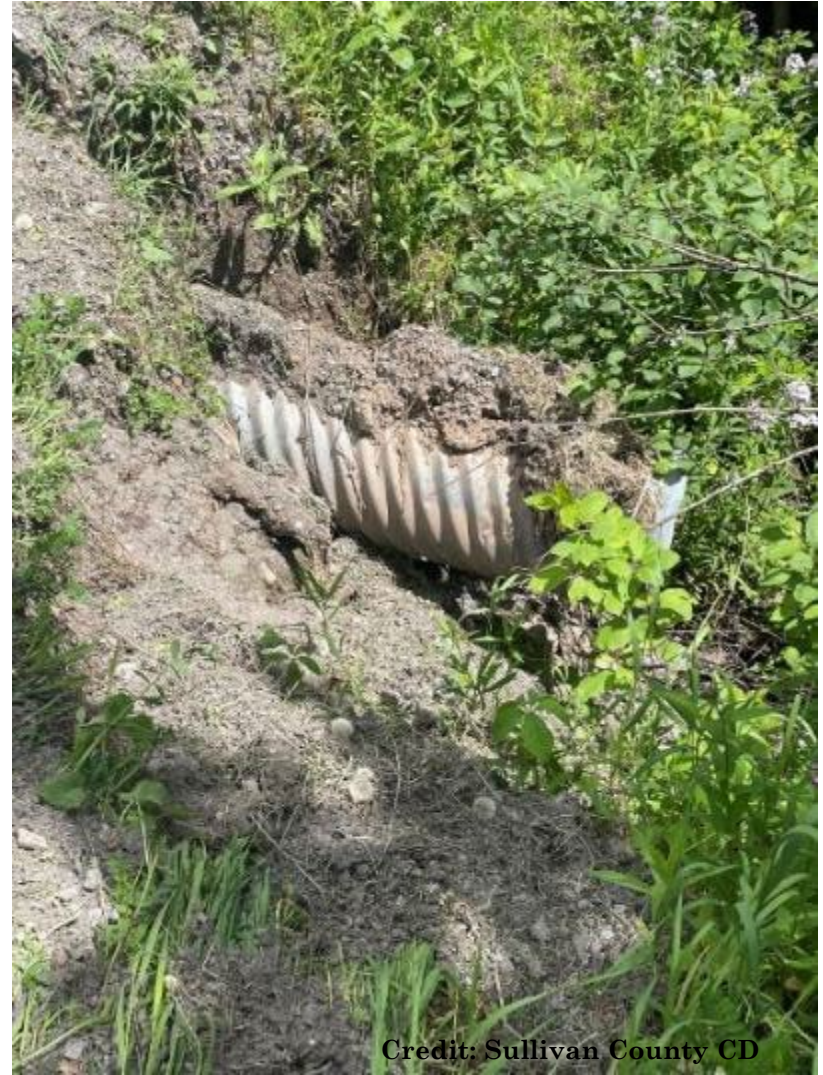
South Black Creek Road

Bank Failure Due To Surface Erosion Before Outfall Pipe Stabilization

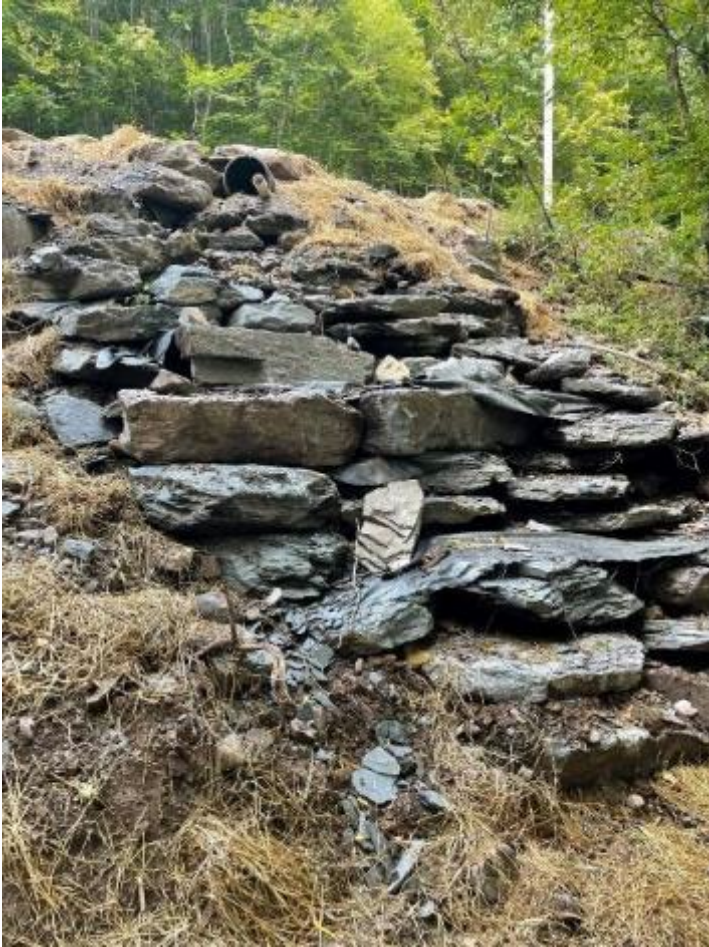
**Reconstructed bank
at pipe outfall**

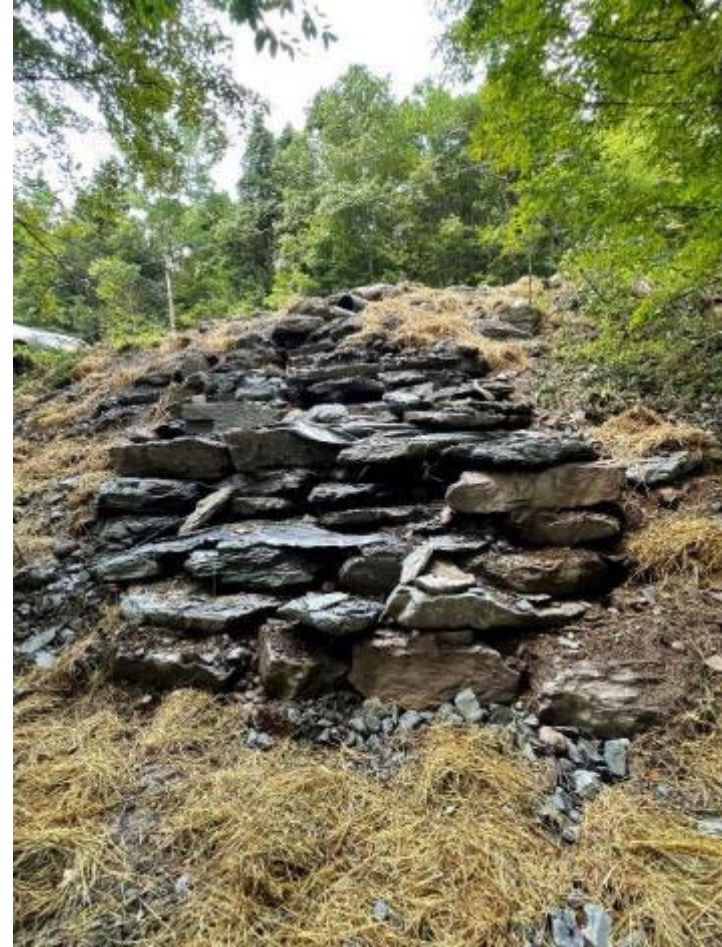
**Rock at stable angle
with large rock at toe**
