Dirt Gravel and Low  
Volume Road Program  
January 19, 2023

# SPREAD FOOTER BRIDGES

# Indiana County

Green Township Barr Road

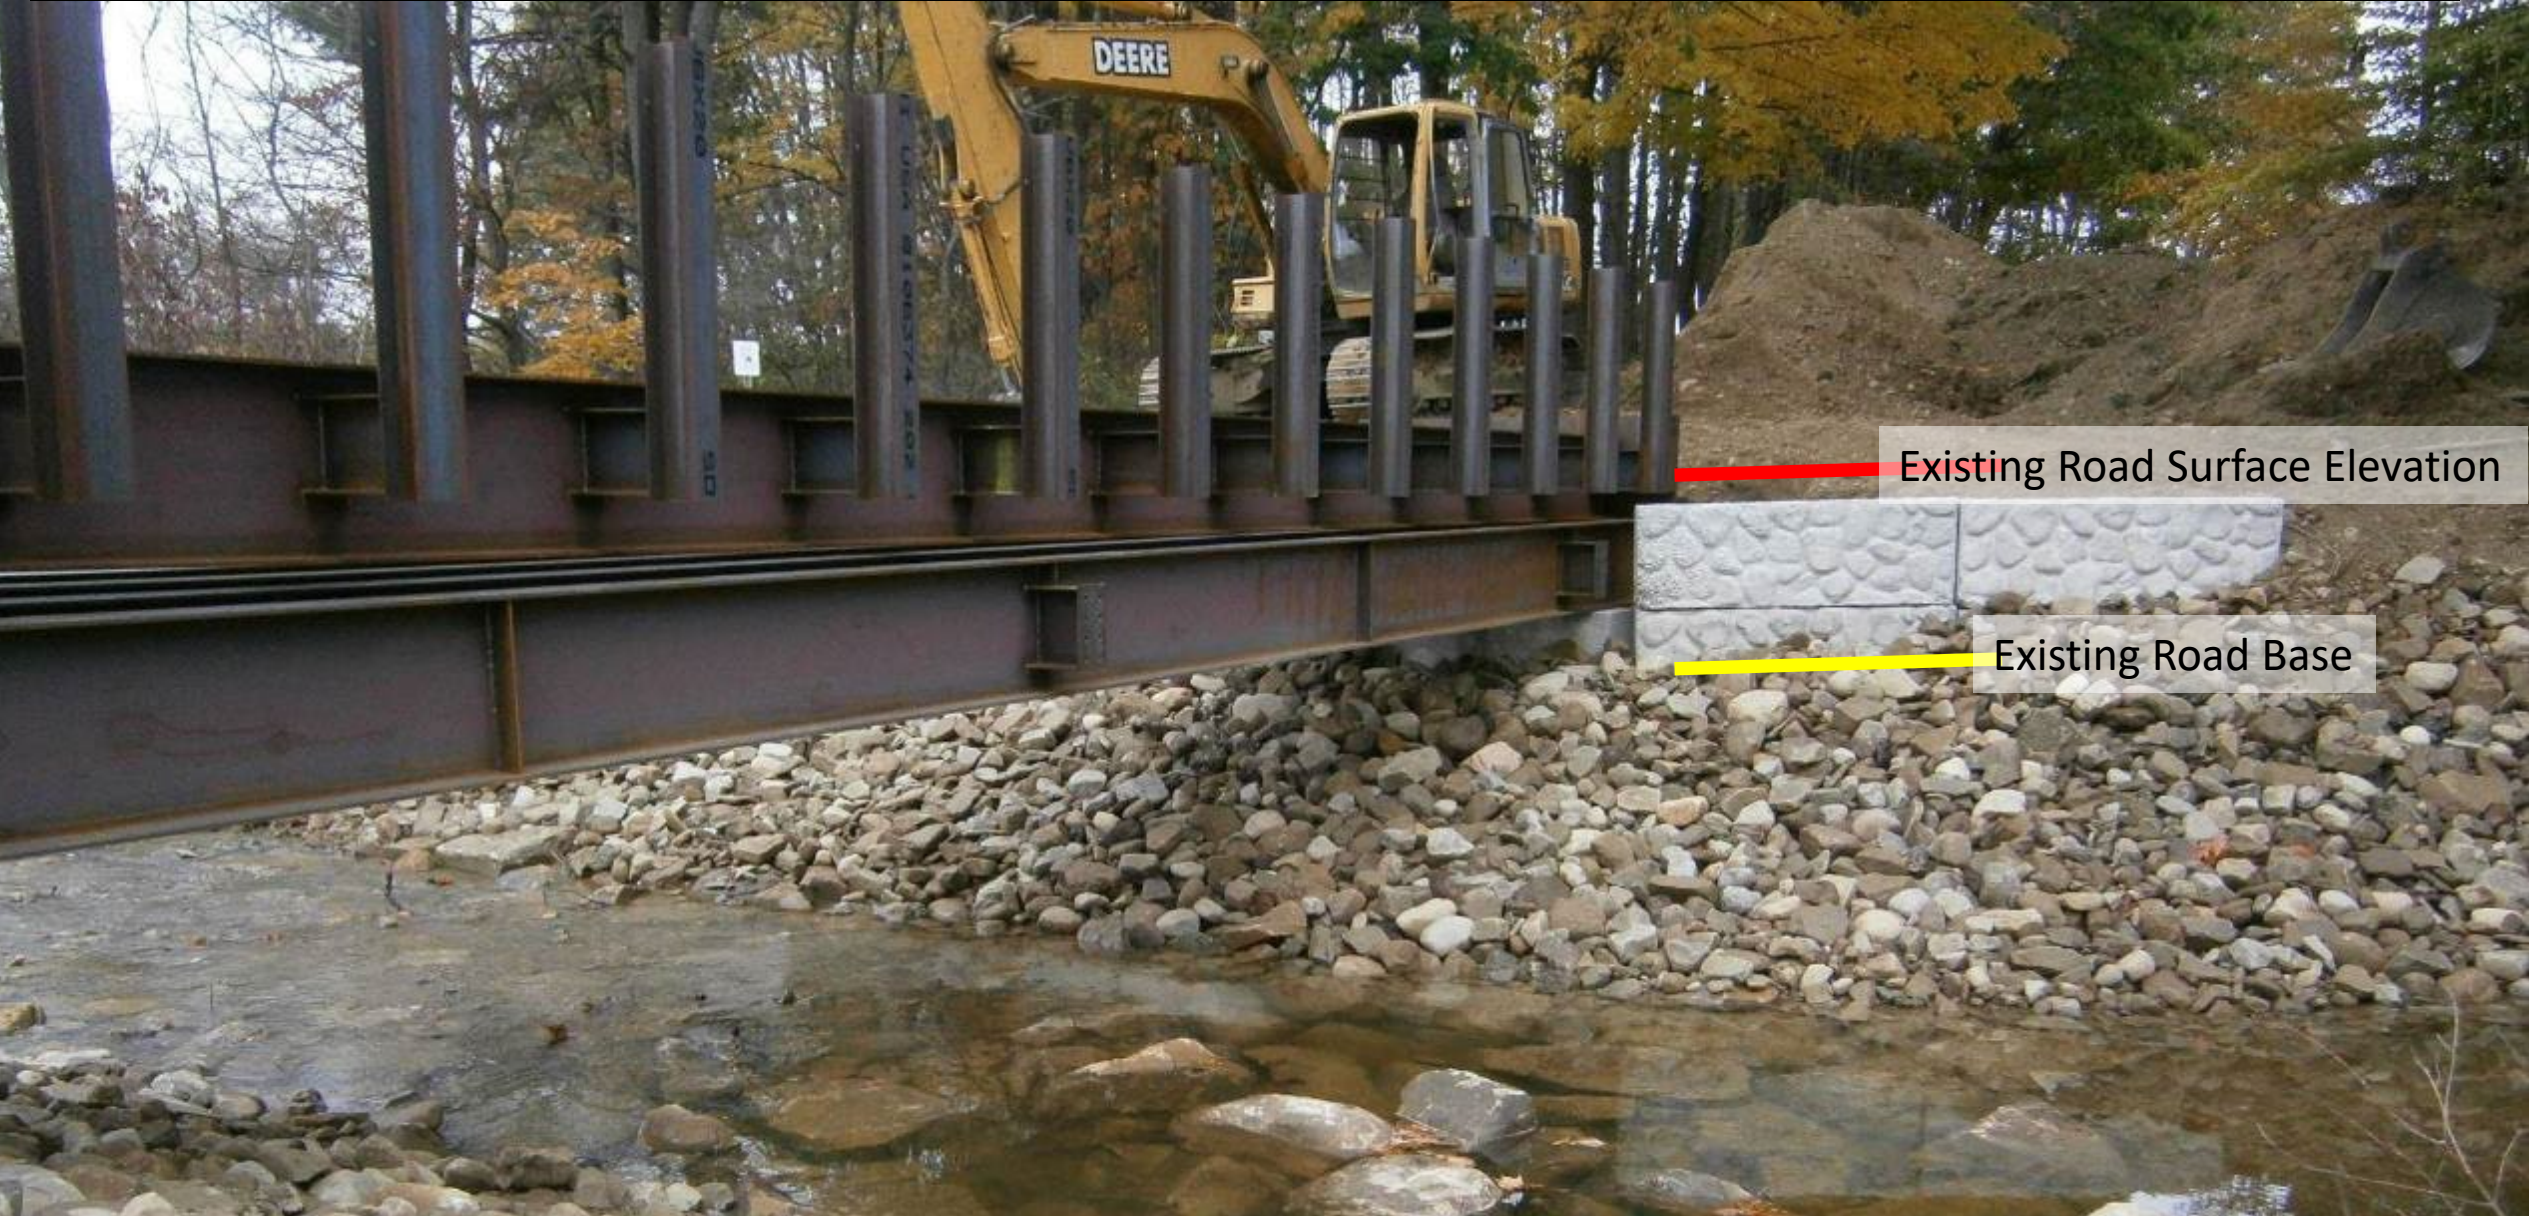
Existing Road Surface Elevation

Existing Road Base

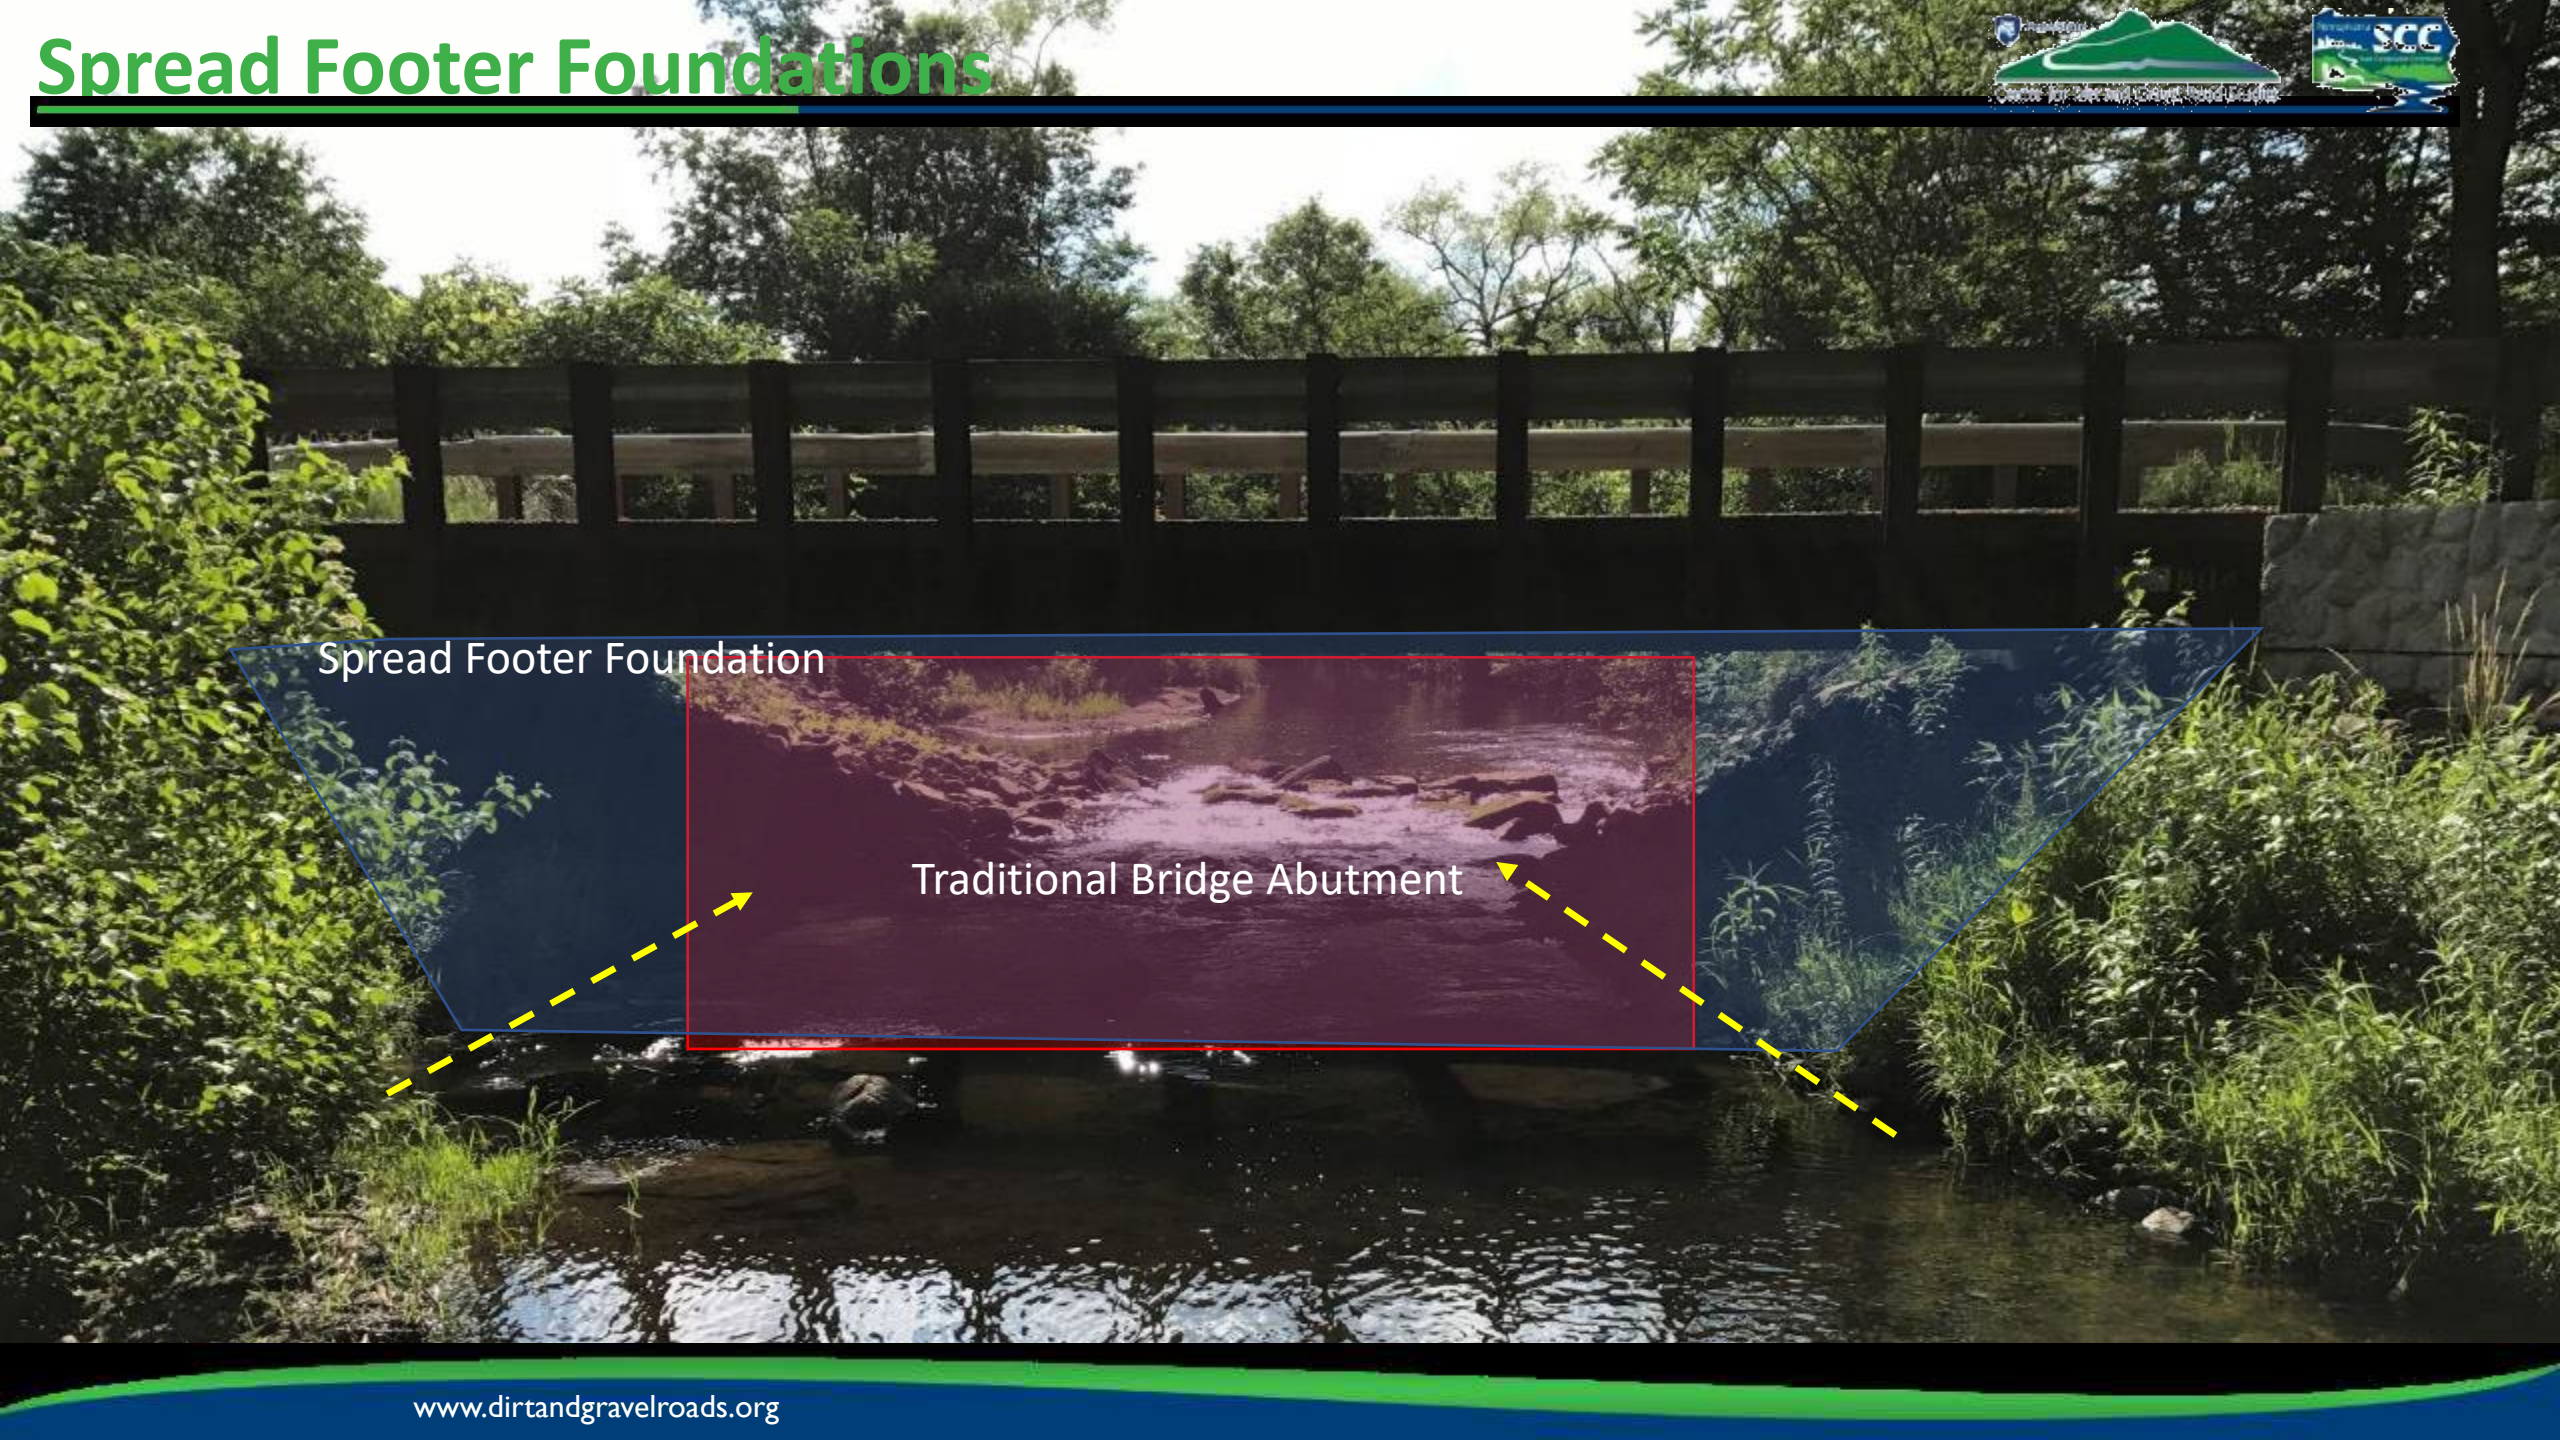
Spread Footer Foundation

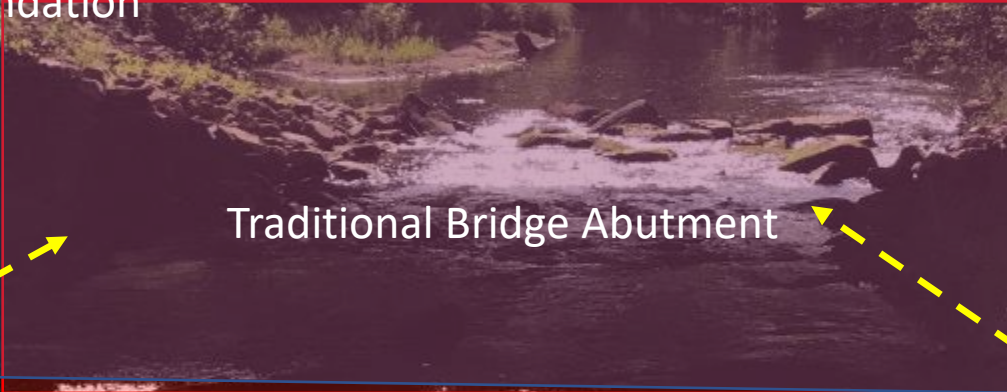
Traditional Bridge Abutment

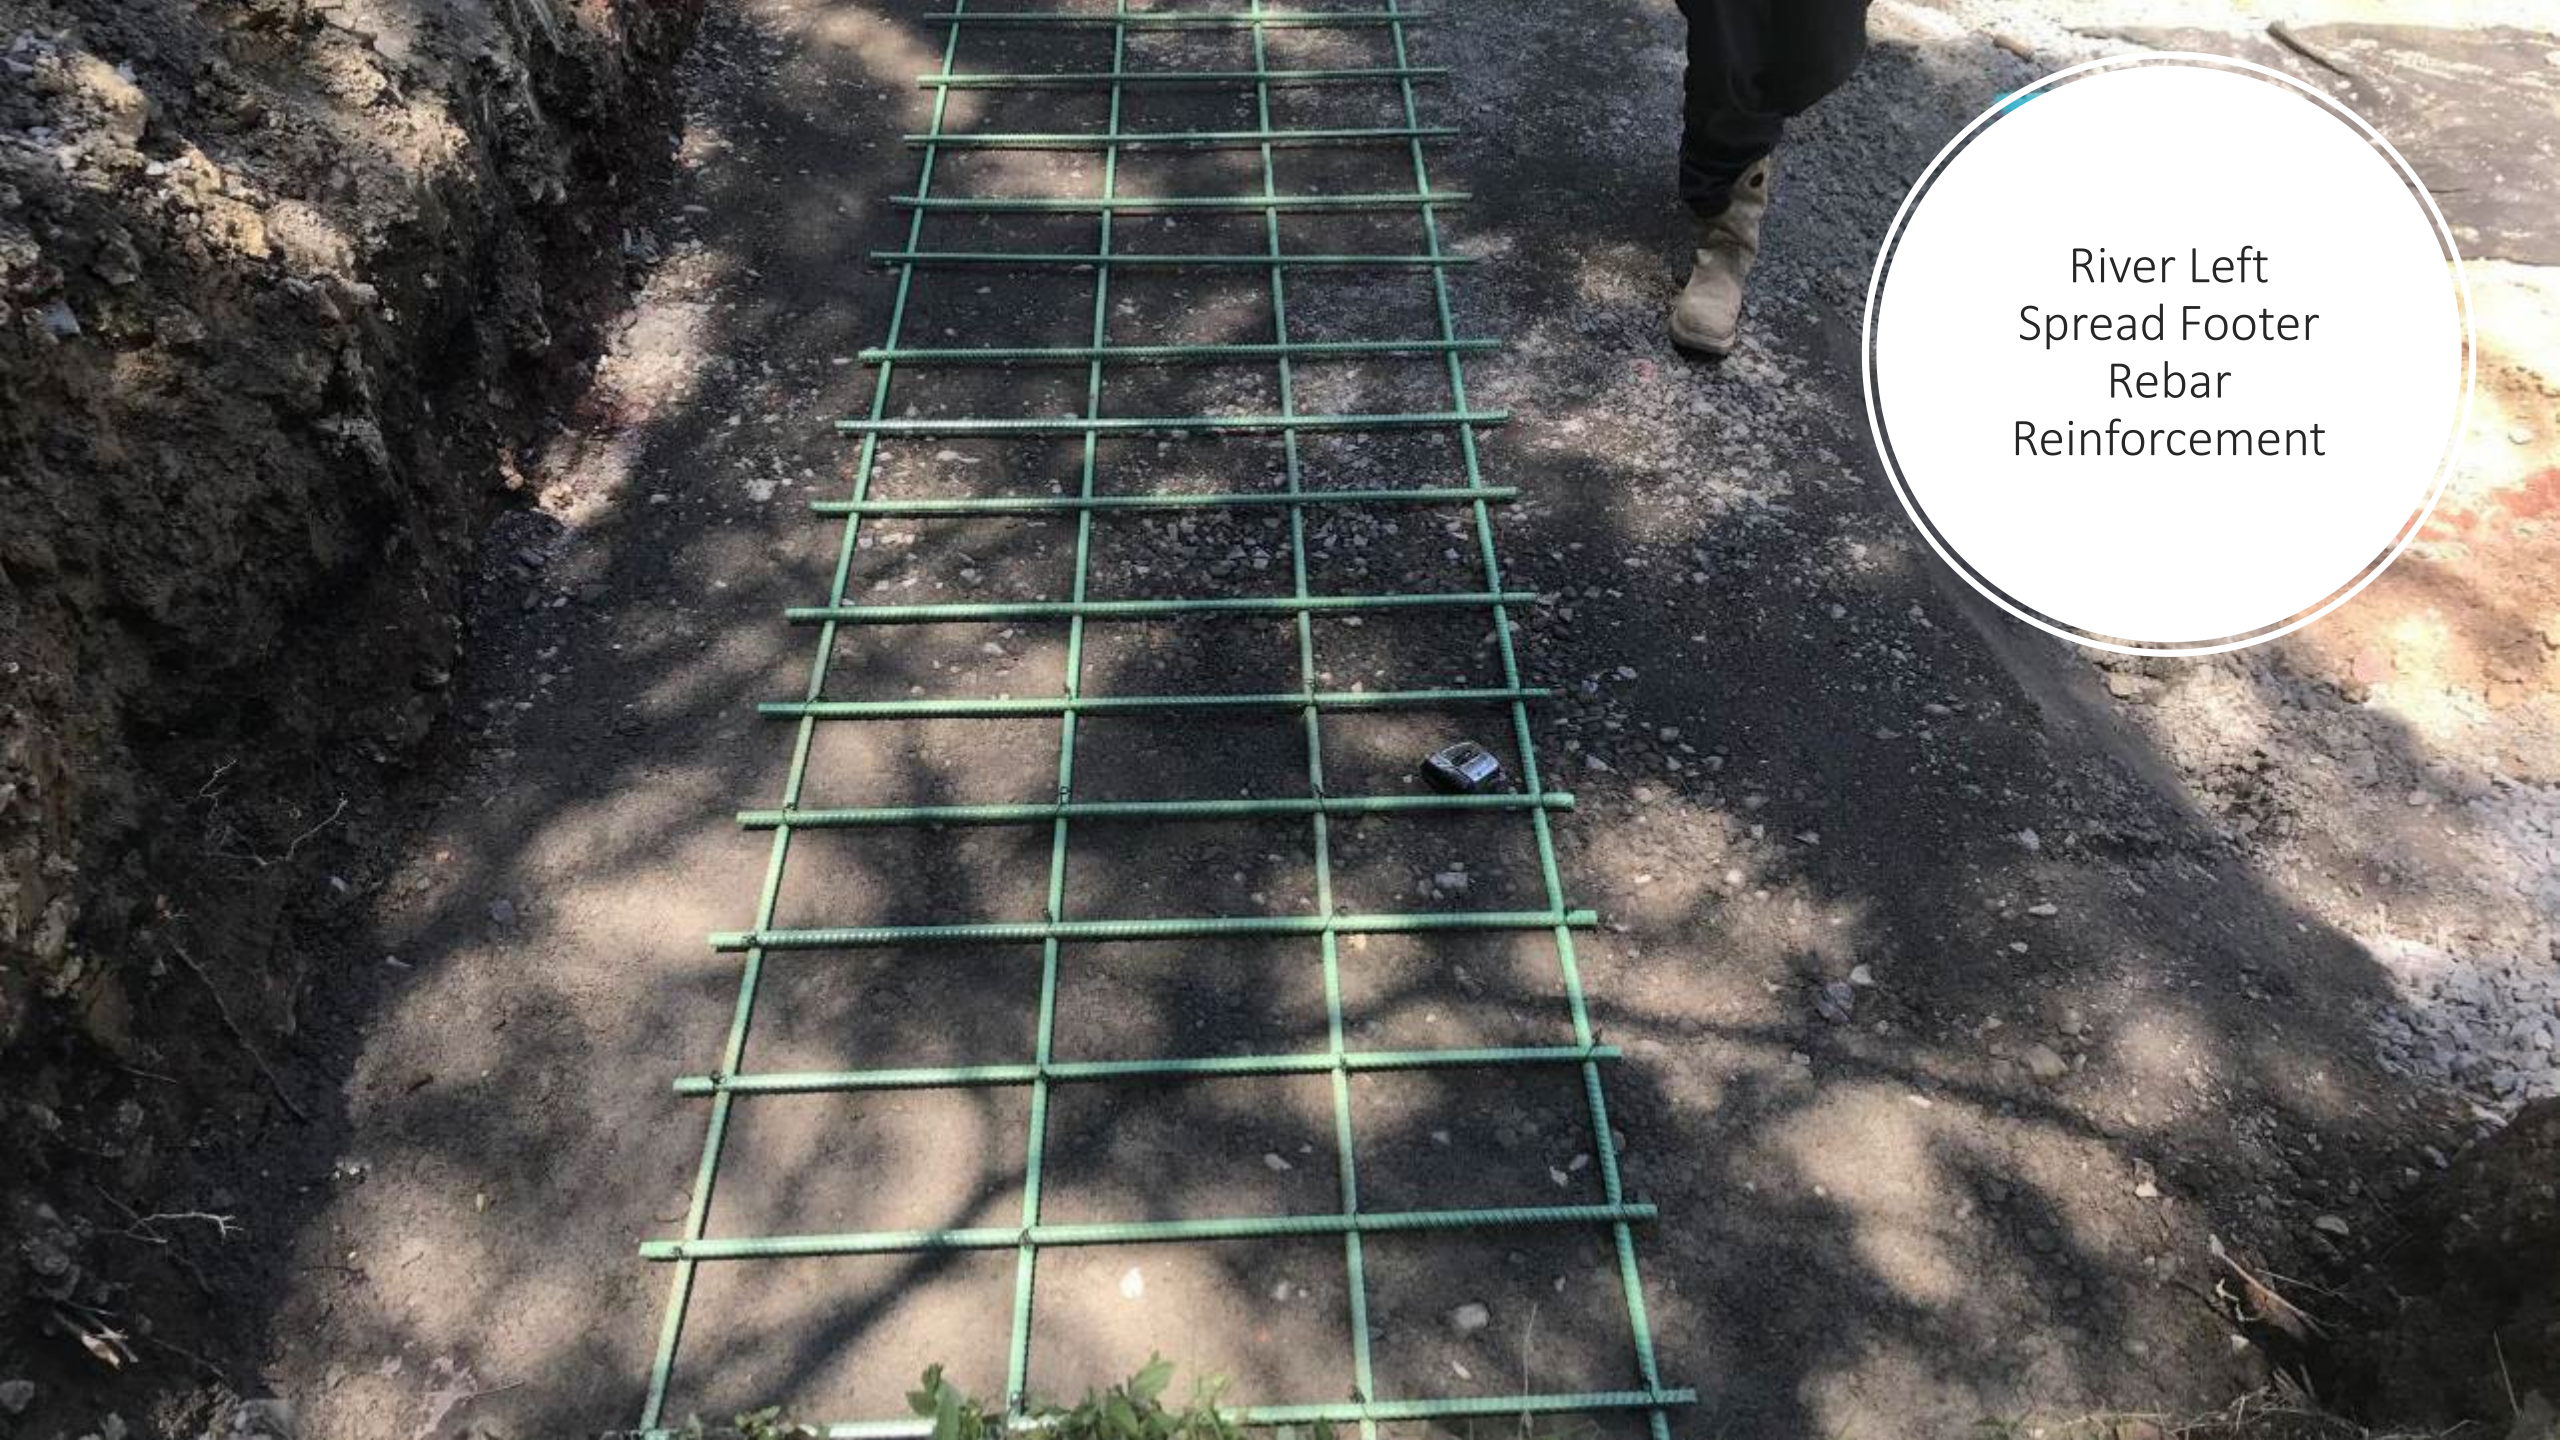
River Left  
Spread Footer  
Rebar  
Reinforcement

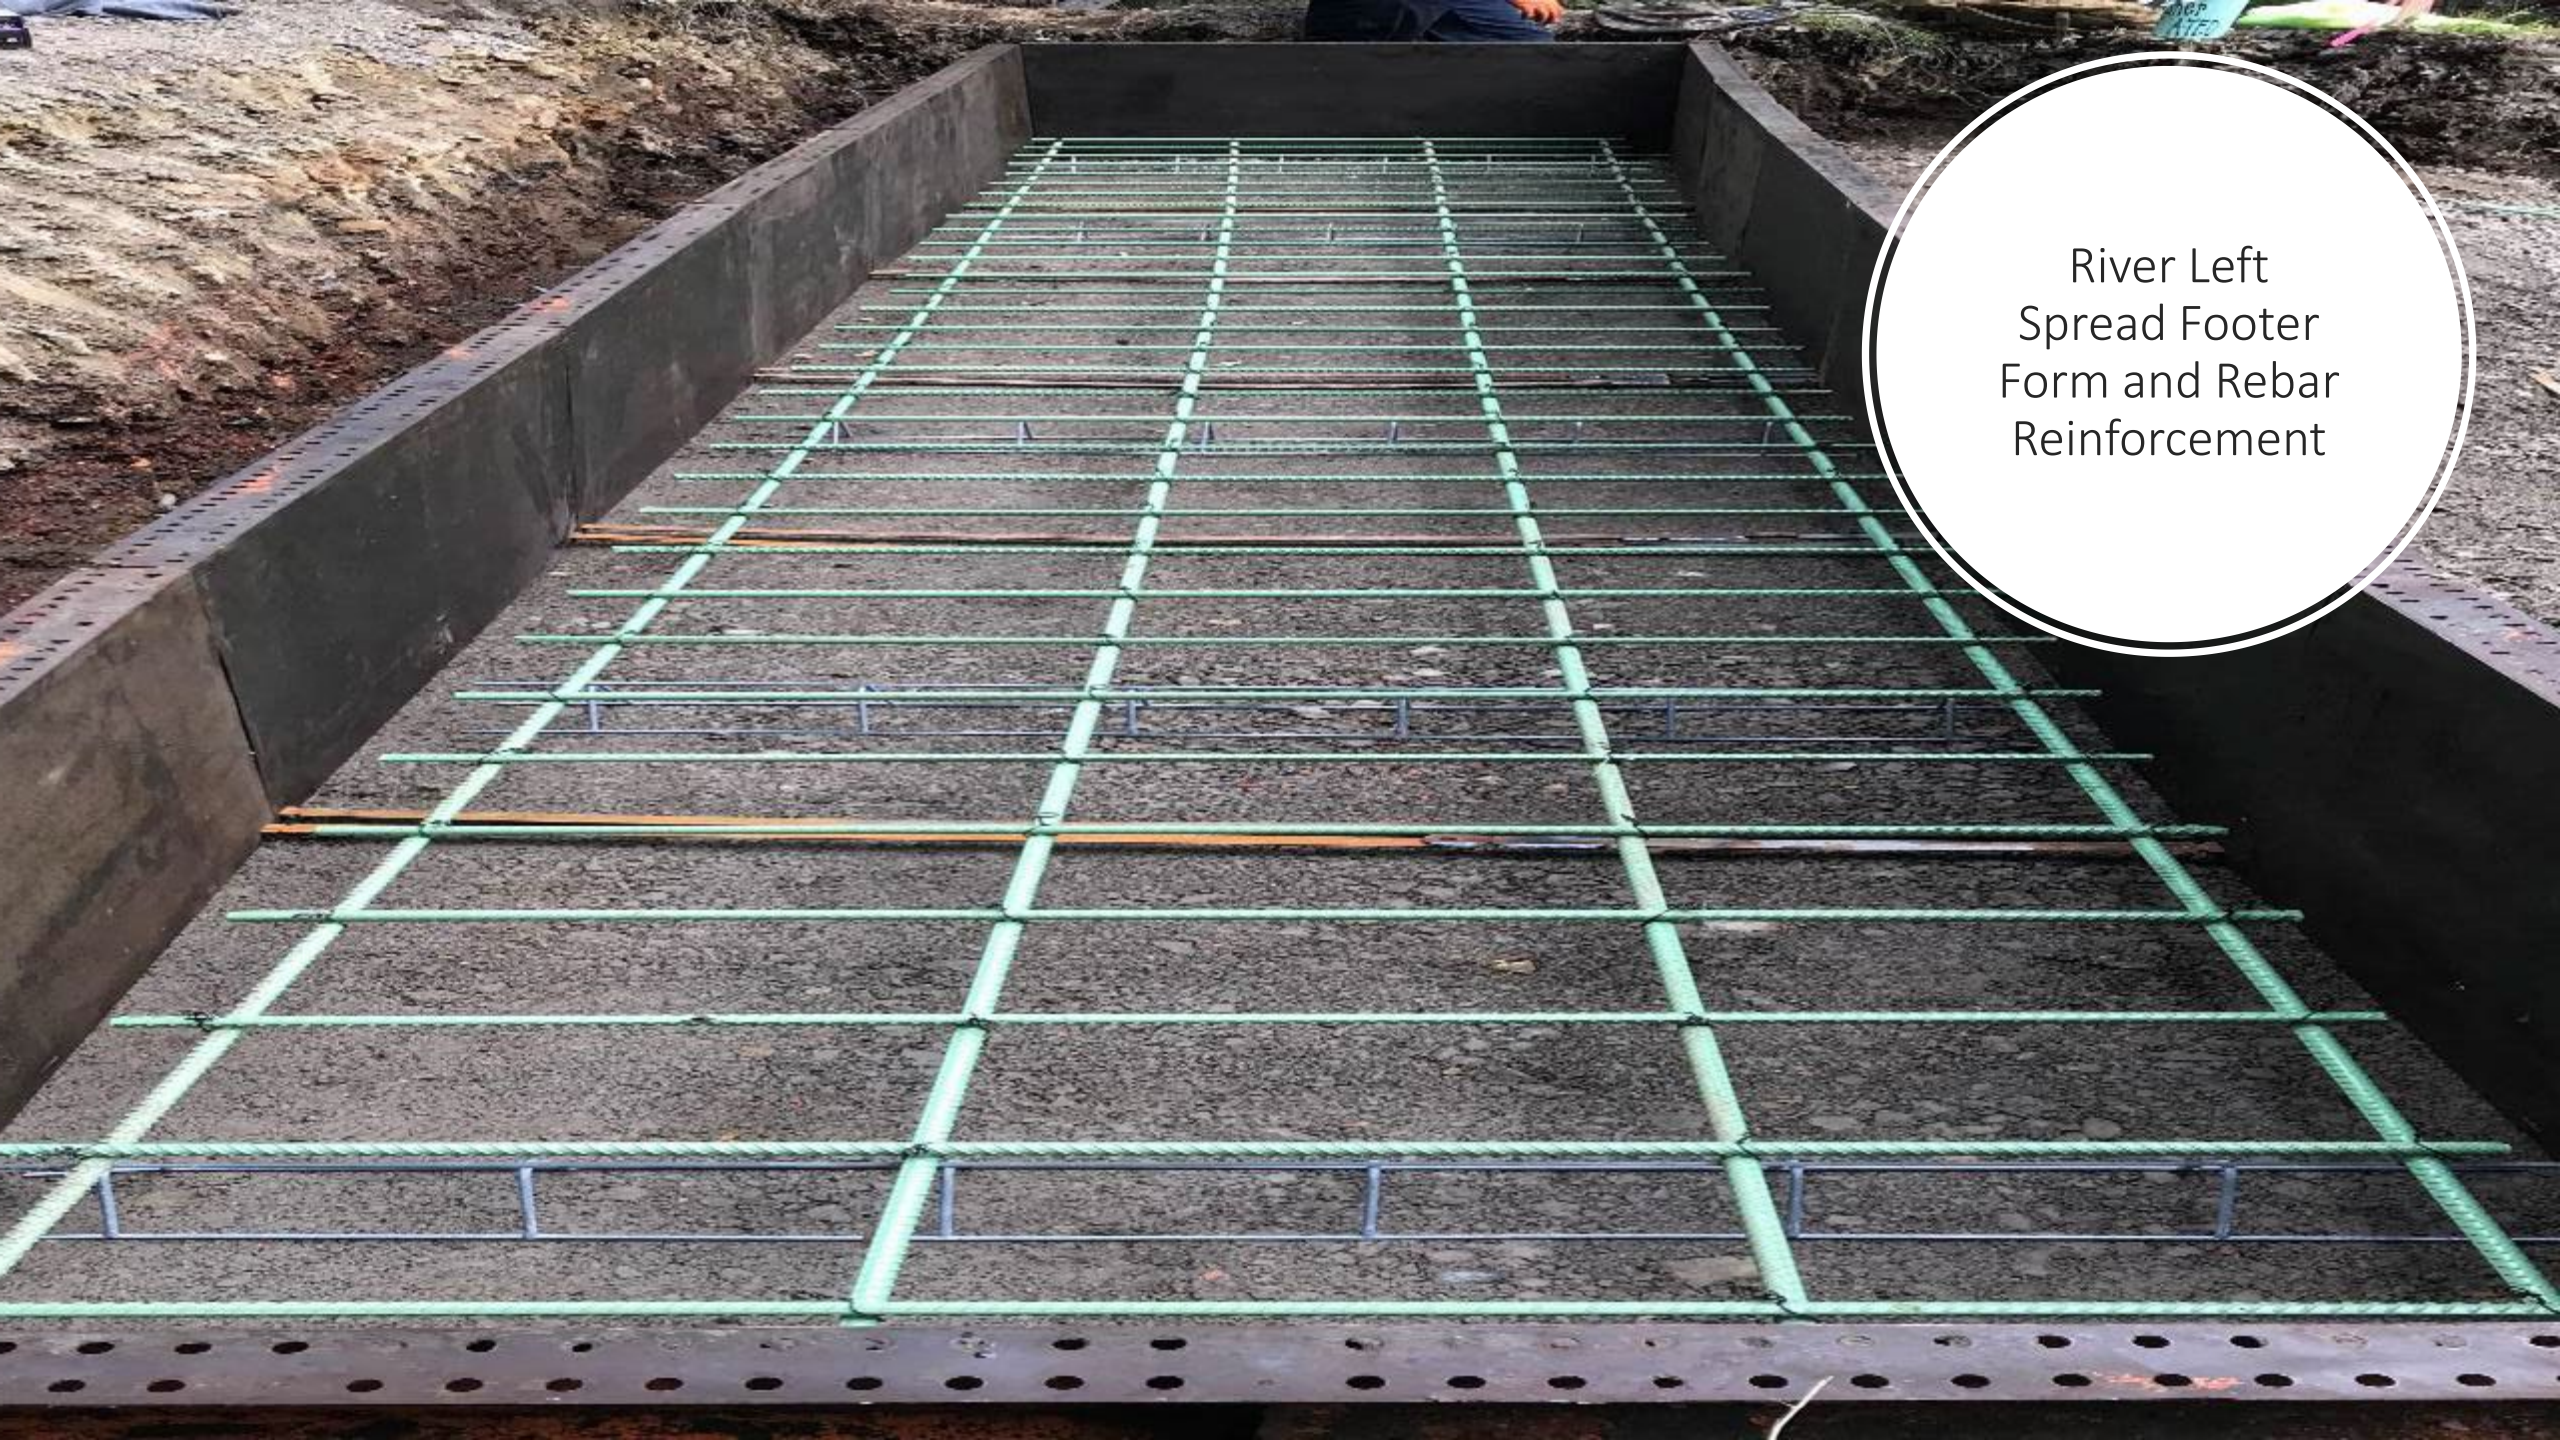
River Left  
Spread Footer  
Form and Rebar  
Reinforcement

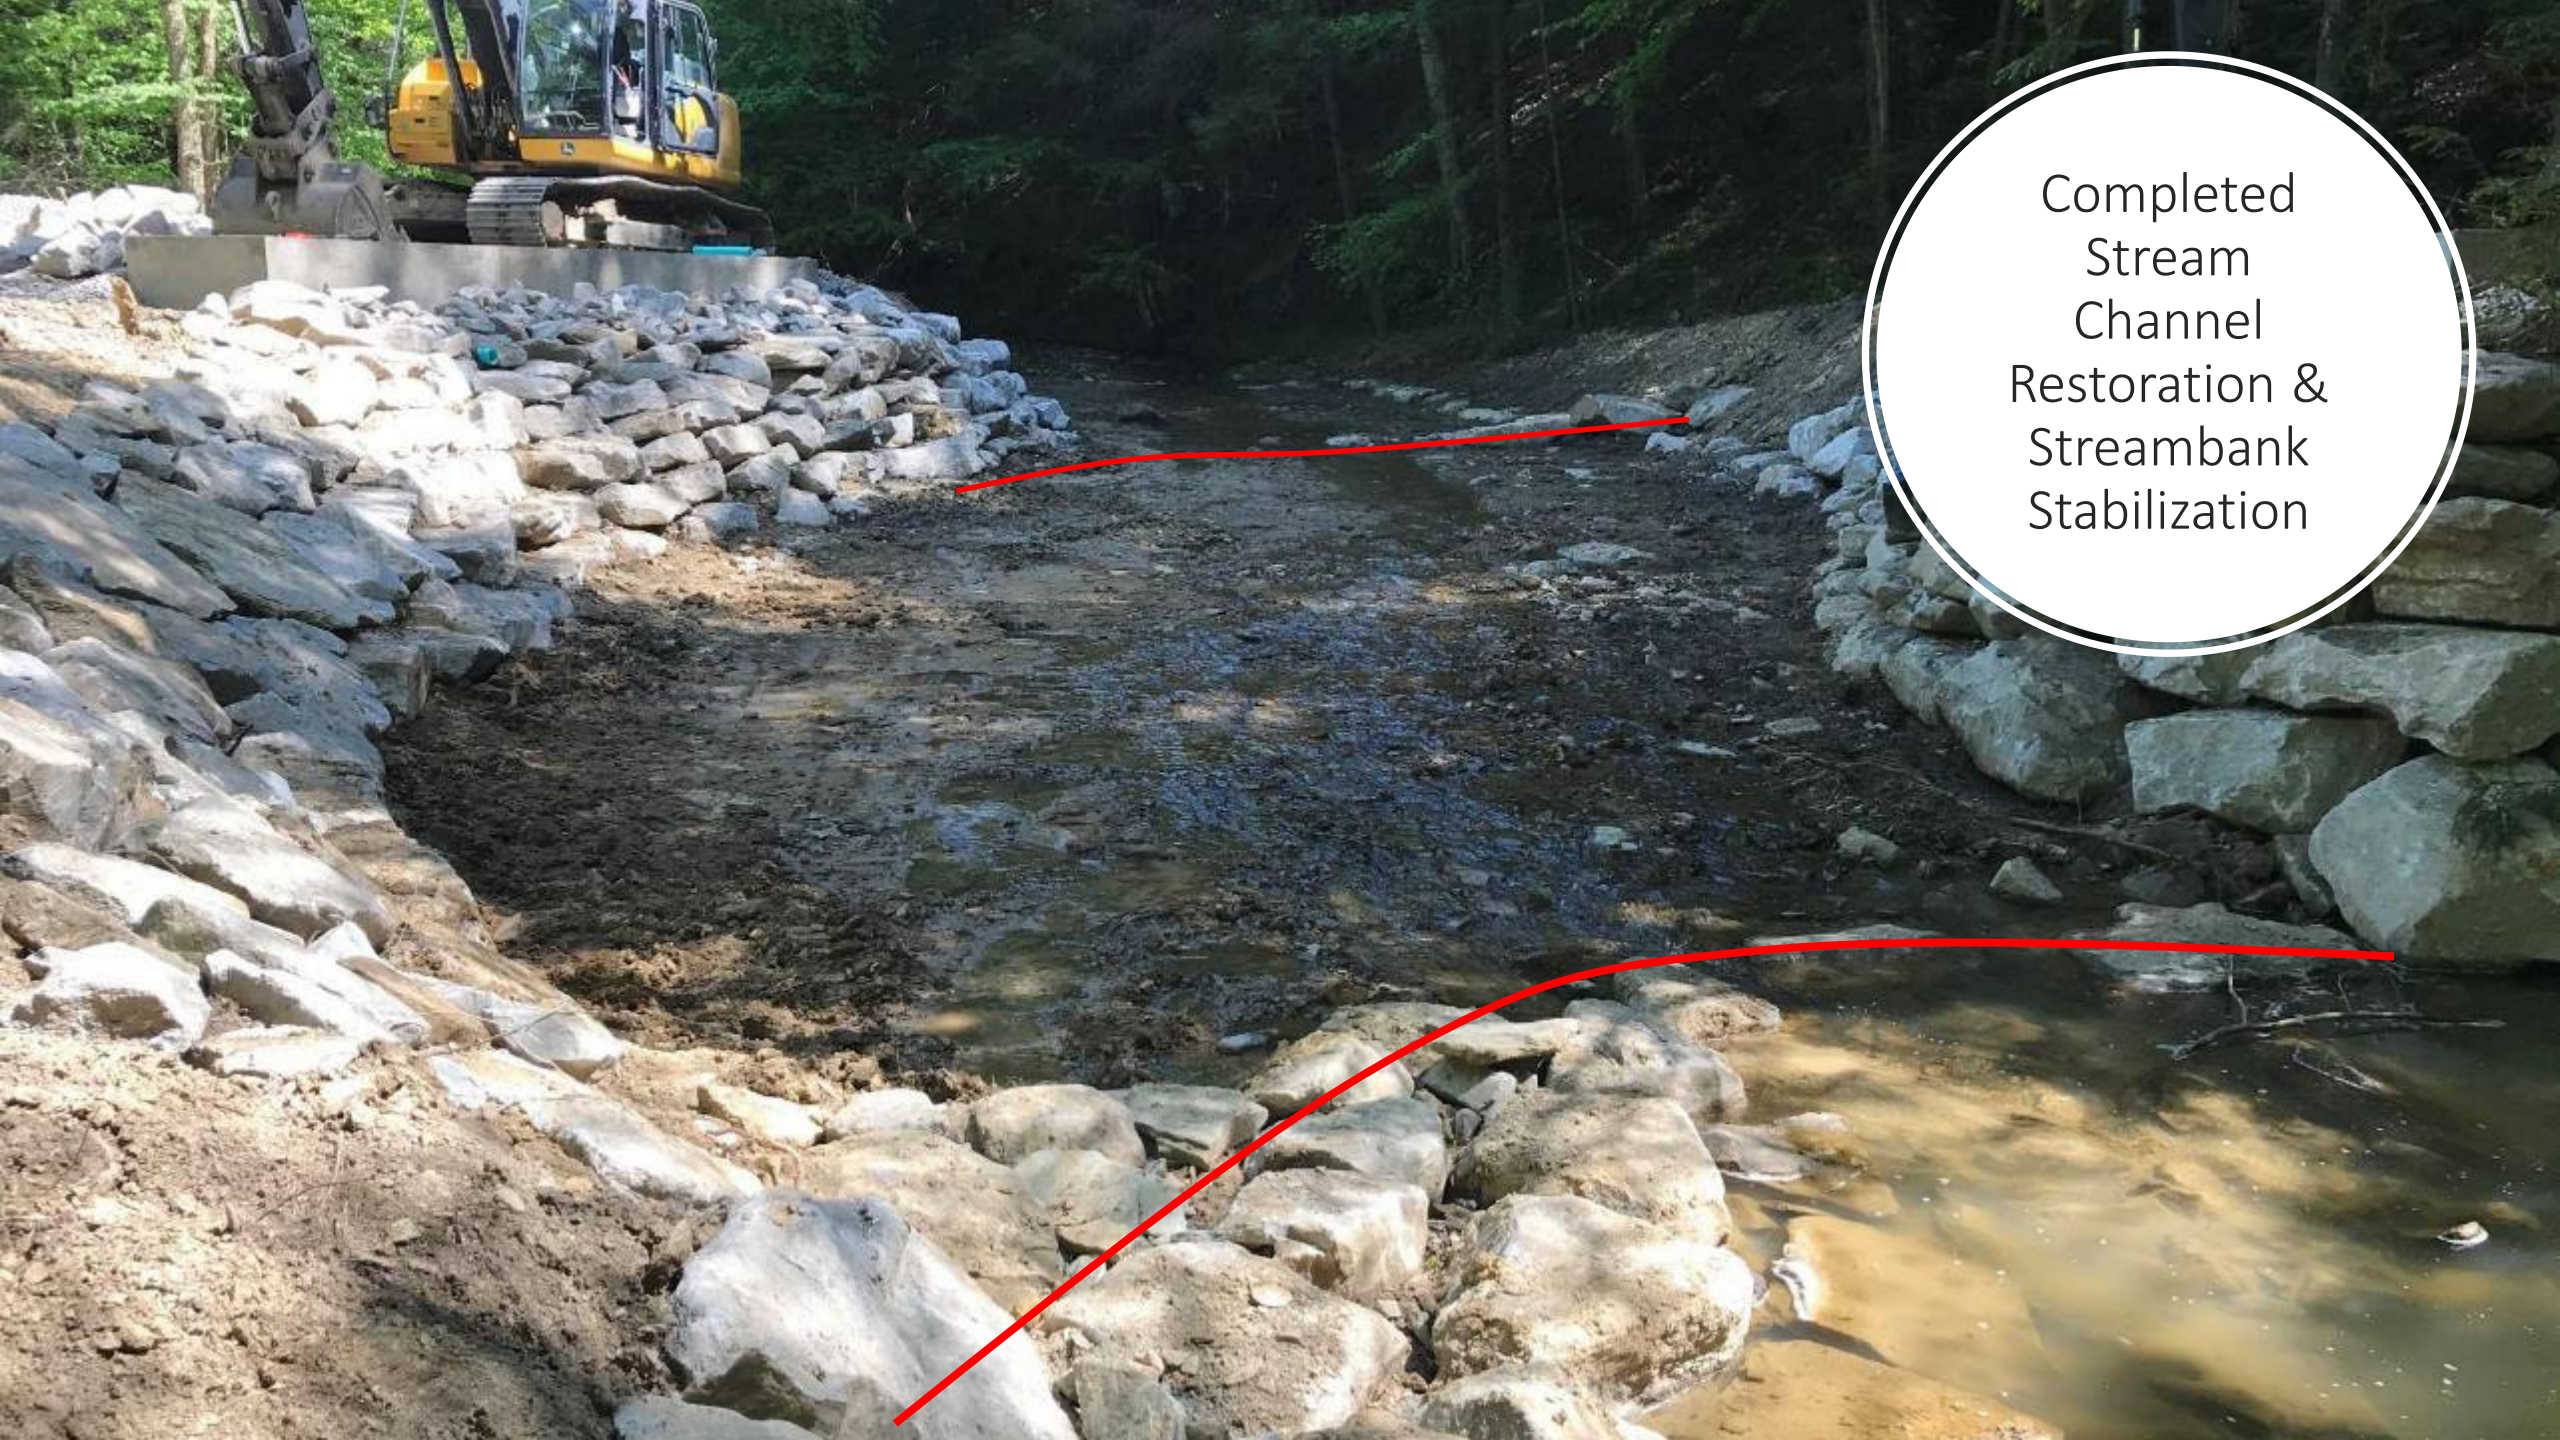
A photograph showing the construction of a spread footer. The structure is a long, narrow trench lined with dark metal sheet piling. Inside the trench, a grid of green rebar is laid out. A central steel I-beam runs the length of the trench. The trench is supported by wooden bracing on both sides. The ground around the trench is gravel and dirt. A white bucket is visible on the right side. The text "River Right Spread Footer Framing" is overlaid in a white circle on the right side of the image.

River Right  
Spread Footer  
Framing

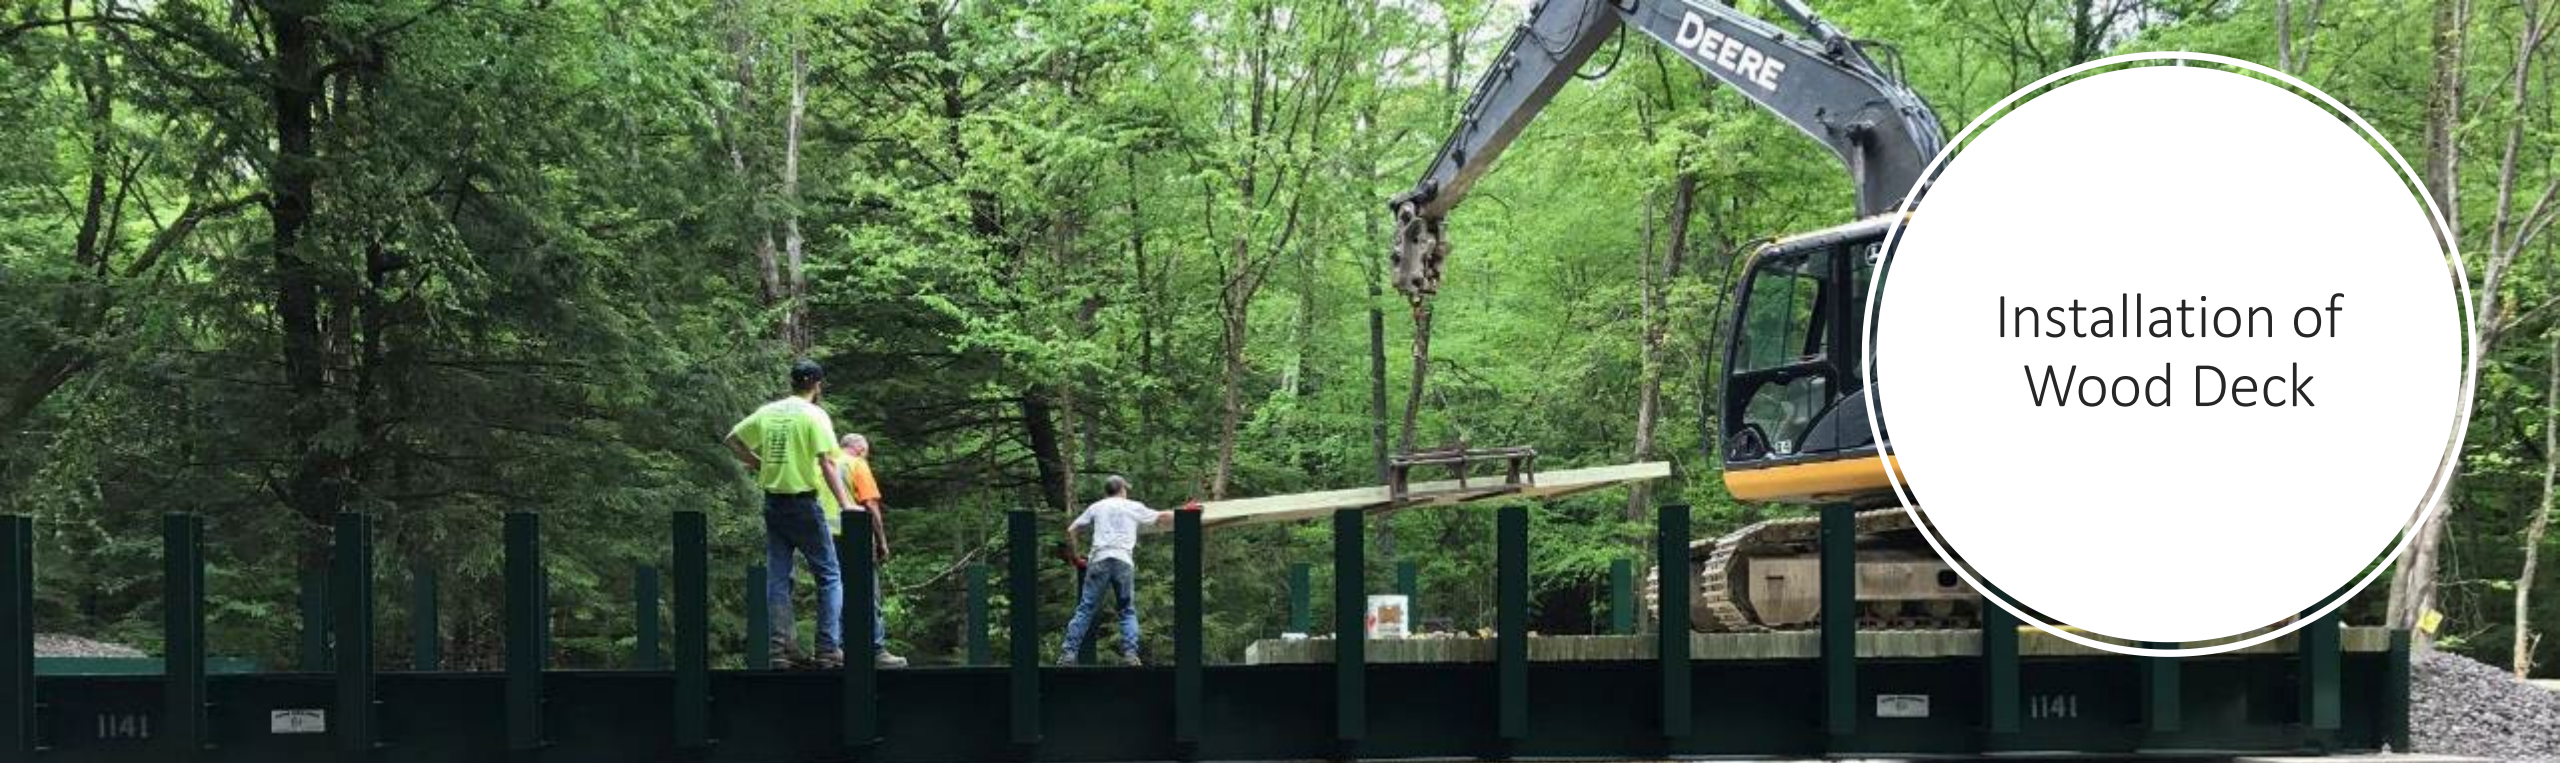
Placement of  
Bridge on  
Spread  
Footers
