Dirt Gravel and Low  
Volume Road Program  
January 19, 2023

# SPREAD FOOTER BRIDGES

# Indiana County

Green Township Barr Road

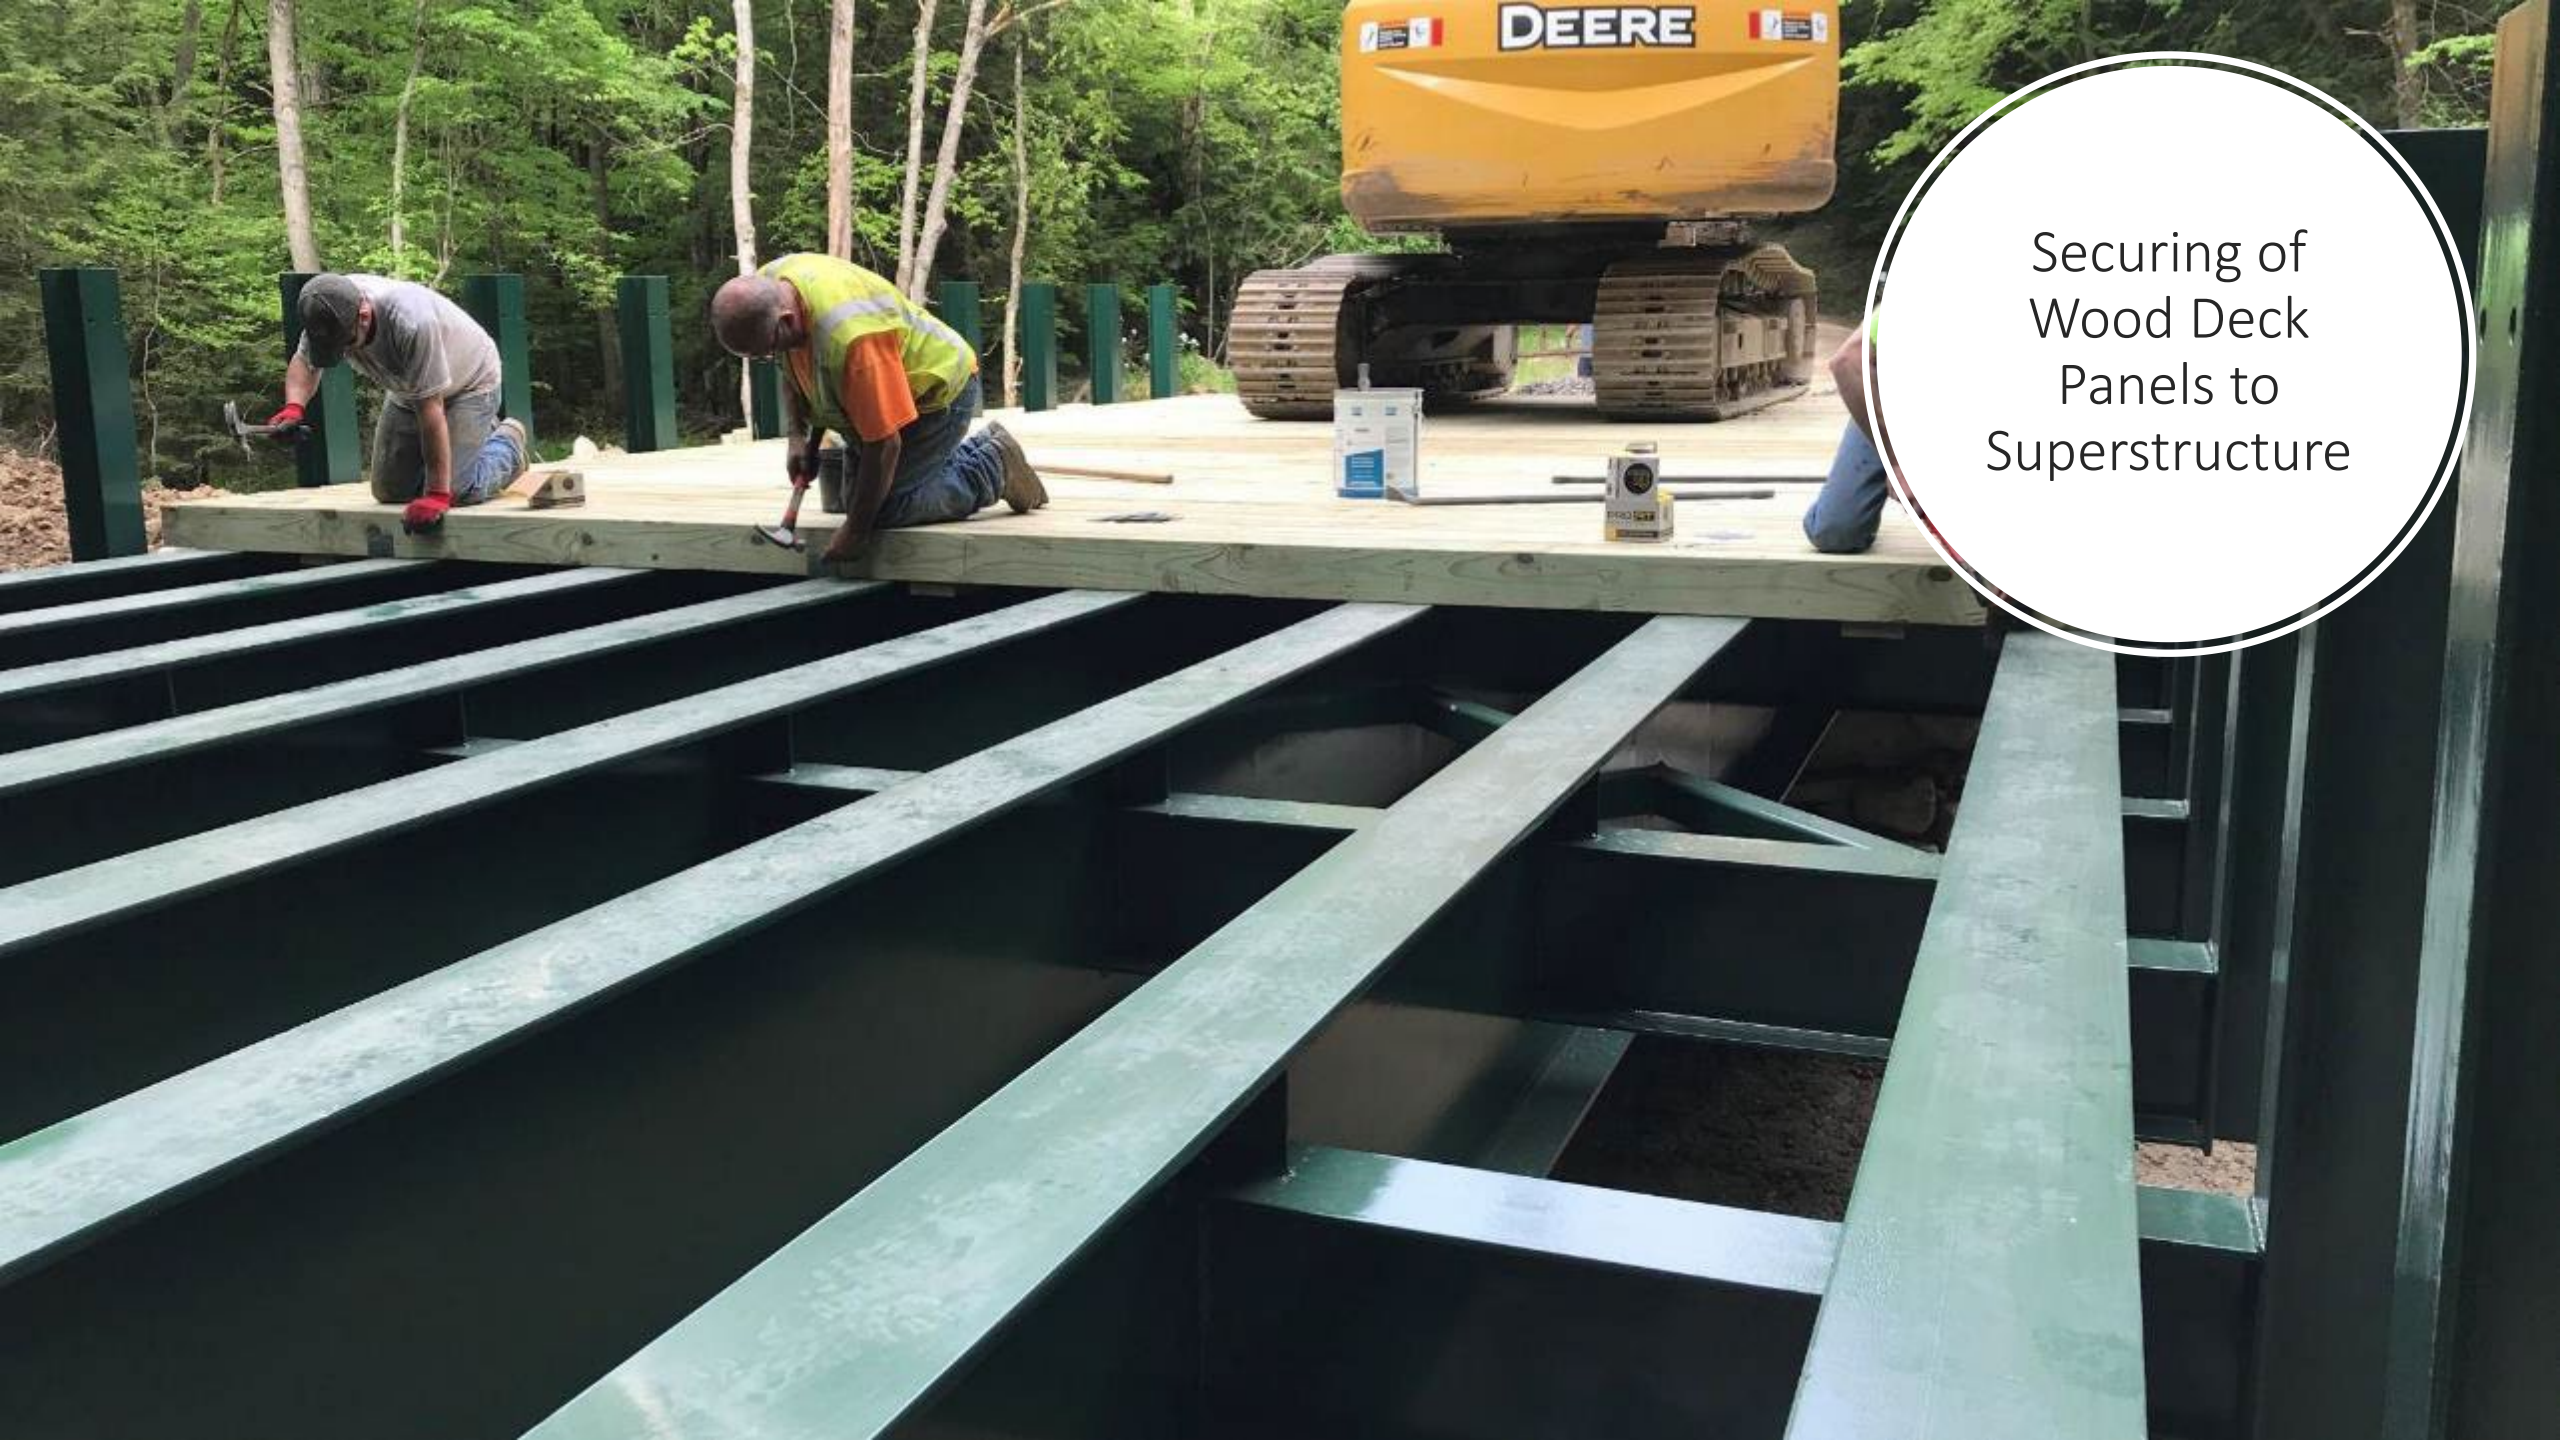
A photograph showing two construction workers installing wood deck panels. The workers are standing on a raised deck structure supported by dark green posts. One worker in a bright yellow shirt and blue jeans is pointing towards the structure, while another in a grey shirt and blue jeans is working on the panels. The background is a dense forest of green trees. A white circular graphic with a thin black border is overlaid on the right side of the image, containing the text 'Installation of Wood Deck Panels'.

Installation of  
Wood Deck  
Panels

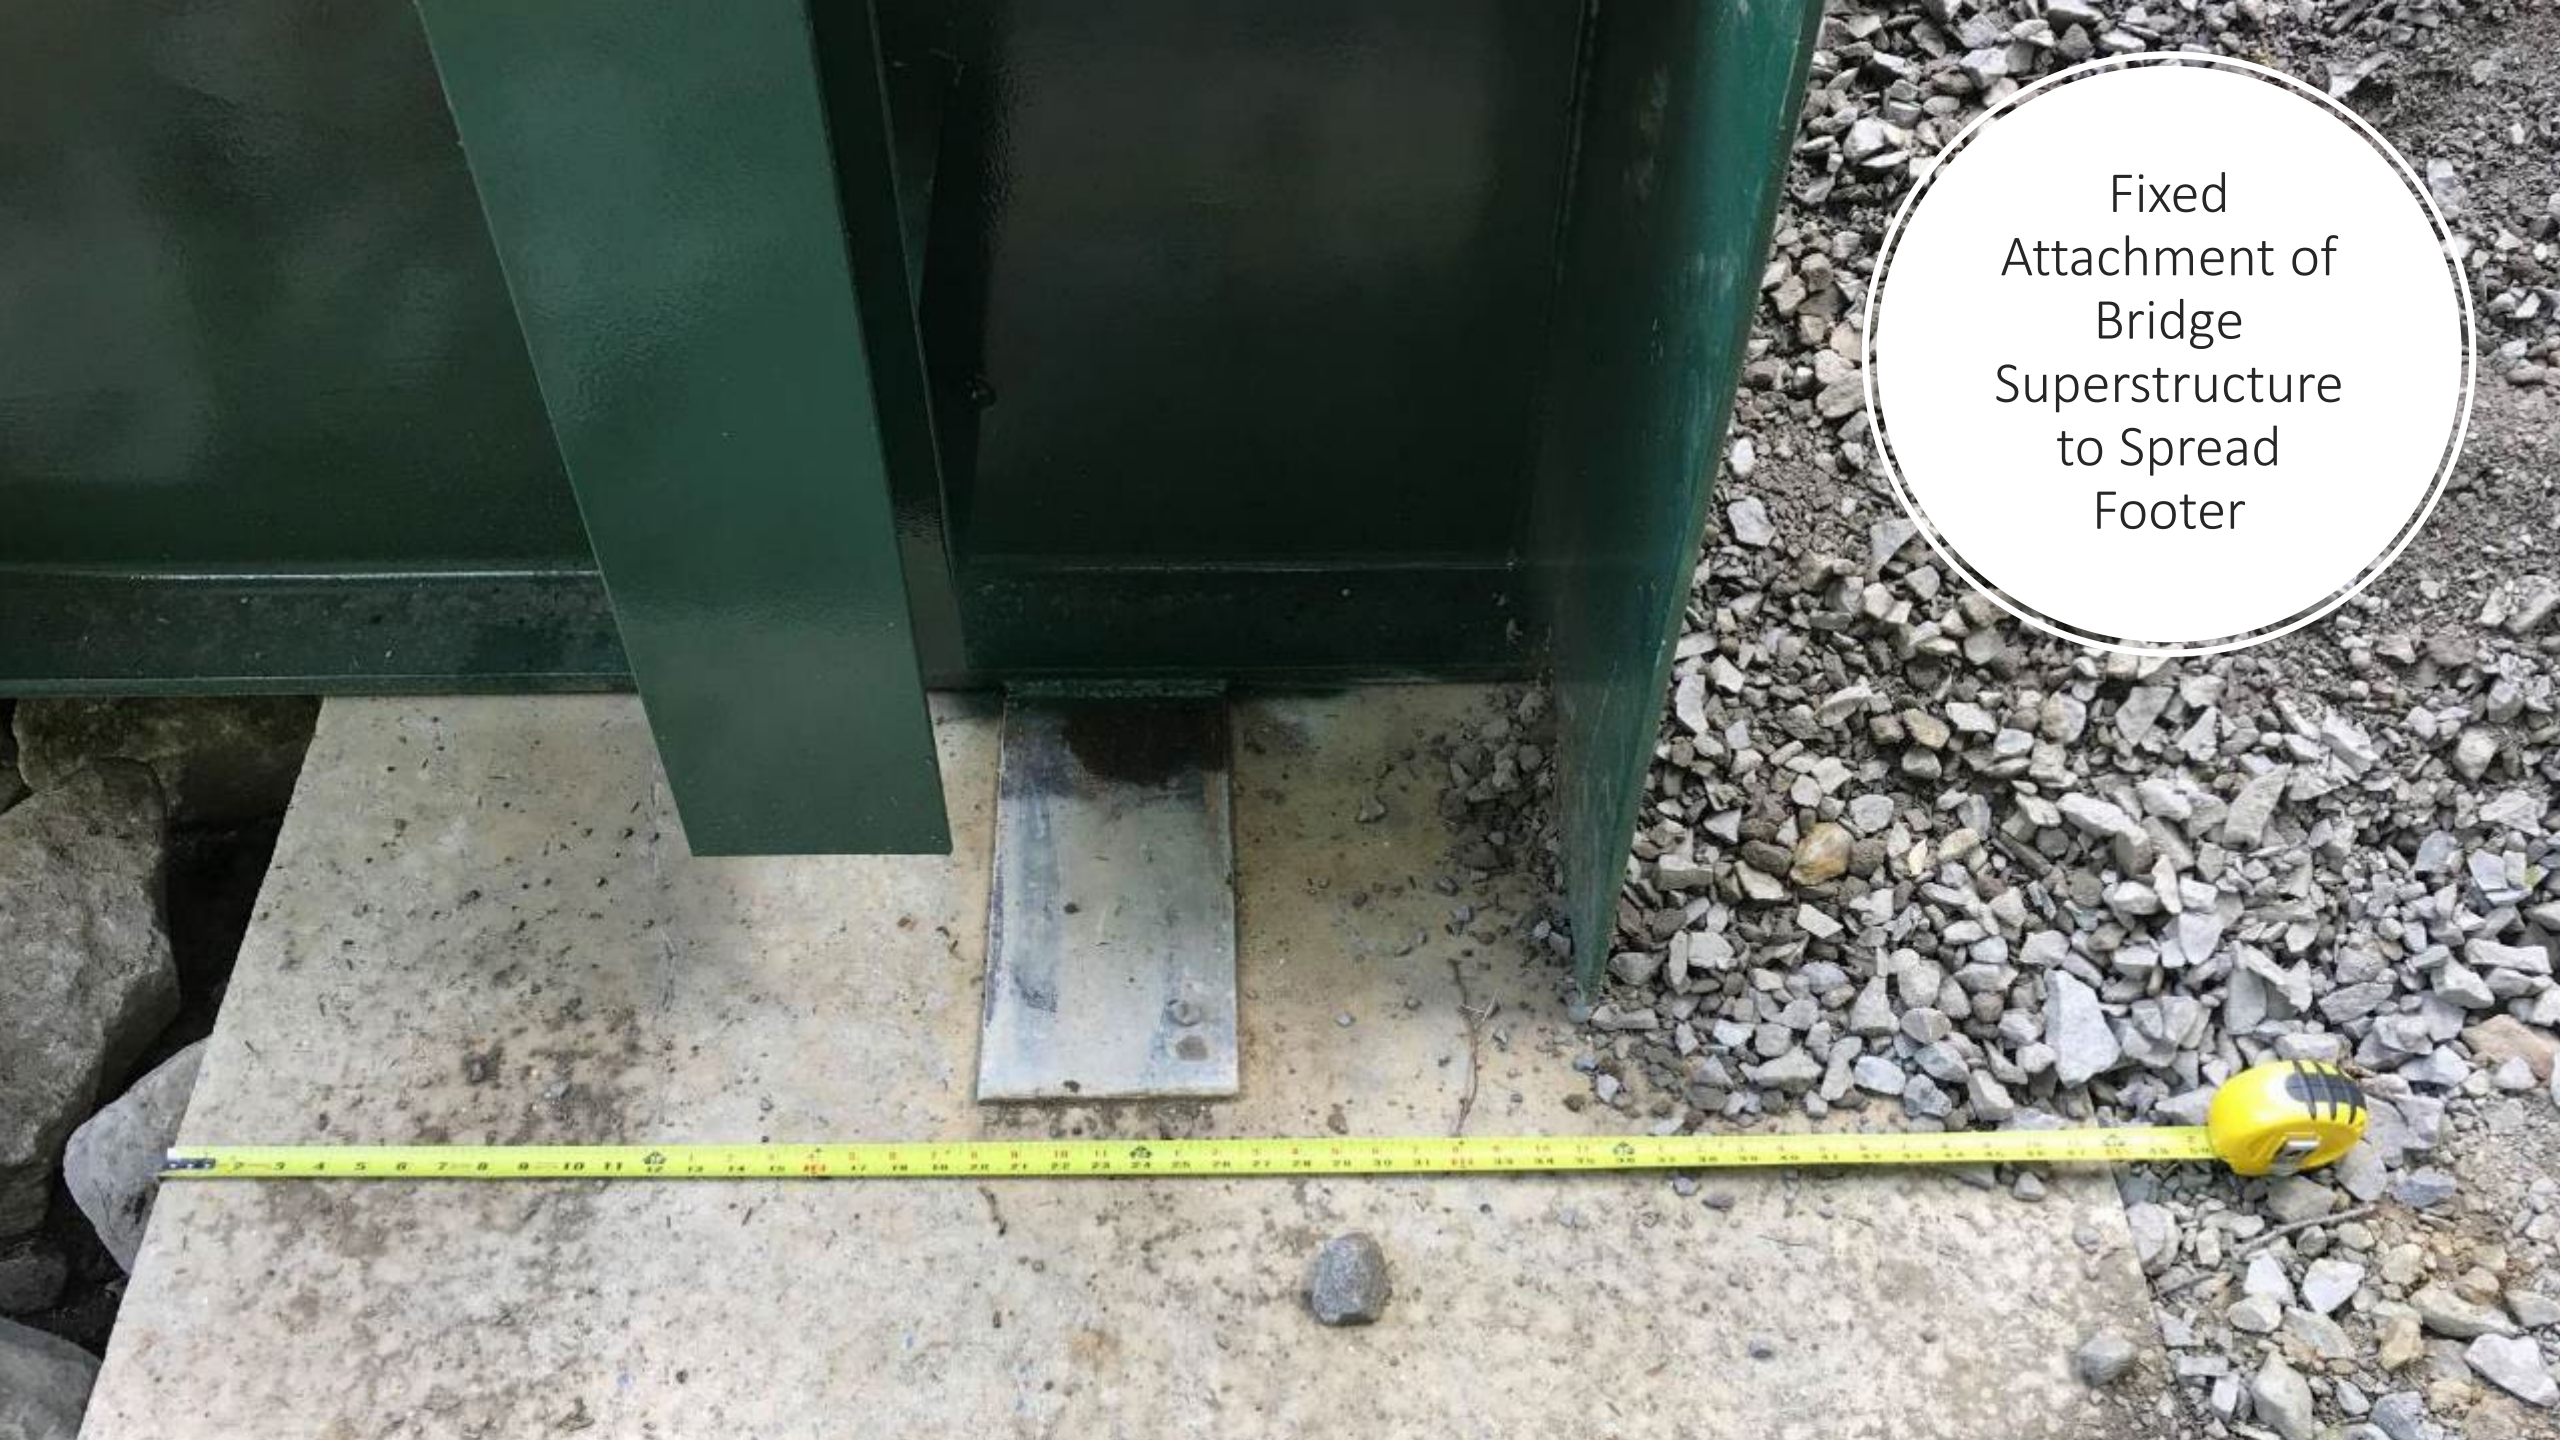
A close-up photograph of a bridge expansion anchor. The anchor is a dark, rectangular metal component with a stepped profile, mounted on a concrete spread footer. The footer is a wide, flat concrete slab. The anchor is positioned at the end of a bridge girder, which is visible as a dark, textured surface at the top of the frame. The concrete footer shows some signs of wear and discoloration. A white circular callout box is overlaid on the right side of the image, containing the text "Expansion Anchor of Bridge to Spread Footers".

Expansion  
Anchor of  
Bridge to  
Spread  
Footers

Fixed  
Attachment of  
Bridge  
Superstructure  
to Spread  
Footer

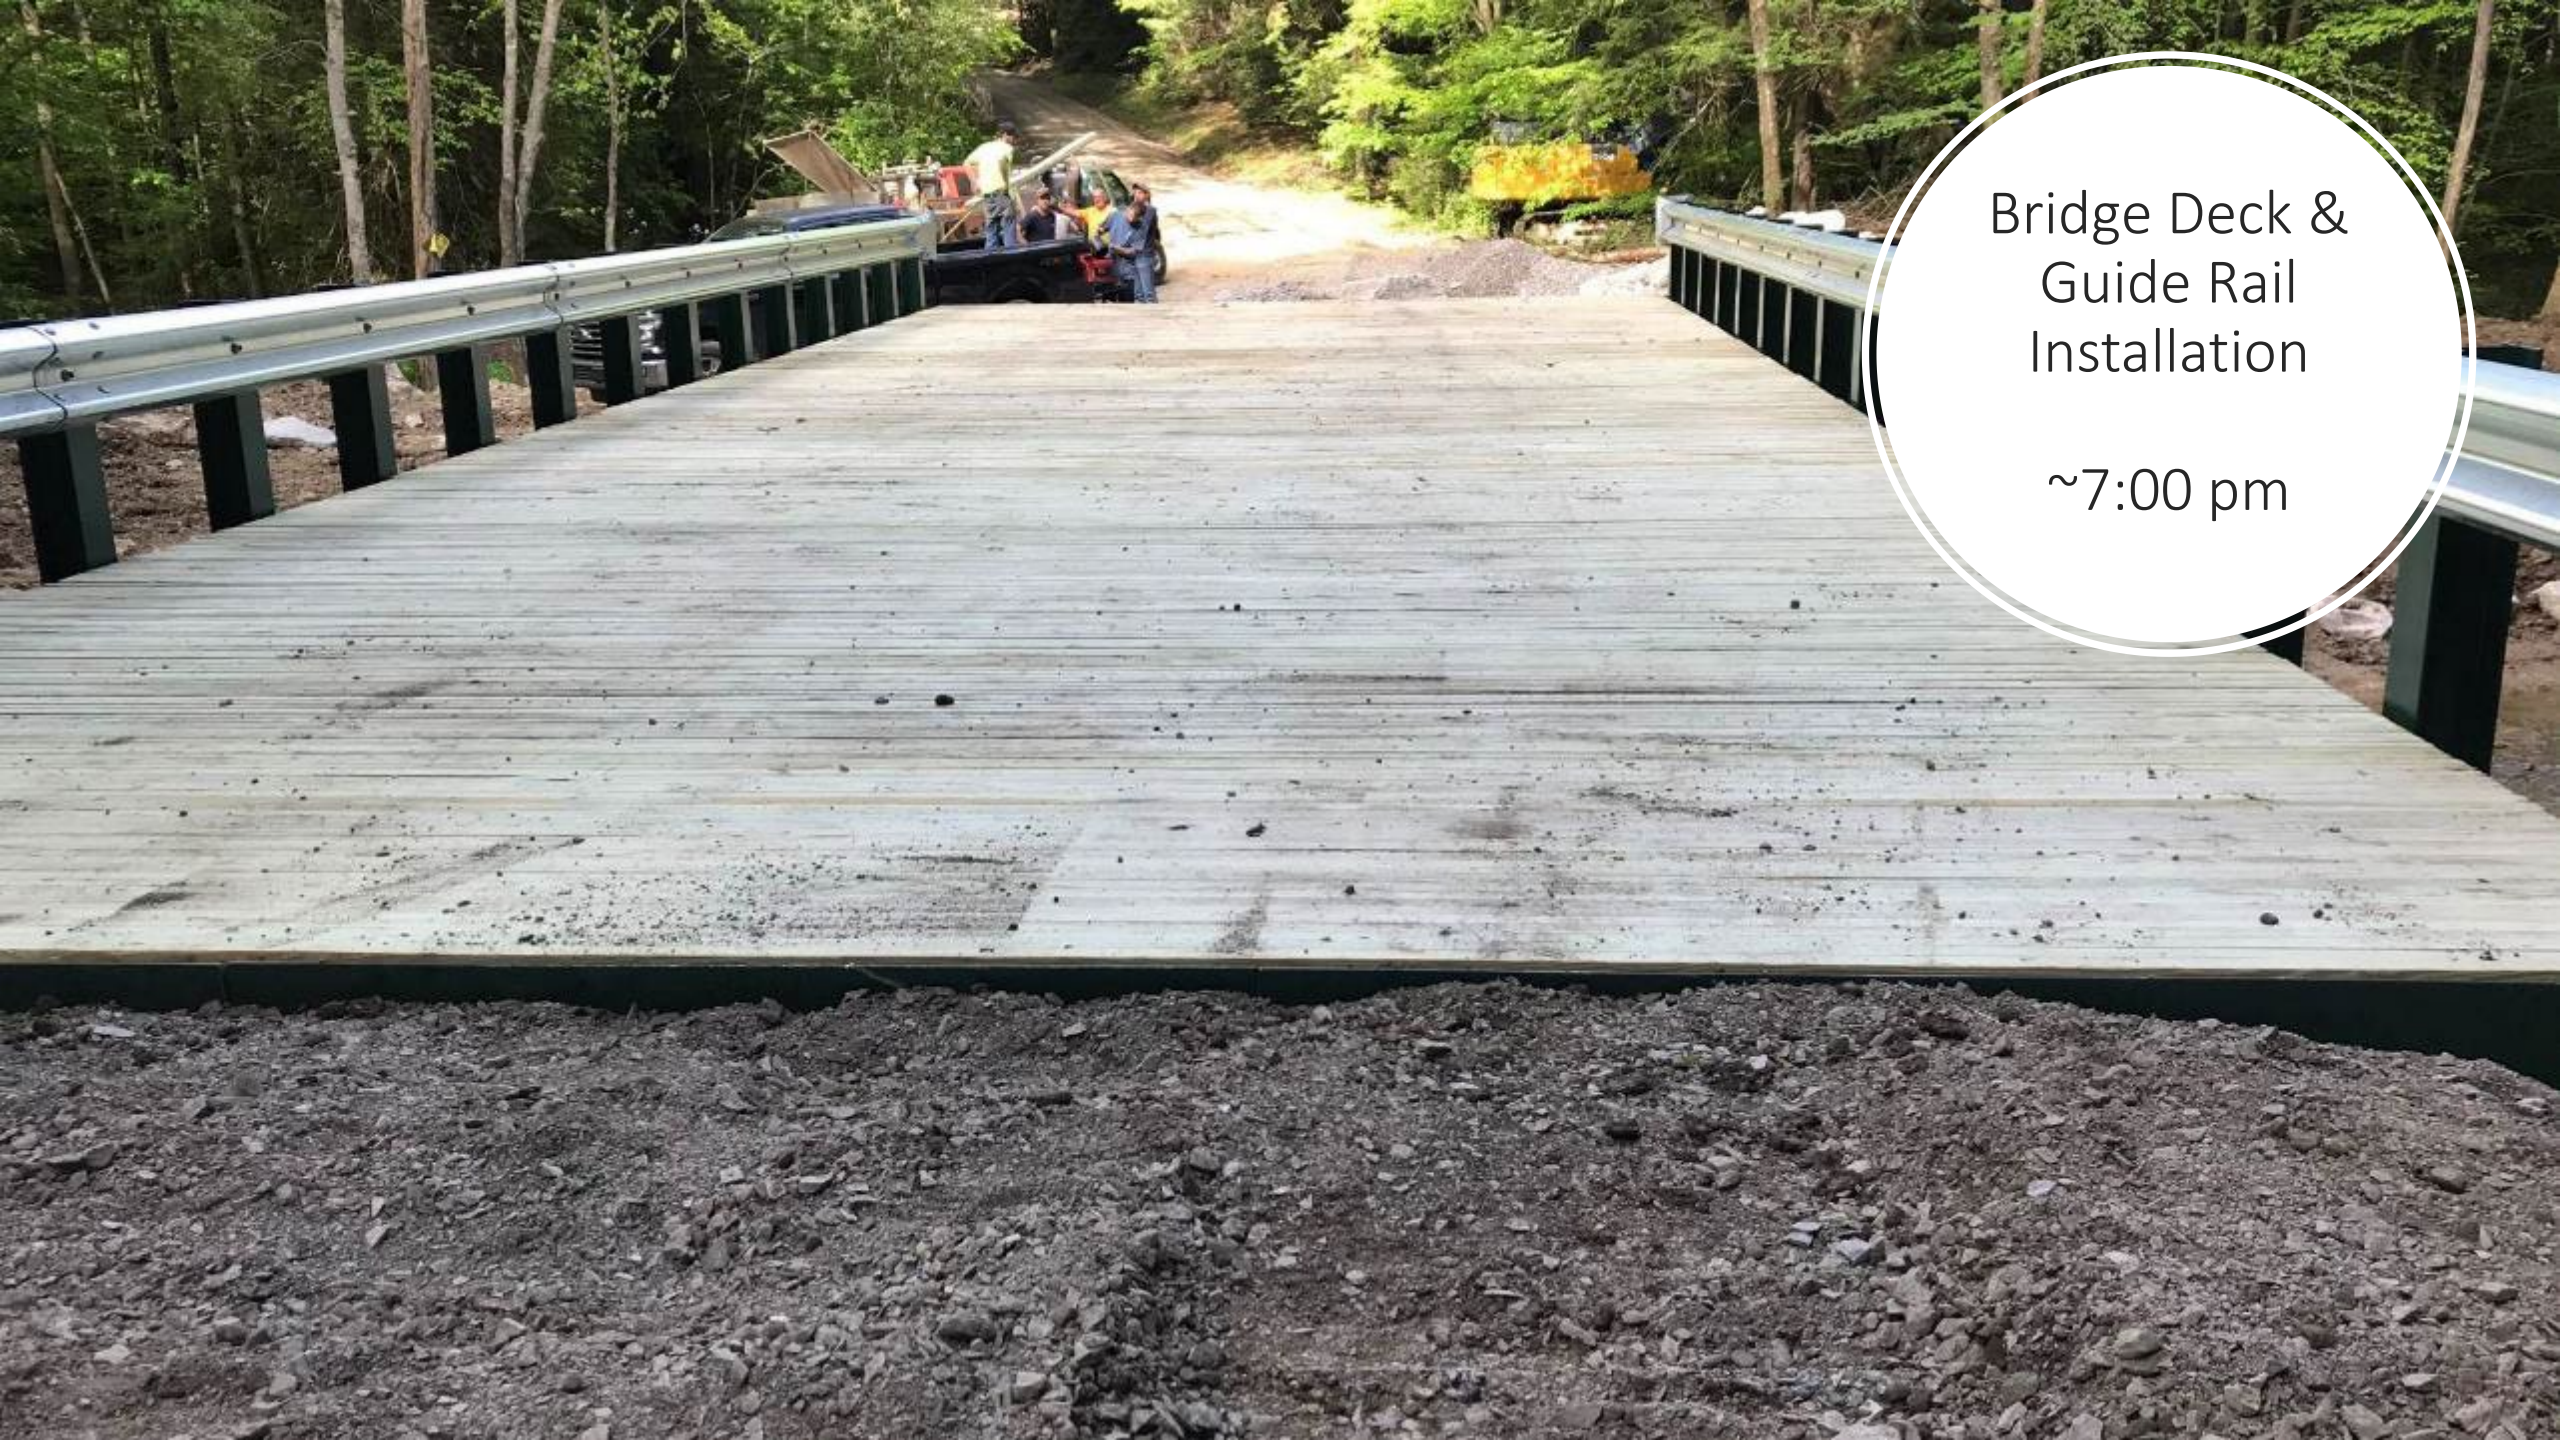
A photograph taken from underneath a bridge, looking towards a stone abutment. The bridge's superstructure consists of several large, green-painted steel I-beams supported by a network of smaller steel members. The deck above is made of wooden planks. Below the bridge, a concrete curb is visible, followed by a large, well-constructed stone masonry wall. The scene is brightly lit, suggesting daylight.

Bridge  
Superstructure

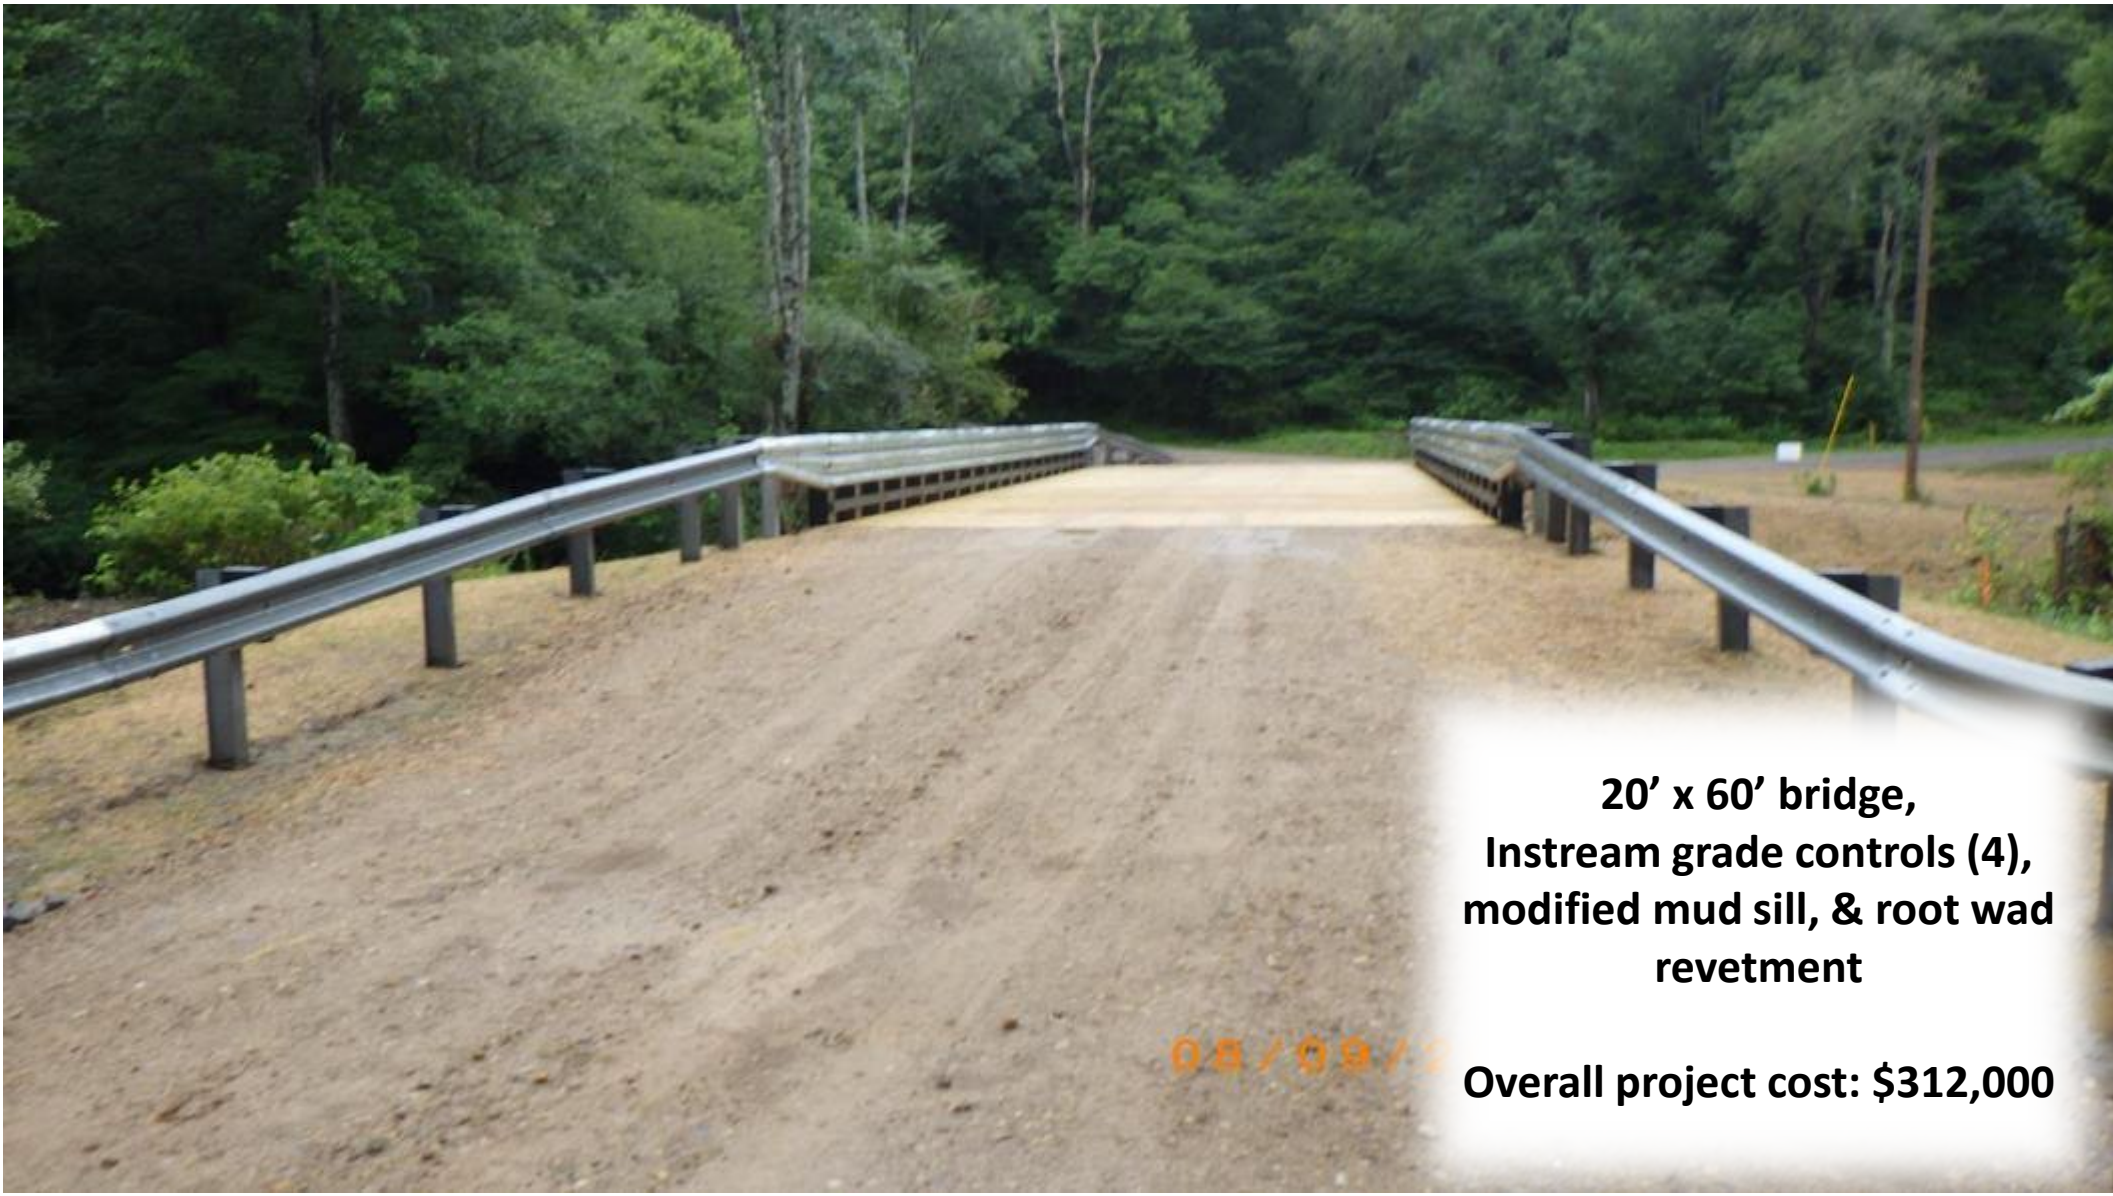
**20' x 60' bridge,  
Instream grade controls (4),  
modified mud sill, & root wad  
revetment**
