PA Dirt, Gravel, and Low Volume Road Maintenance Program

2018-19 Unpaved Road Assessment Guide

Reference Pictures

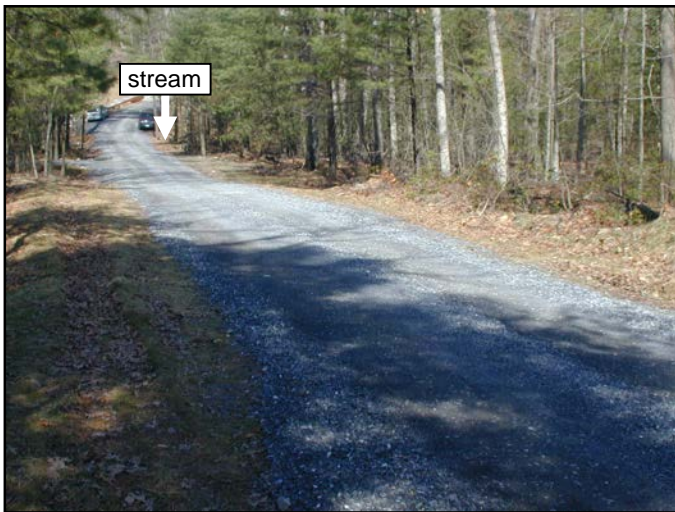
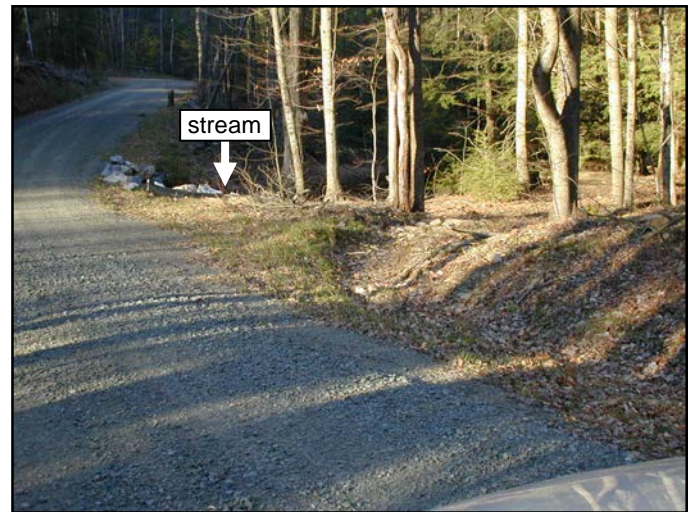
Slight

A small amount of road sediment finds its way into the stream. Minimal direct inputs of sediment from parallel ditches. Ditches outlet before stream. Some flow may reach stream through vegetated buffer in high flows. Some minor area may drain to stream at crossings. The roads pictured below turn their ditches out before the stream, but some runoff may reach the stream with minimal filtration.

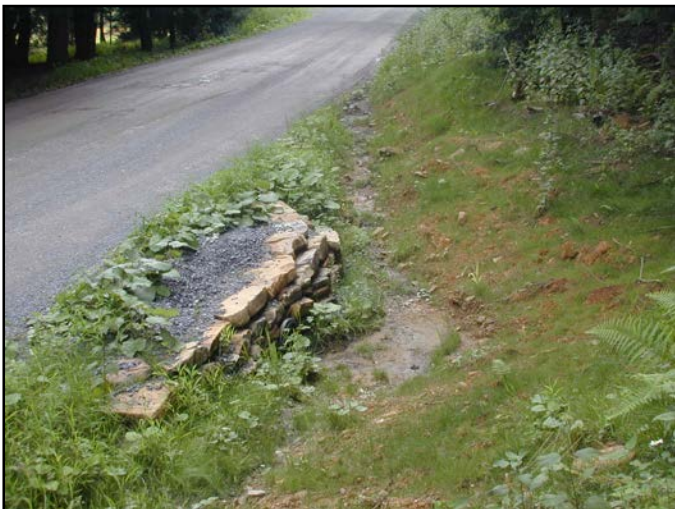
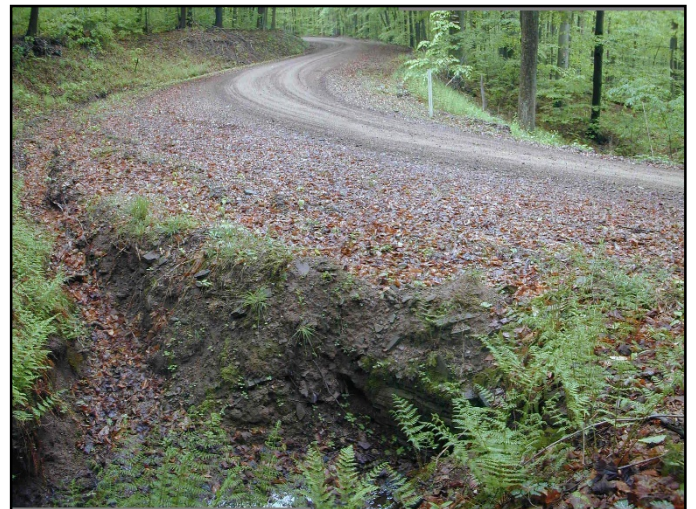
**MODERATE**

Inadequate buffer exits or some road sediment has a direct route to the stream. The culverts pictured below have direct routes to the stream (located directly across the road), but the amount of drainage entering the stream is small because of the topography, short ditch runs, and adequate road surface.

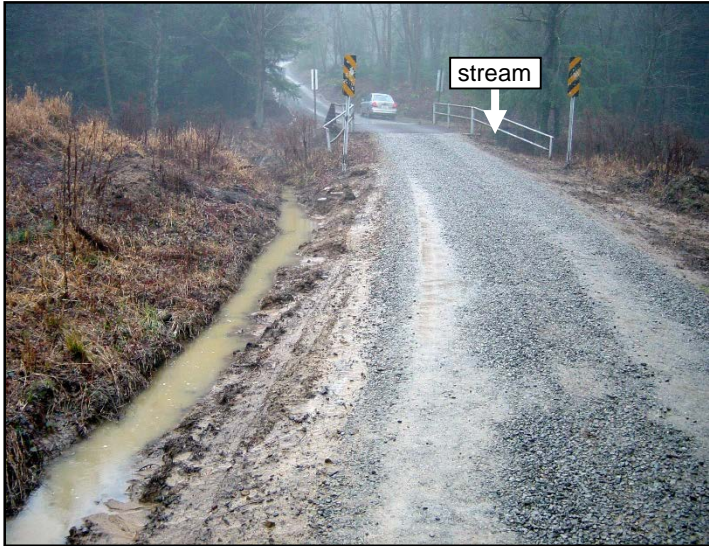
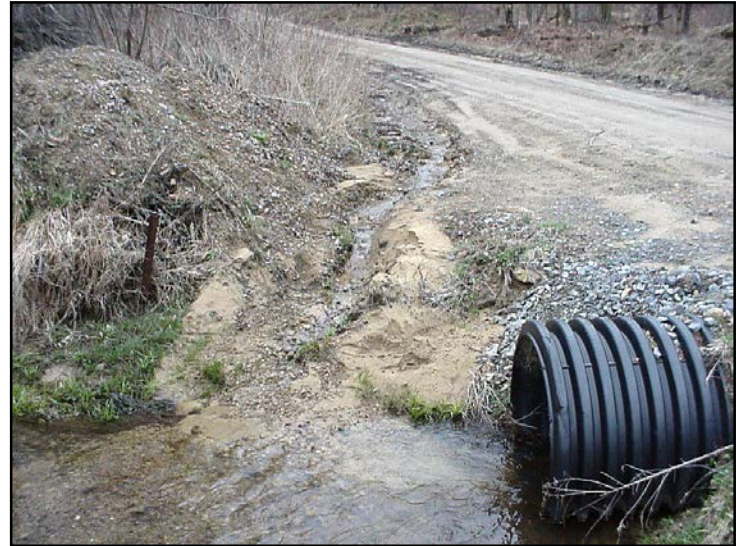
SEVERE

Obvious and direct stream pollution from road. A large portion of the road area drains into the stream. Sediment deltas and road material may be visible in stream. Stream encroachments, where the stream is cutting into the road bank, and fords are also in this category.

These two pictures above illustrate the common practice of draining long ditch runs directly into the stream at crossings. Both crossings pictured here drain all four ditches directly into the stream. The sediment delivery is very high due to the poor road composition, direct discharge, and long ditch runs.

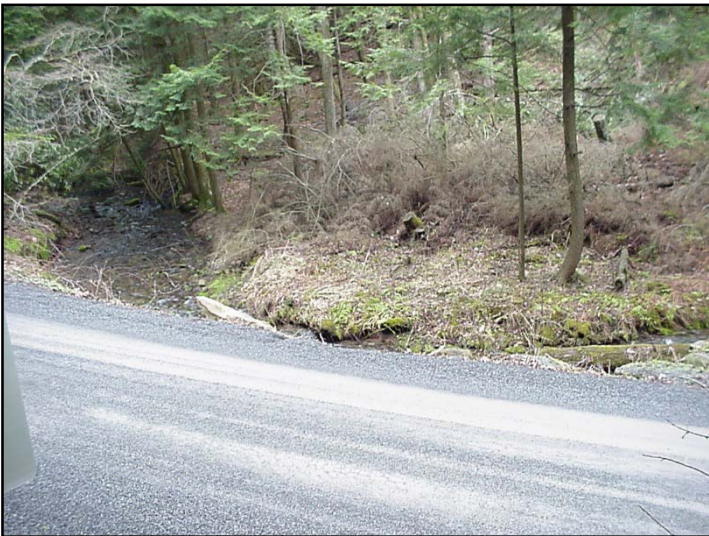
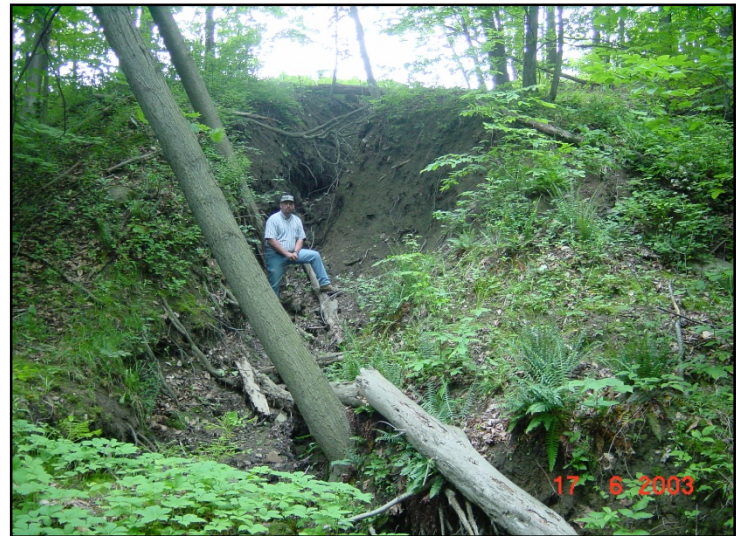
This site illustrates a stream encroachment where the stream is beginning to undercut the base of the road. Fords also fall into the category of stream encroachment.

You don't always need running water! The small canyon pictured here is actually a culvert outlet! The culvert collect ~ 1,500 feet of road ditch drainage. This is a case where the road ditch is the headwaters of the stream.

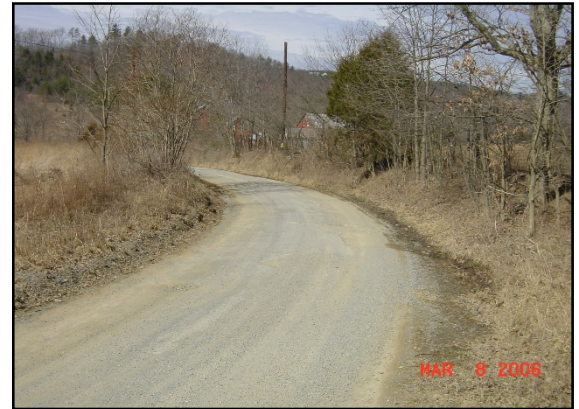
Saturated Ditches

Road ditch shows signs of frequent saturation. Some standing water may be present. Look for hydrophilic plants in and around the road ditch.

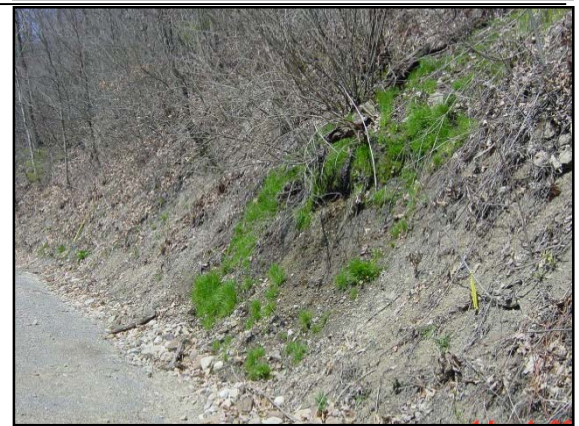
**Roadside Springs**

Roadside springs and seeps often appear in the uphill cut bank. They can destabilize the road base and create additional drainage and pollution problems. The spring pictured here is obvious, since the area around the seep has vegetated before the rest of the road bank.

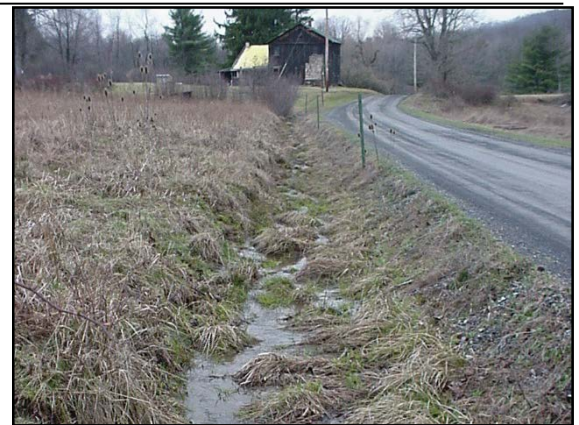
**Flow in Ditches**

When ditches become too saturated with groundwater, or collect roadside springs and seeps, they will contain flowing water even in dry periods. This creates many concerns including increased erosion, sediment transport, and road base saturation. Often in these cases, the road ditch becomes the headwaters of a stream!

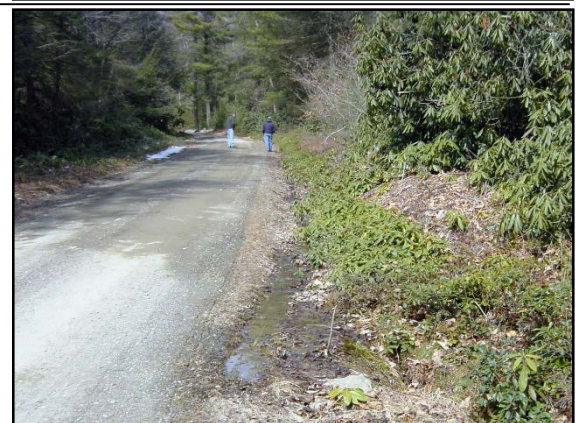
**Saturated Base**

Water, water, everywhere... Look for symptoms such as: wet areas wetland roadside plants, potholes, standing water, mottled soils, and fine particles pumping up through the road. The road pictured to the right has roadside springs, flow in the ditches for several hundred feet, and a saturated road base.

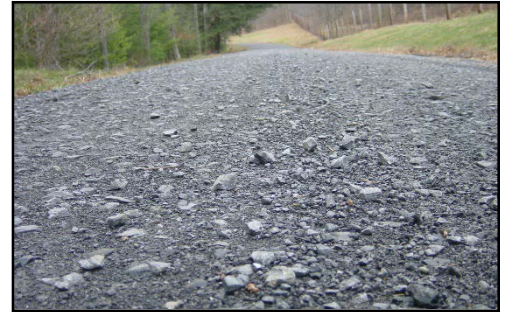
Predominantly placed limestone or sandstone aggregate. Not necessarily DSA, but most likely a purchased and placed aggregate product. Road has a relatively uniform look to it with little to no native soil present and minimal loose aggregate on the surface.

Three year old DSA is pictured to the right.

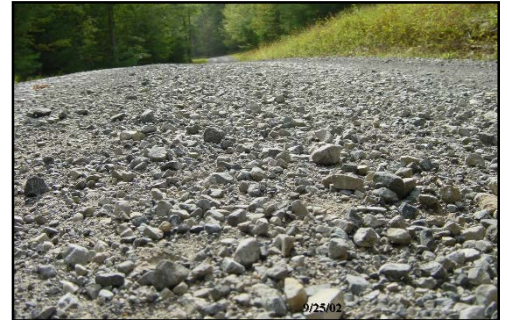
**MIXED STONE**

The mixed stone rating is to be used when there are several different types of stone on the road with no type being dominant. These materials will vary greatly in their hardness and resistance to erosion, so they receive a medium rating. The picture to the right illustrates an old limestone placement that has mixed with the subbase over time.

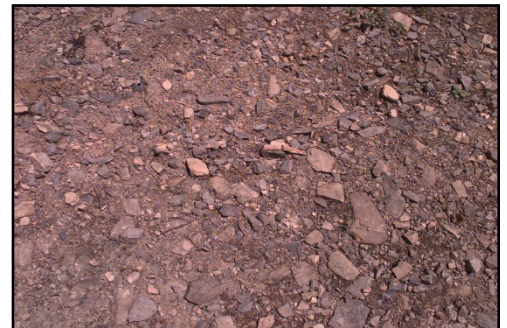
**SOFT STONE / DUST**

A mixture of soft sandstones, shales, bankrun gravel, and soapstones. The surface is predominantly rock with some native material incorporated.

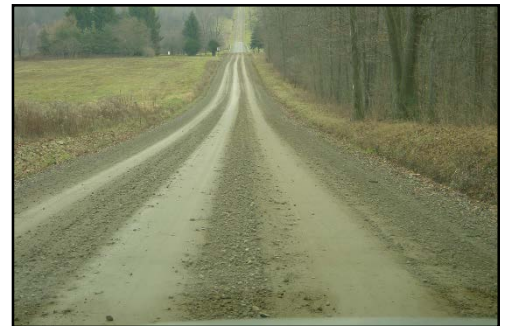
**STONE / DIRT / DUST**

A mixture of past stone placements with native earthen material. Over time, aggregate will erode away and native material will work up to the surface. Expect to see varying degrees of naturally occurring and placed stone in predominantly dirt roads. Dust potential can be seen by observing a lot of loose fine material on the road surface.

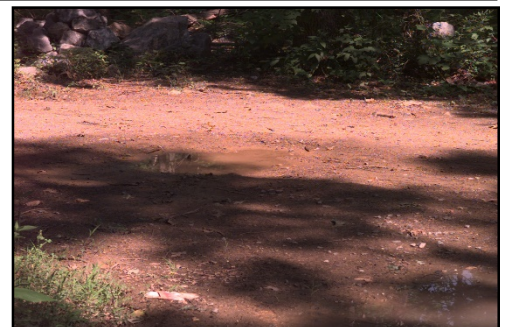
**SEVERE DUST**

Little to no evidence of stone on the road surface. Most of these roads are simply shaped from native earthen materials. Dust and sediment generation from the road surface can be expected to be extremely high.

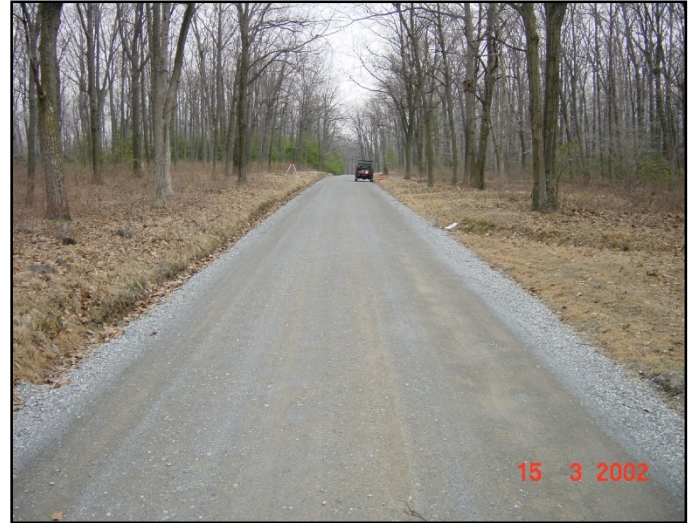
Relatively flat. Rises less than 0.5 foot for every 10 feet of road length. Roads with slopes like the one pictured here do not allow water to build enough speed to cause major erosion problems on the road or in the ditches.

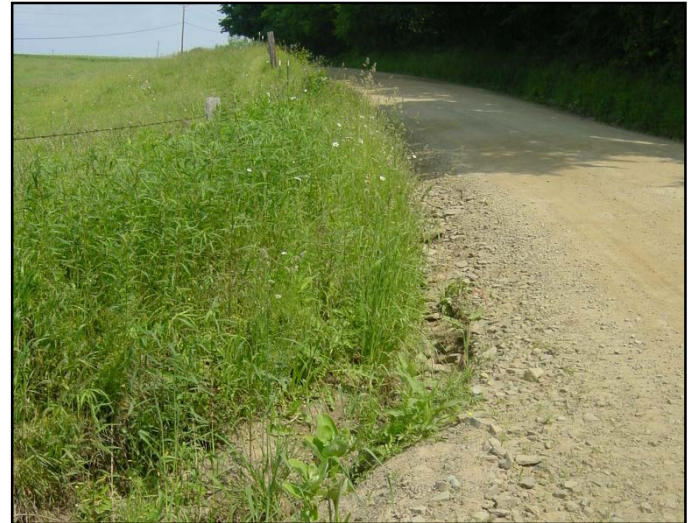
**5% - 10%**

Moderate slope. Rises 0.5 – 1 foot for every 10 feet of road length. Roads such as this one with a slightly steeper slope have a greater potential to generate sediment. Steeper roads require more culverts and turnouts to prevent water from building up enough speed to cause major erosion problems.

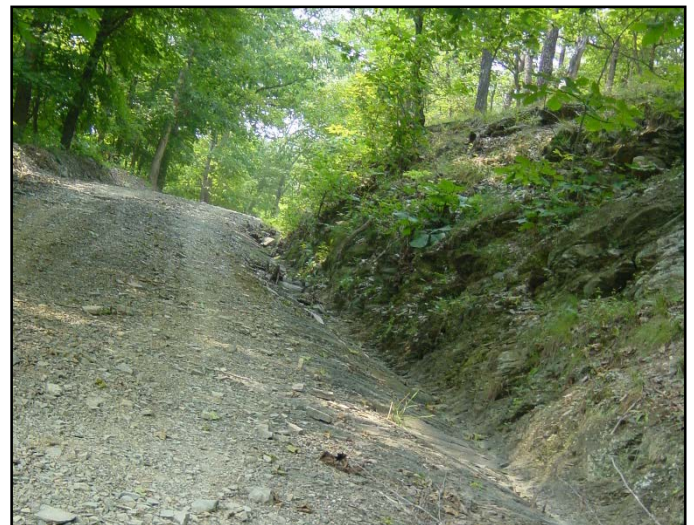
**>10%**

Steep slope. Rises more than 1 foot for every 10 feet of road length. They can generate large quantities of sediment and are some of the most difficult sites to address.

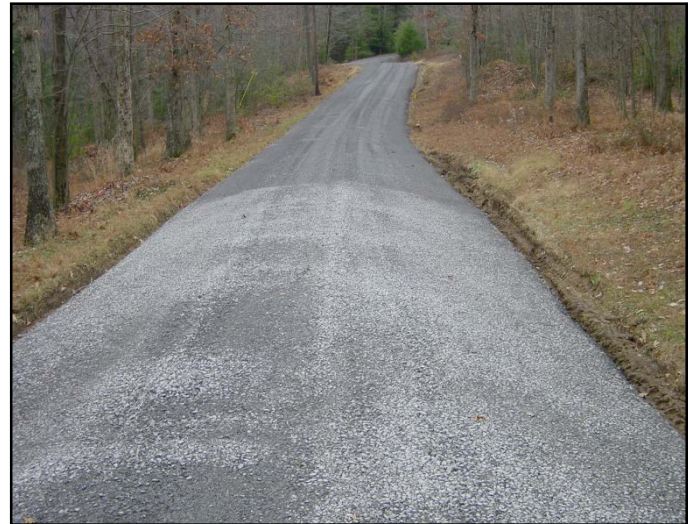
Good surface drainage will shed water perpendicular to the roadway. A crown, which sheds water to each side like a roof, is most common. Side slopes, where the entire road is sloped in one direction, will also work. The road pictured here has good crown.

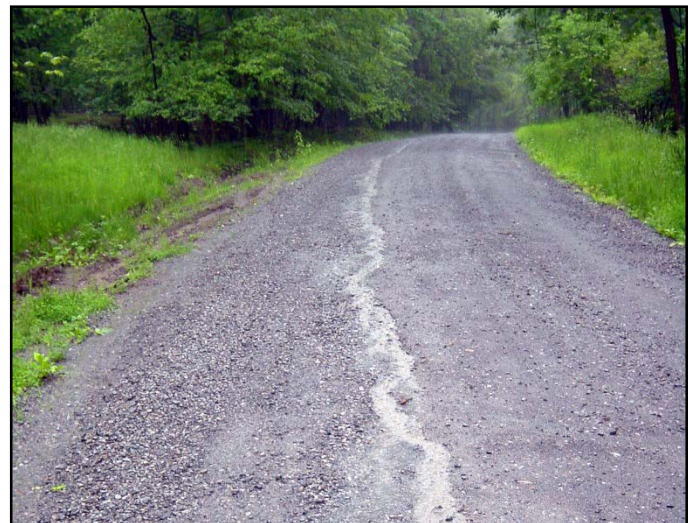
**FAIR**

A relatively flat road that may even have some evidence of water flow in wheel tracks. The road pictured here is relatively flat, and water is beginning to flow down the road instead of to the side.

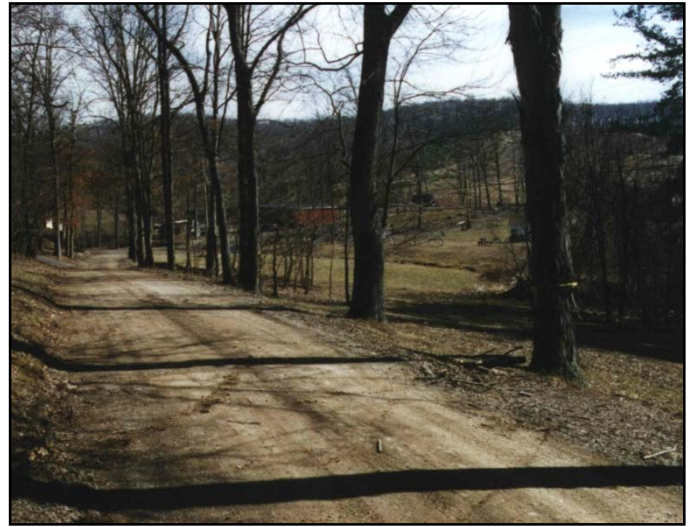
Relatively gentle grade between road and stream. This equates to less than 3 feet of fall for every 10 feet of horizontal distance away from the road. You would have little trouble walking to the stream and back. Roughly equates to a <15 degree slope.

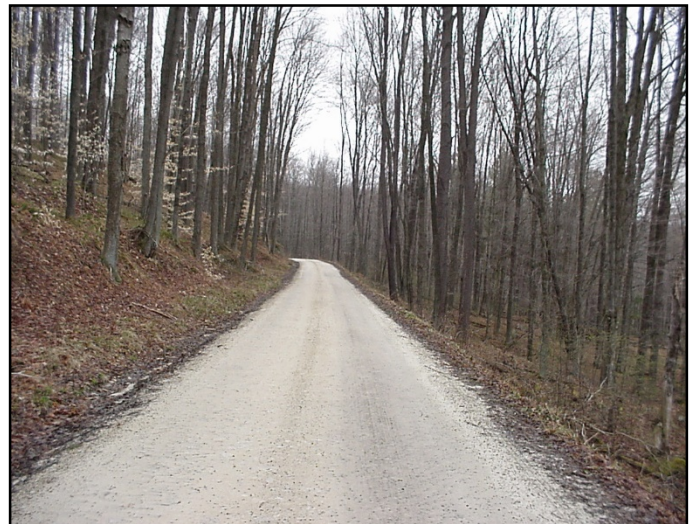
**30% to 60%**

A relatively steep grade between the road and stream. This equates to 3-6 feet of fall for every 10 feet of horizontal distance away from the road. Walking to the stream and back is still possible, but increasingly difficult. Roughly equates to a 15-30 degree slope.

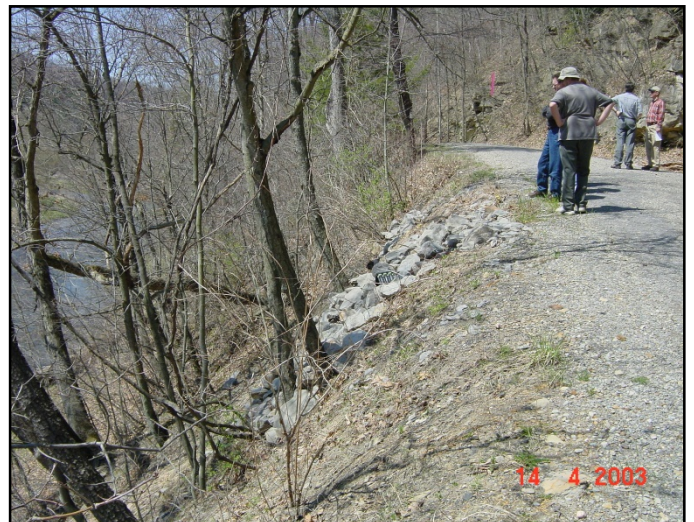
**More than 60%**

A very steep grade between the road and stream. This equates to over 6 feet of fall for every 10 feet of horizontal distance away from the road. Walking to the stream and back is dangerous to impossible. Roughly equates to a >30 degree slope.

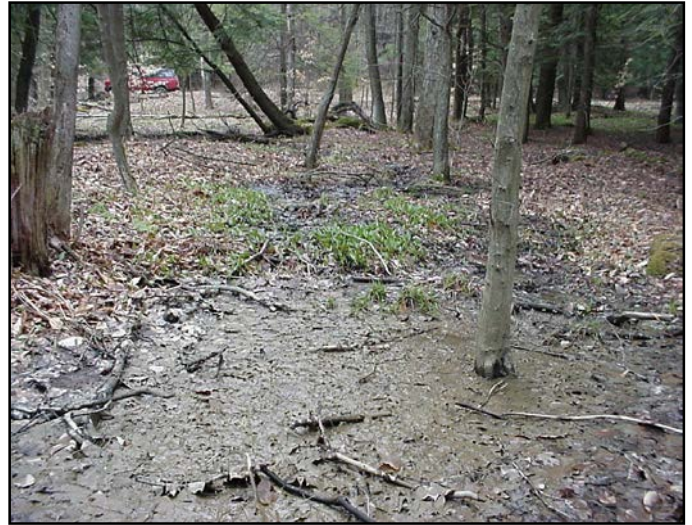
Road stays at least 100 feet away from stream. There are no well-defined channels or tributaries to carry runoff and sediment to the stream. The picture to the right illustrates how far road sediment can travel away for the road corridor. Notice the distance from the road sediment to the truck in the distance that marks the road.

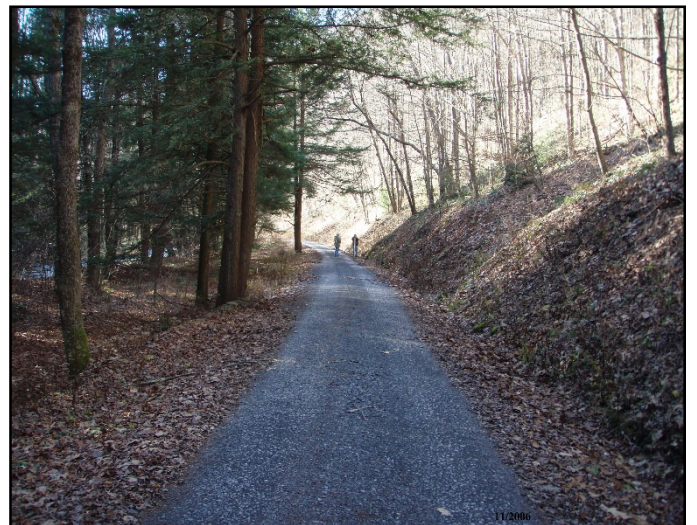
**50 to 100 Feet**

Road stays at least 50 feet away from stream.

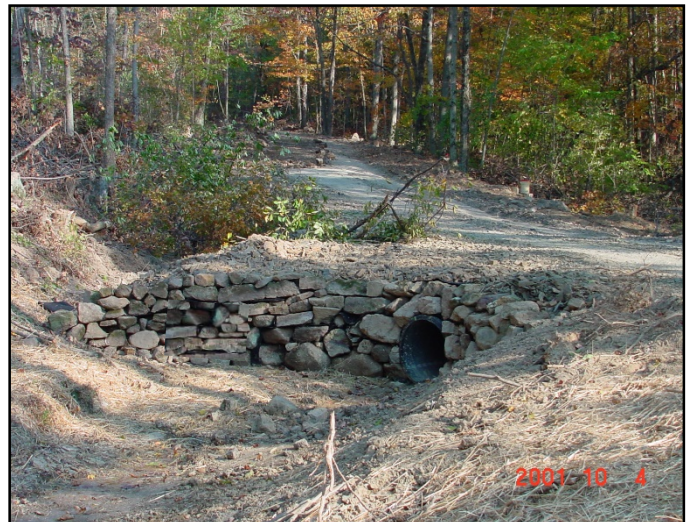
**Less than 50 Feet / Crossing**

Road is within 50 feet of stream, or road crosses stream. These sites present the highest potential for direct discharge of sediment into the stream. The picture to the right shows a dry stream channel. Remember that any sediment that make it to an intermittent channel will eventually make it to a perennial channel. In many cases, road drainage will effectively become the headwaters of the stream!

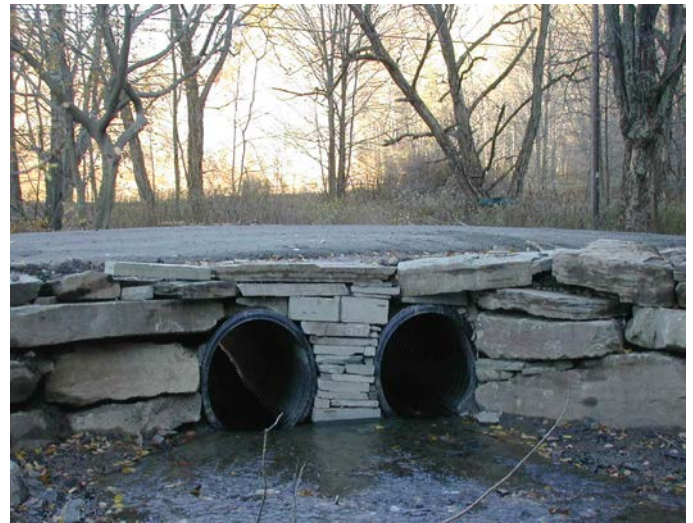
In most cases, if there are no outlets to the stream, you should not be scoring the site because it should not be a worksite. An example of a worksite where you may answer “none” would be if the drainage enters directly from a bridge, not from the ditch outlets. Use this rating where concentrated drainage does not directly enter the stream. The road pictured to the right has no ditch outlets to the stream. A small amount of road area (~100') around the crossing does enter the stream and justify creation of a worksite.

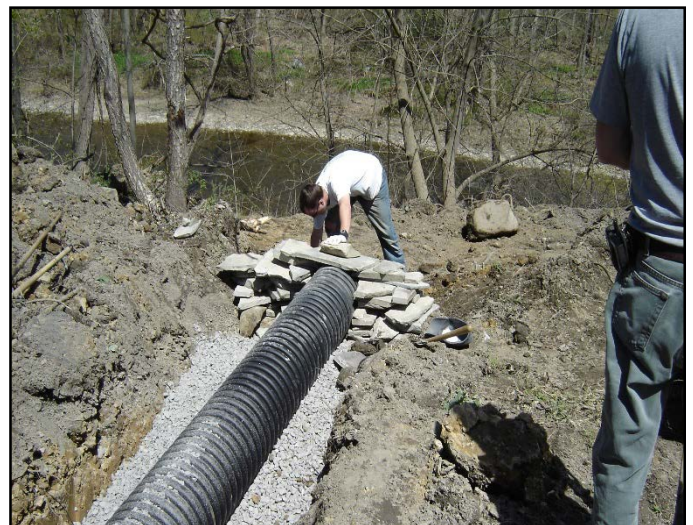
**NEAR STREAM**

In this case, the turnout or culverts empties out near, but not directly into the stream. There should be some chance for filtration and infiltration, but some of the runoff may still affect the stream. In the picture to the right, the pipe being replaced discharges about 40 feet from the water's edge.

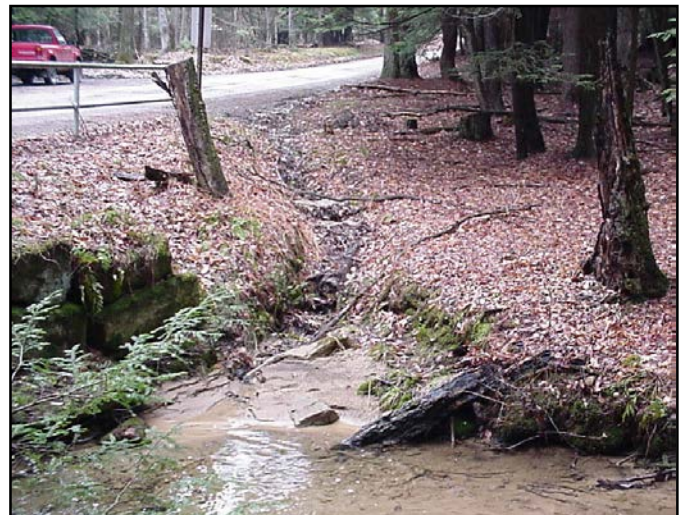
**DIRECTLY INTO STREAM**

These are the obvious worst case offenders. These are ditch outlets (culverts and turnouts) that either empty directly into a stream, or have clearly defined channels cut to the stream. The picture to the right illustrates a ditch that empties directly to the stream at a bridge. A delta of fine road material is clearly visible.

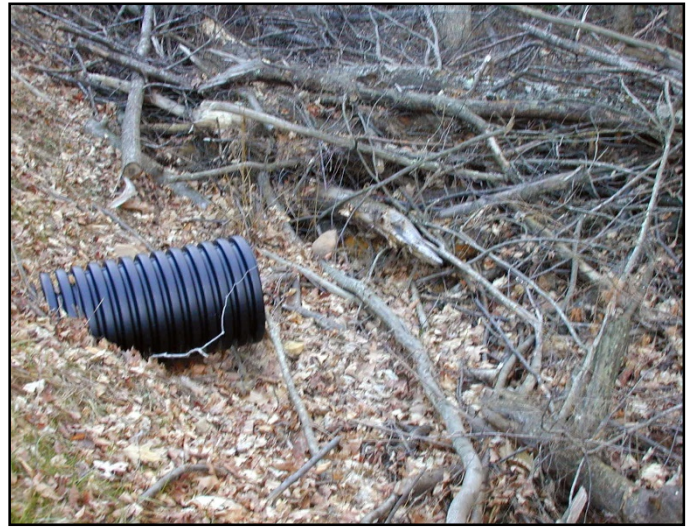
No erosion at culvert or turnout outlet. Preferably, outlets should be at natural ground elevation to promote infiltration and have minimal flow to reduce erosion. Some factors making outlets more stable:

- low water flow volumes
- thick, well rooted vegetation
- well-drained soils
- low gradients
- wide and shallow outlets
- no evidence of erosion from base of outlet
- shallow crosspipes that outlet at ground level

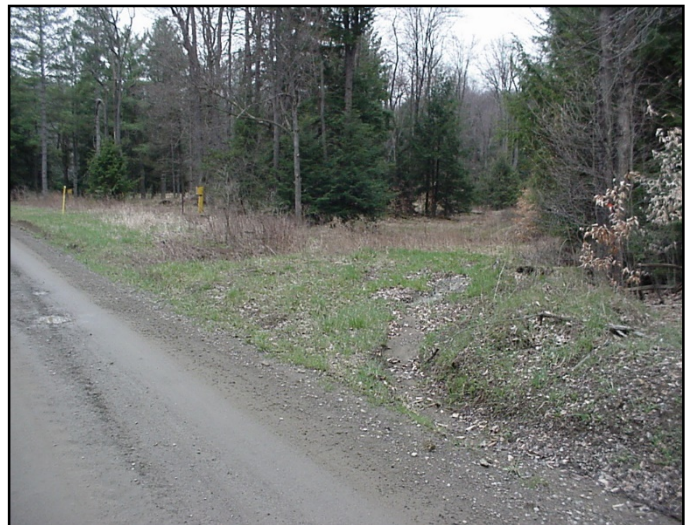
**MODERATE**

Some erosion is evident below the turnout or culvert outlet. Likely causes of erosion are poor soils, lack of vegetation, excessive water flow, and deep or narrow outlets. The bleeder outlet pictured here shows some minor signs of erosion and deposition.

Outlets and bleeders carry water away from the road. They include culvert discharges, turnouts, swales, and any other place where water leaves the road area. They are one of the most important, yet frequently overlooked parts of erosion prevention. Water flow volumes are the major determining factor in outlet stability.

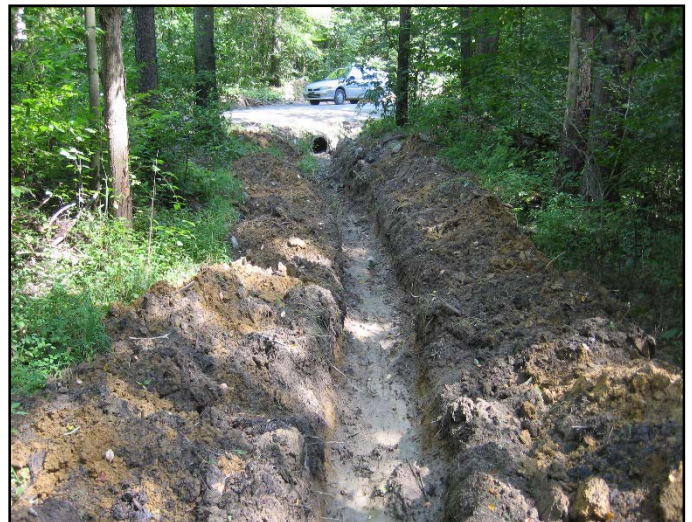
**UNSTABLE**

Outlets are contributing sediment to road runoff. Excessive flow is the major cause of outlet scour, and prevents establishment of vegetation. Outlets from deep culverts are also unstable because they require constant maintenance and disturbance to keep flowing. The unstable outlet to the right is caused by excessive water flow, and a deep culvert that necessitates frequent cleaning of the deep outlet trench.

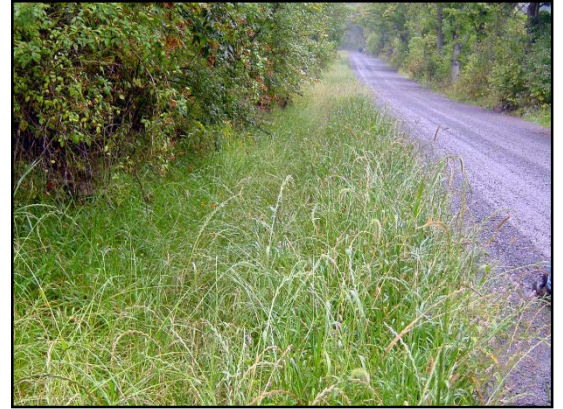
Road Ditch Stability: stability of parallel road ditches**STABLE**

The ditch is either non-existent or shows no evidence of scour or erosion from flowing water.

Instabilities in the road ditch are usually symptoms of excessive water flow. Factors such as off right-of-way water sources, steeper roads, poor material, and lack of outlets will all increase ditch erosion.

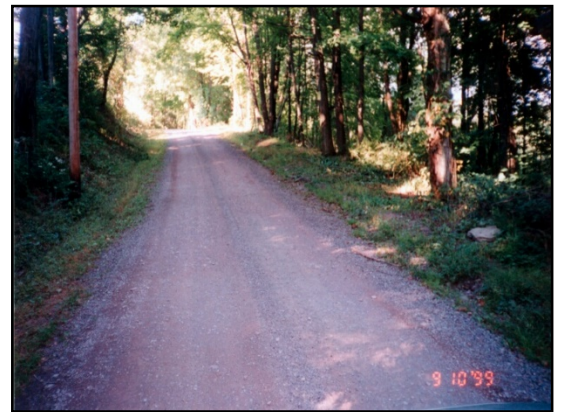
**FAIR**

There is some evidence of flow in the ditch with movement of some fine particles. There is no evidence of downcutting or movement of larger particles over 1". The road pictured to the right has relatively stable ditches, but the long ditch run without an outlets means that large rain events could cause flow volumes and velocities that lead to ditch erosion.

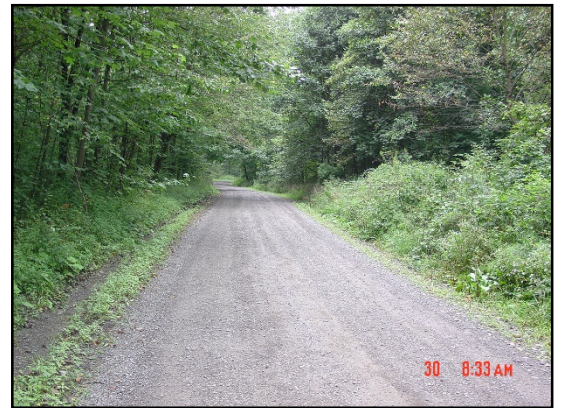
**POOR**

Fairly obvious evidence exists of flow in the ditch. Look for debris racks, movement of larger particles, and the beginning of downcutting.

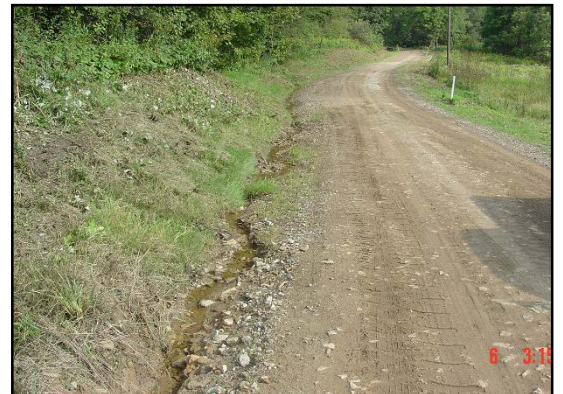
**UNSTABLE**

Some down cutting is occurring in the ditch. The ditch is obviously a source of additional sediment to road runoff. Larger particles (>2") are being moved in the ditch.

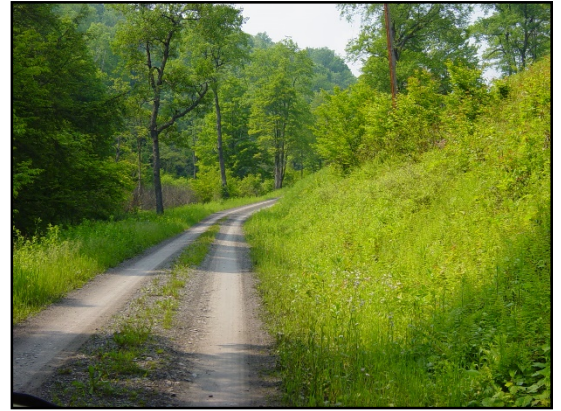
Road Bank Stability: stability of bank on up-slope side of road**STABLE**

Low to moderate slope with good vegetative or rock cover (i.e. <30% slope with 60%+ cover). The uphill road bank is well vegetated and at a stable angle. Little to no soil loss can be expected from the bank. Be sure to account for the time of year when assessing vegetative cover. Bedrock outcrops in the bank are also considered to be stable.

Vegetative cover and slope are the most important factors in determining bank stability. Vegetative cover is important because it reduces erosion from raindrop impacts, and helps to hold the bank together with its root structure. Remember that for sites with varying conditions, you will need to rate the average bank stability.

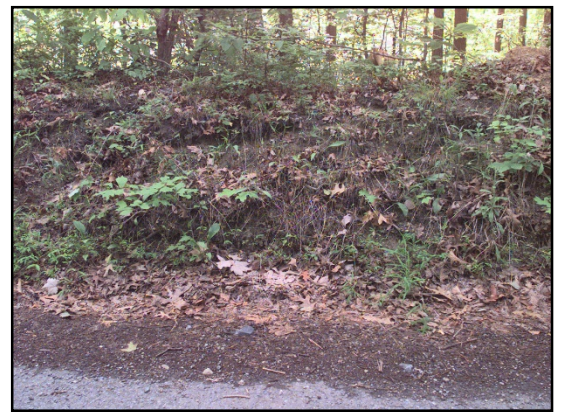
**FAIR**

Some erosion potential. Moderate slope with moderate cover (i.e. 10% - 60% slope with about 50% cover). These banks will have sporadic vegetative cover, but some soil loss can be expected. The bank pictured to the right is fairly steep, with a fair amount of vegetation, but some exposed soil.

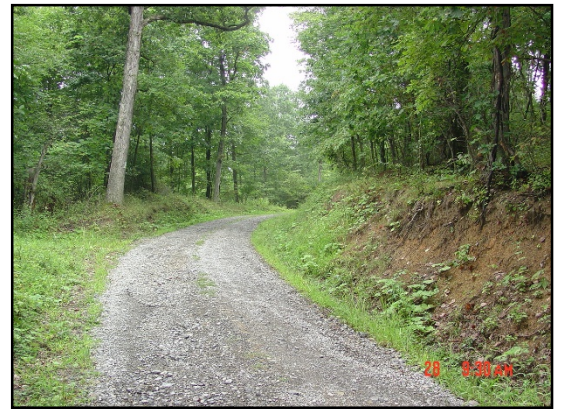
**POOR**

Bank is eroding. Low to moderate slope with little cover. (i.e. 20% - 60% slope with less than 40% cover). Vegetation is sparse with potential for substantial soil loss. The bank pictured here has some vegetated sections combined with some bare sections.

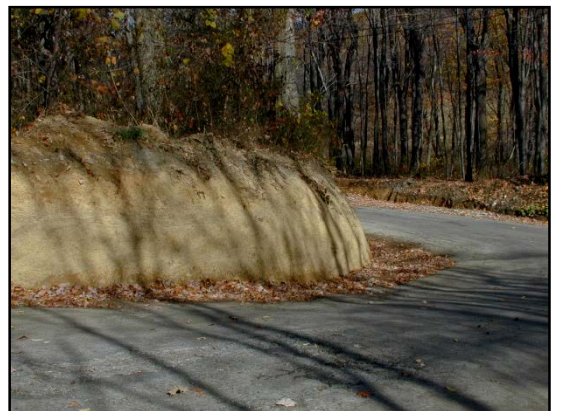
**UNSTABLE**

Obvious bank erosion and soil loss. Moderate to steep slope with little vegetative cover (i.e. >30% slope with <30% cover). In many situations, unstable vertical banks are caused by the continual cutting of the toe or bottom of the slope during ditch maintenance activities. The bank pictured here is extremely unstable because the toe of the slope is continually cut away during maintenance activities.

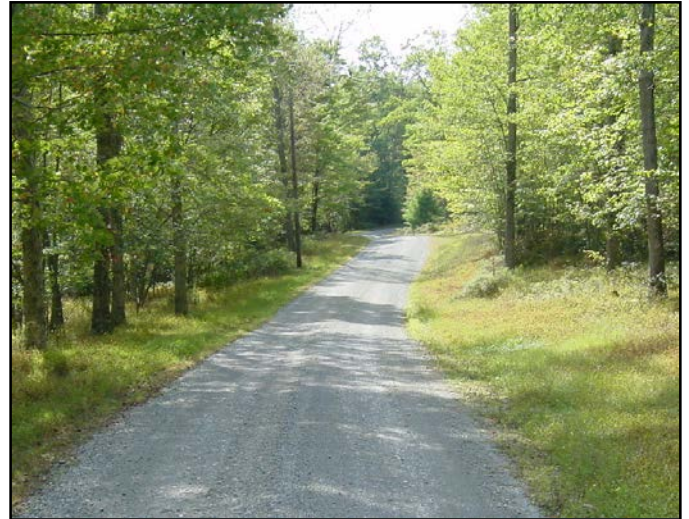
Average Canopy Cover: relative amount of shading on roadway**MODERATE**

Moderate canopy cover is preferred for most roads. Moderate canopy cover can be thought of as about half of the road being shaded during a typical summer day. If the leaves are not out, approximately 10% shading would be optimal.

Canopy cover affects the amount of moisture retained by the road. A moderate or ~50% summertime shading is preferred (equates to ~10% shading when leaves are not out). A lack of cover dries the road to create excessive dust. A heavy canopy causes the road to retain water and be more susceptible to rutting.

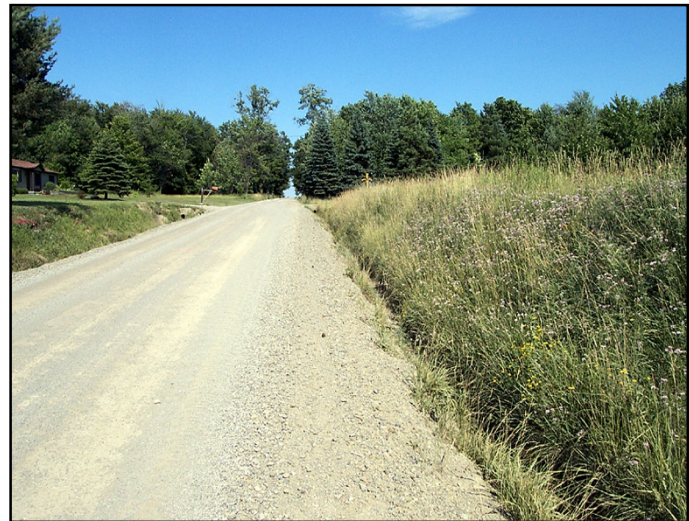
**MINIMAL**

The road has little to no shade, even if all leaves are out. These roads will often have excessive dust problems in dry weather. The canopy cover or degree and consistency of shade affects: direct impacts of precipitation, rate and pattern of drying, rate and pattern of thawing, ability of vegetation to stabilize banks, aesthetics and maintenance costs.

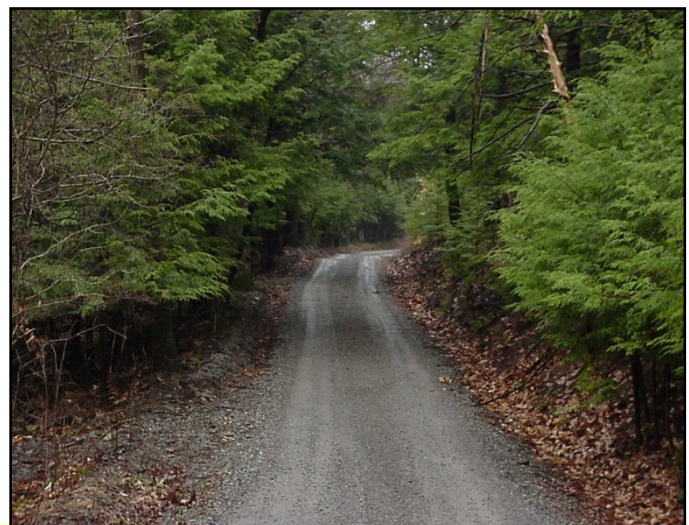
**HEAVY**

Some sections of road are totally shaded by trees or nearby hills. This causes evaporation of any water in the road area to occur very slowly. Proper drainage is very important on roads that are heavily shaded.
